HOME INSPECTION REPORT

Report Number: 4507

Address: N3691 Claire Rd. Taylor

Opelt's Home Inspection LLC

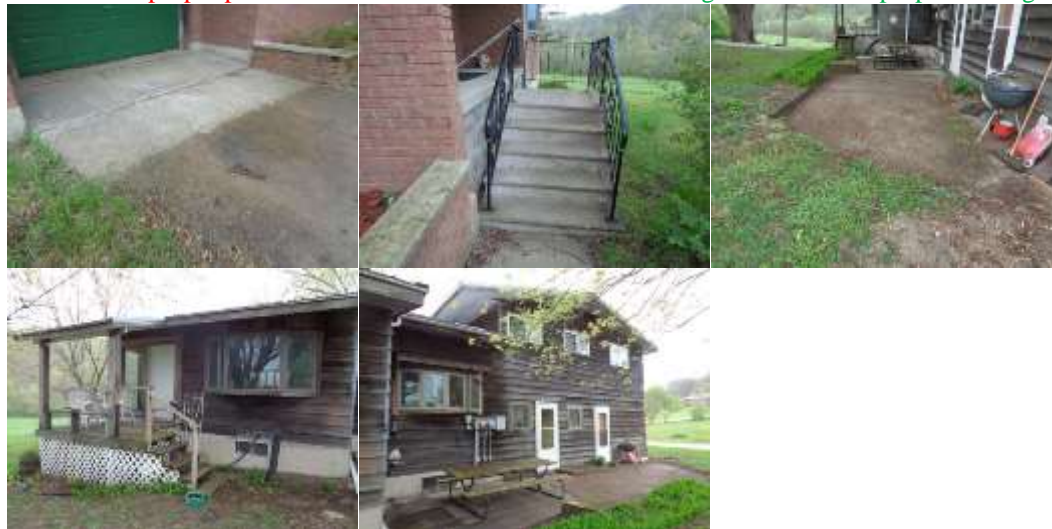
**DRIVEWAY/PARKING**Material: ☒ Concrete ☒ AsphaltCondition: ☒ Reviewed**STOOPS/STEPS**☒ **Safety Hazard** ☒ large gap between home/step oneMaterial: ☒ ConcreteCondition: ☒ Reviewed ☒ **Settled****DECK/BALCONY** (flat, floored, roofless area)Material: ☒ Wood ☒ **Railing/Balusters (proper spacing) recommended**Finish: ☒ Treated ☒ damaged/worn woodCondition: ☒ Reviewed ☒ **there was some unconventional framing visible****LANDSCAPING AFFECTING FOUNDATION**(See remarks page) ☒ **Trim back trees/shrubberies**Negative Grade: ☐ East ☐ West ☐ North ☒ South ☒ Reviewed (may be limited do to landscape materials)☒ **Recommend maintain a proper pitch away from the foundation**☒ Some negative pitching was visible (one or more areas) recommend repair as needed**PATIO**☒ **Pitched towards home (See remarks page)**Material: ☒ Concrete/paversCondition: ☒ Reviewed ☐ Not Reviewed ☒ **Settling****GENERAL COMMENTS**

Uneven slabs in walks, could be a tripping hazard, repair and/or replace as needed. Recommend moving the balusters closer together – may be a safety concern for small children. Steps were settled and in need of repair and/or replacement. Recommend proper pitch from foundation in low areas. Monitor gutter drains for proper drainage

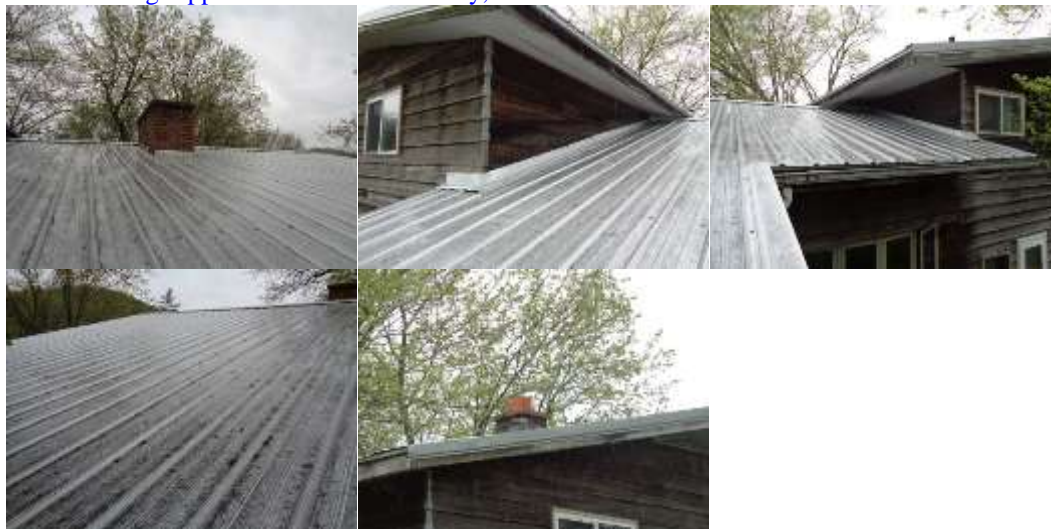
Note: Some deflection may be present to roof structure(s) due to age/construction of the home.
Note: Joints/flashings covered with tar/sealant may need on-going maintenance.

Roof coverings appeared overall satisfactory, but will need minor maintenance.

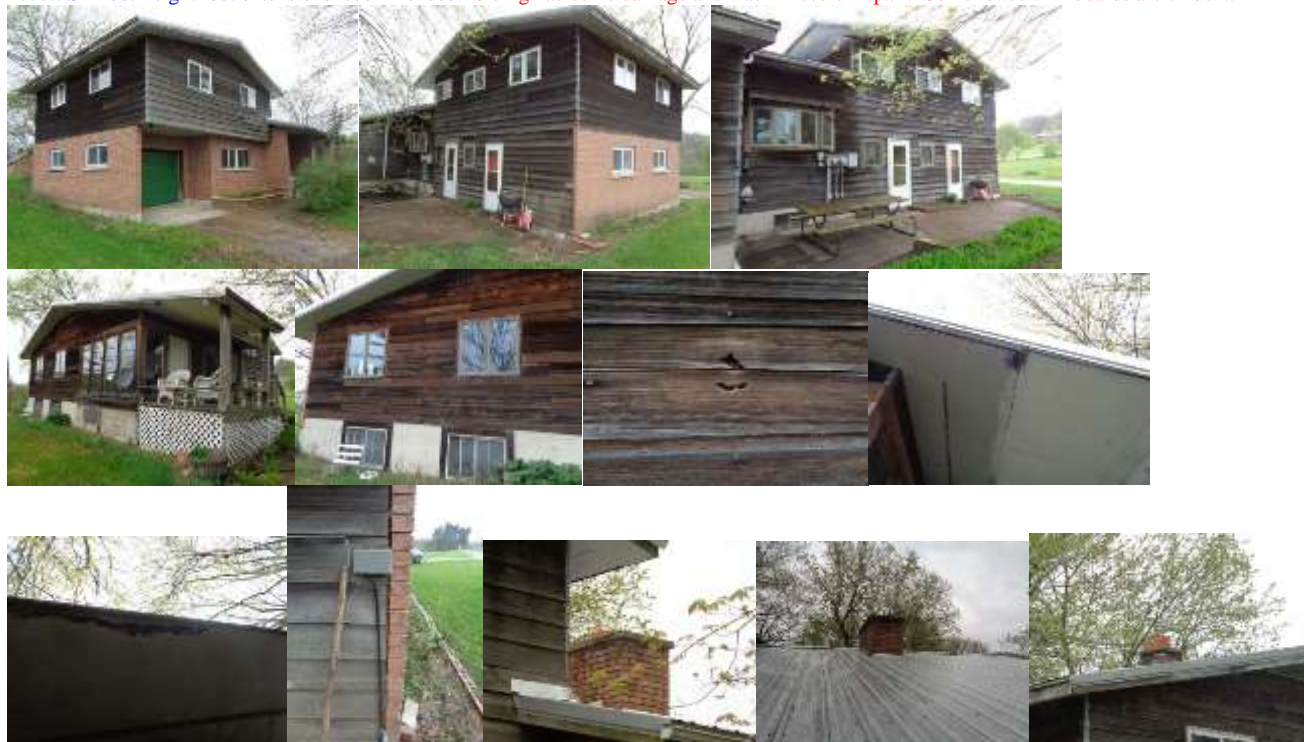
Recommend capping the flue with a screened weather cap. Chimney flue was not evaluated. Insides of gutters are full of debris and need to be cleaned out. Gutters on only a portion of the house, recommend additional gutters where needed. Recommend adding downspout extensions to discharge away from the house. Six foot - eight foot extensions recommended. Siding had some damage and was in need of repair. Some rotted trim boards are evident.

Basement area showed signs of standing water *Recommend maintain a proper pitch away from the foundation*
Siding had some damage and was in need of repair. Some rotted trim boards are evident.

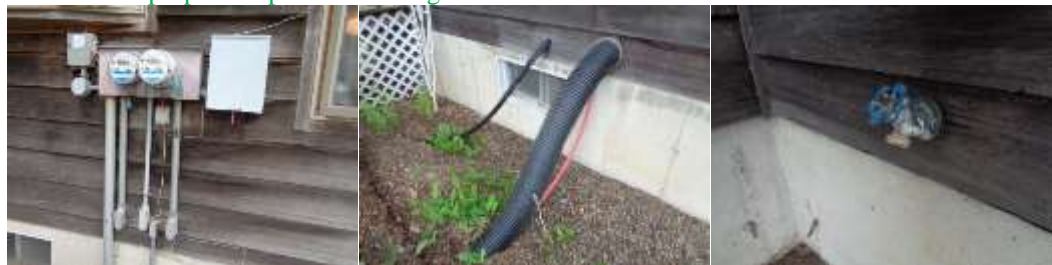
Recommend proper sump drain discharge line.

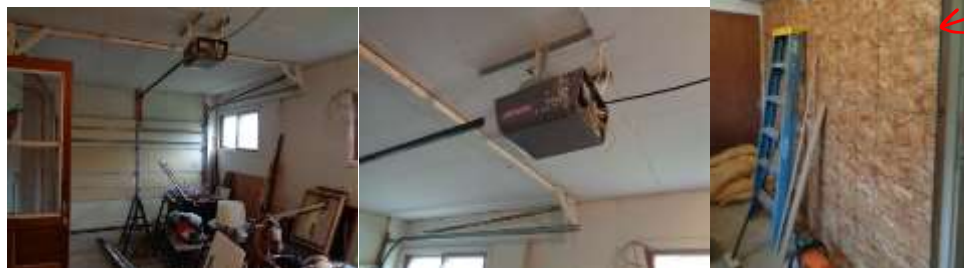
GFCI Present: ☒ No **Operates:** ☒ Handyman/extension cord wiring, open junction(s) ☒ Safety hazard
FIRE SEPARATION WALLS & CEILING
 (Between garage & living area) ☒ potential firewall breach

Garage door and opener was in normal working order. The foundation was overall adequate with no major defects evident. Garage floor has typical cracks. Firewall between garage and living area not present in some areas - Potential Safety Hazard Handyman wiring was found repair as needed (extension cord wiring, missing GFCI protection).

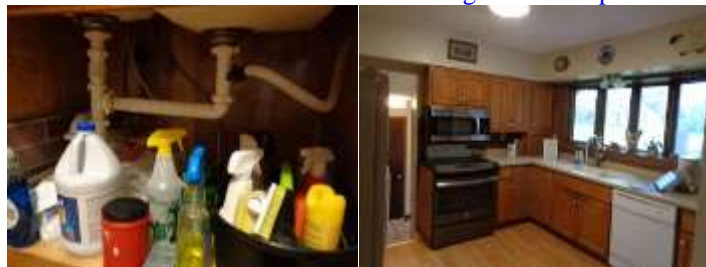
Counter top has normal wear. Cabinets have normal wear. Water flow was normal with several fixtures operated at the same time. Drain lines had no visible leaks or signs of backup at the time of inspection.

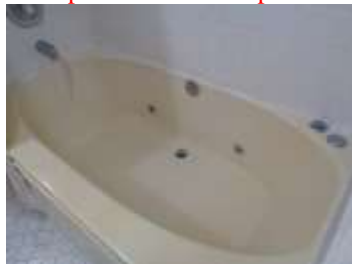
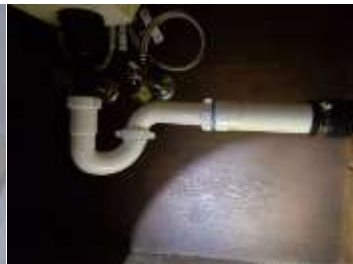
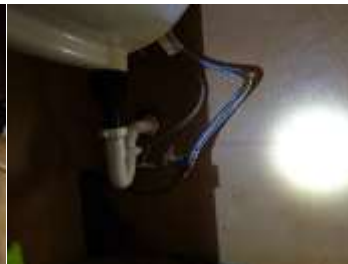
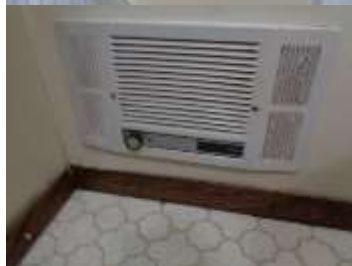
Whirlpool tub did not operate.

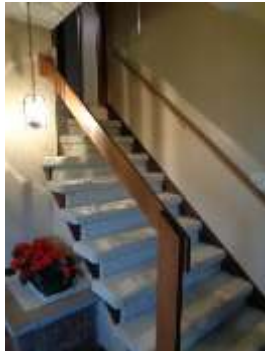
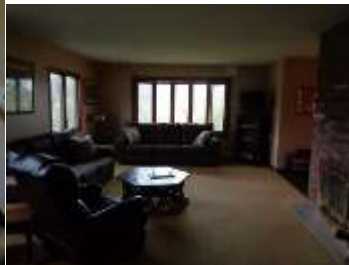
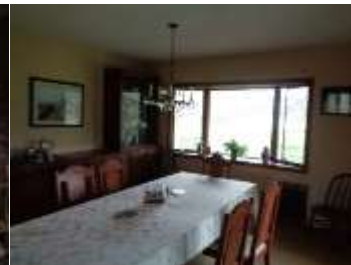
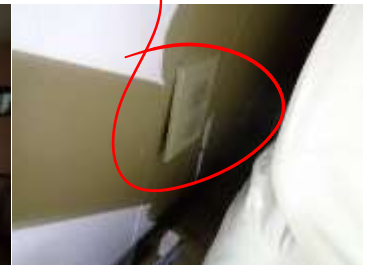
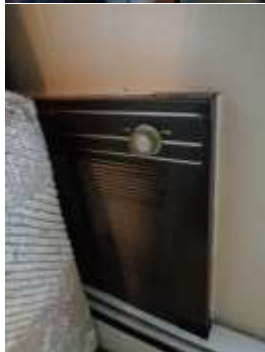
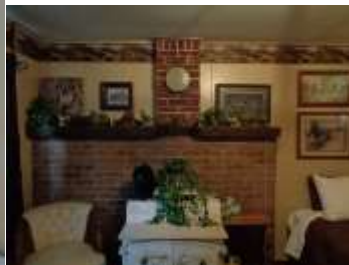
LOCATION: FIRST FLOOR

heat thermostat on living room wall did not know what it controlled. Loose outlet.
Missing balusters.

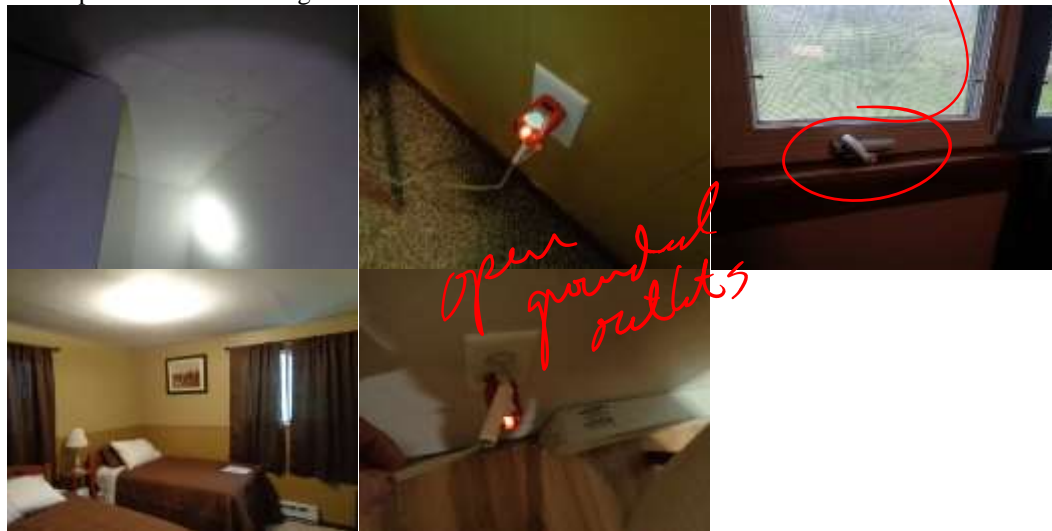
LOCATION: SECOND FLOOR

Past repairs/stains on ceiling

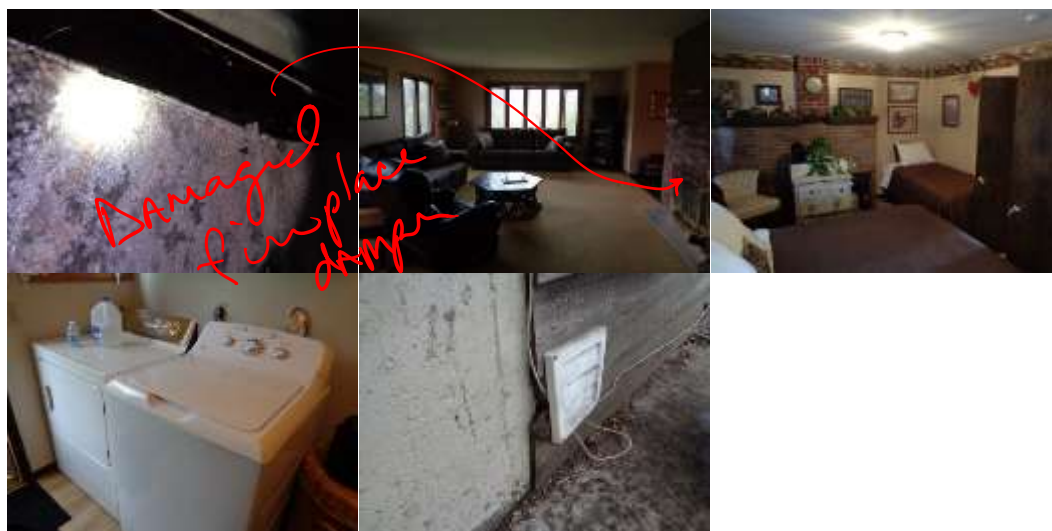
Note: Flues area not tested/inspected Location(s): [Family room](#)
Type: ☒ Wood ☒ Wood-burner stove (See remarks page)
Material: ☒ Metal (pre-fabricated) ☒ Masonry
Damper operates: ☒ No
Hearth Adequate: ☒ Yes ☐ No **Mantle:** ☐ N/A ☒ Adequate ☐ Loose/missing
Physical Condition: ☒ Reviewed ☒ **Fireplace need repair before use**

(See summary page) ☐ Missing in one or more areas
Present: Smoke Alarm/detector(s): ☒ Yes ☐ No (detector(s) are not tested) ☒ battery operated ☐ Hard wired
 CO Alarm/detector(s): ☒ Yes ☐ No (detector(s) are not tested) ☐ battery operated ☒ Hard wired/plugin
Note: Recommend proper Smoke or C/O in recommended areas of the home as required before closing (not all detectors may have been visible/verified). Recommend verify at closing walk through.

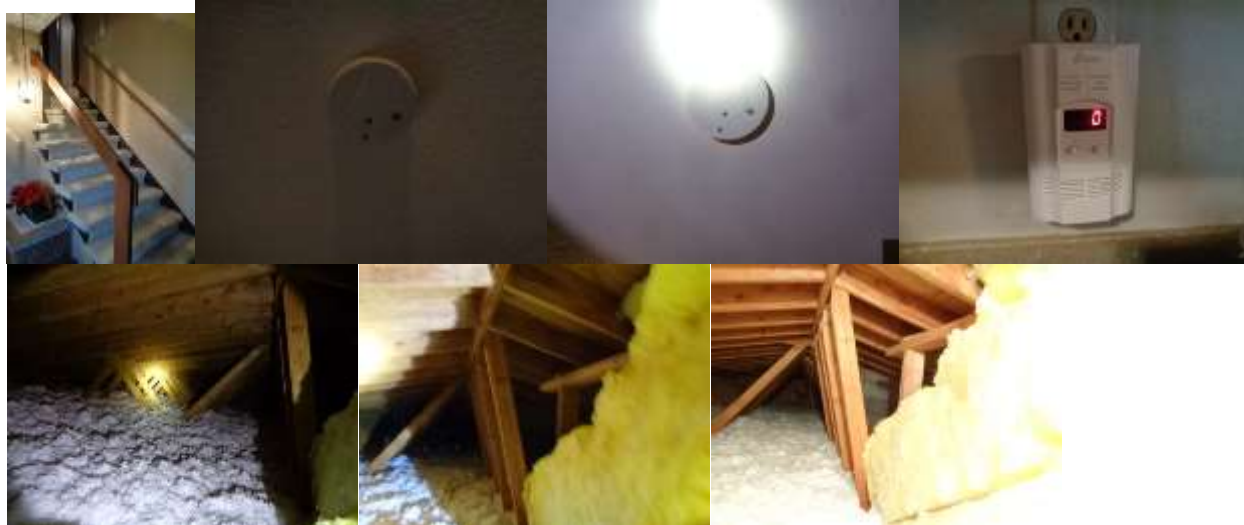
Note: recommend proper closet light(s) as needed as Incandescent bulbs are not allowed (possible safety concern).

Co detectors are needed on each level. Change smoke detectors as manufacture specs. Rafters/trusses appeared to be in overall adequate condition. Roof sheathing, examined from the attic, showed no major defects or moisture damage. Insulation was sufficient for homes in this area. Ventilation was normal.

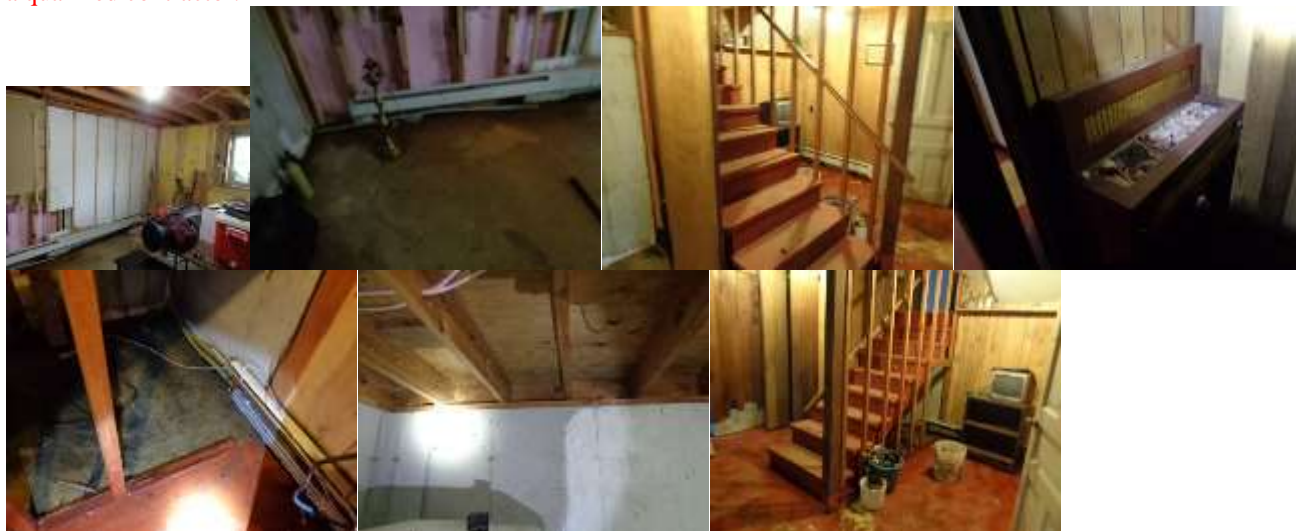
FOUNDATION **Condition:** ☒ Reviewed **Repair:** Fresh moisture present ☒ recommend evaluated/repaired
☒ Visible cracks/moisture.

Indication of Moisture: ☒ Yes ☒ stains (present/past) ☒ Efflorescence present
☒ Mildew/mold like substance was visible on some surfaces ☒ Basement area showed signs of standing water.

Foundation showed only typical minor shrinkage cracks. Floor appeared to be in overall satisfactory condition.
 Mold/mildew substance was visible recommend repair. Standing water is present in the basement - recommend evaluation by a qualified contractor.

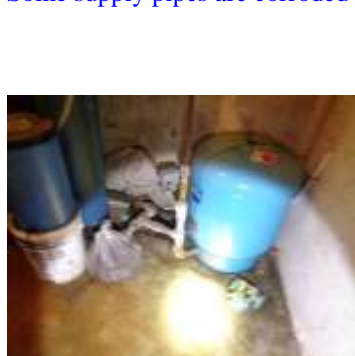
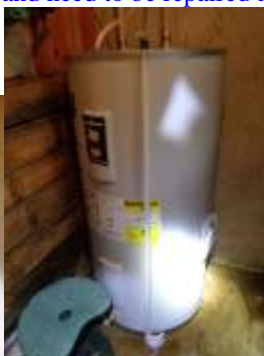
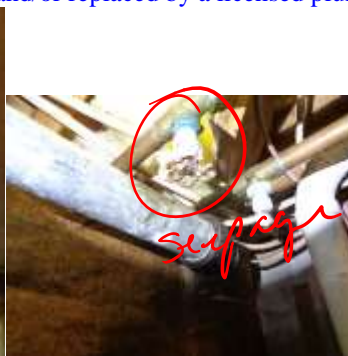
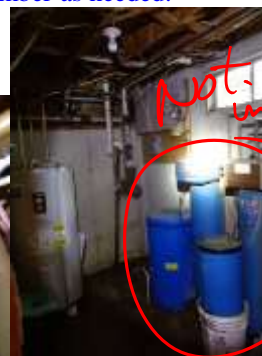
Some supply pipes are corroded and need to be repaired and/or replaced by a licensed plumber as needed.

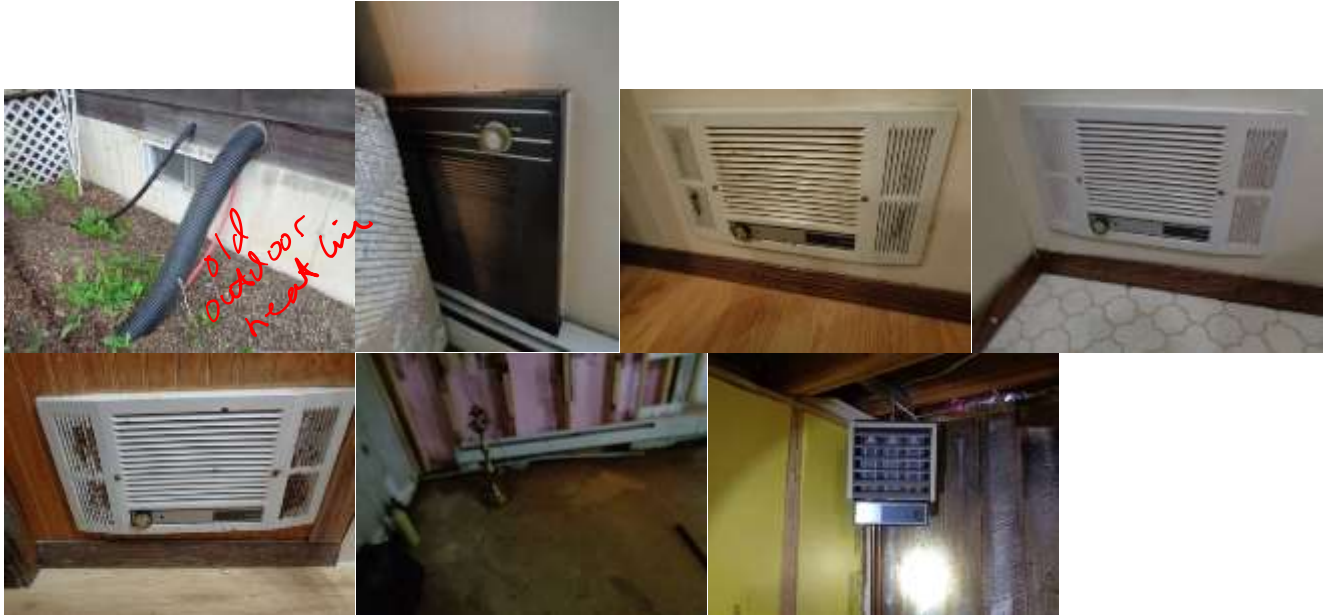
Electric heaters were in working order. Outdoor wood stove/hydronic heat was not in use.

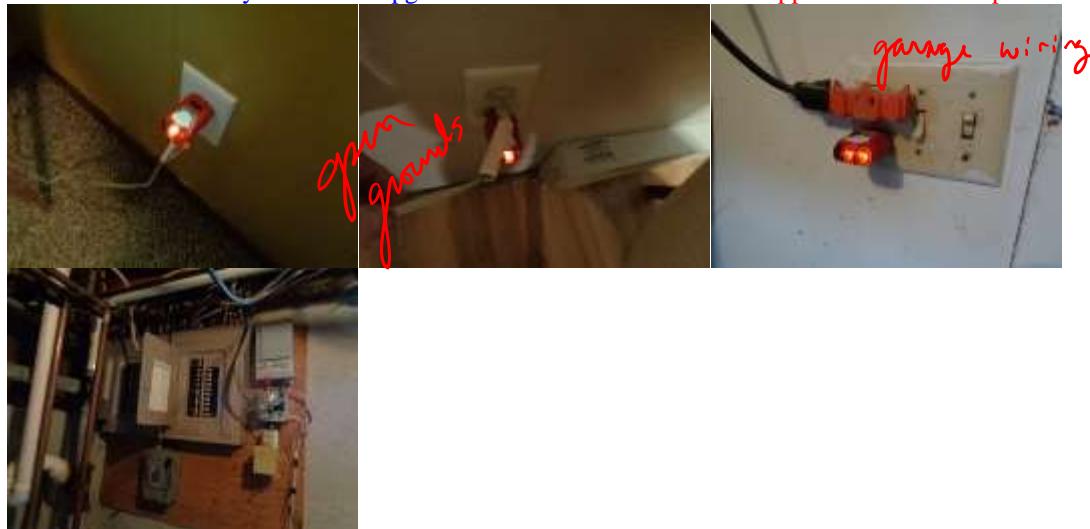
Adequate Clearance to Panel: ☒ No recommend proper clearance.

☒ Double tapped breakers are not recommended.

☒ Extension/lamp cord wiring ☒ Loose/unprotected (NM) wiring visible in one or more areas (recommend proper conduit protection)

Panel was full and may need to be upgraded for future needs. Double tapped breakers were present.

Recommend electrician evaluate/repair electrical system as needed*

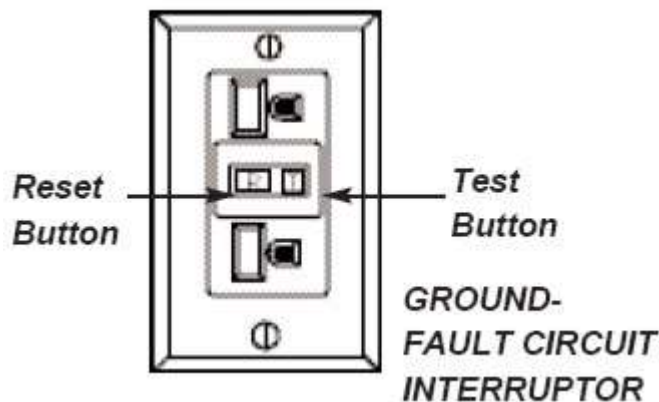
See diagram below:

Every effort has been made to evaluate the size of the service. Three wires going into the home indicate 240 volts. The total amperage can be difficult to determine. We highly recommend that ground fault circuit interrupters (G.F.C.I.) be connected to all outlets around water. This device automatically shuts the circuit off when it senses a current leak to ground. This device can be purchased in most hardware stores. G.F.C.I.'s are recommended by all outlets located near water, outside outlets, or garage outlets. Pool outlets should also be protected with a G.F.C.I.

If you do have G.F.C.I.'s, it is recommended that you test (and reset) them monthly. When you push the test button, the reset button should pop out, shutting off the circuit. If it doesn't, the breaker is not working properly. If you don't test them once a month, the breakers have a tendency to stick and may not protect you when needed.
