# Property Inspection Report

7112 W 350 N, West Lafayette, IN 47906  
Inspection prepared for: Johnny Klemme  
Real Estate Agent: -

Date of Inspection: 7/17/2023 Time: 9:00 AM  
Age of Home: 62 yrs Size: 1056 sq ft  
Weather: cloudy  
Order ID: 32556

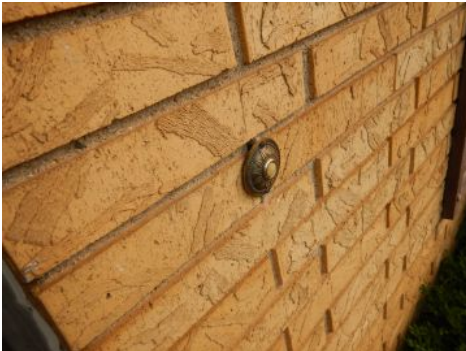
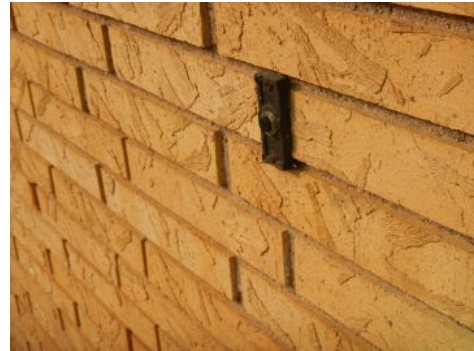
- The door bell operated today

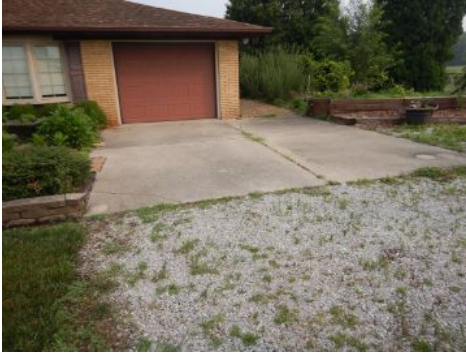
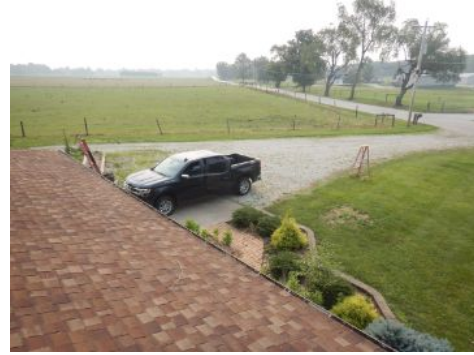
- The exterior hard surfaces were in normal condition at the time of inspection. Minor cracks in concrete or asphalt are normal, considered typical, and cracks in hard surfaces are found at all properties. It is recommended to seal cracks. When water gets in cracks and freezes, it can cause heaving that may shift material or create larger cracks. No concerns present
- no concerns with gravel portion of driveway (older concrete drive has gravel over top by road)

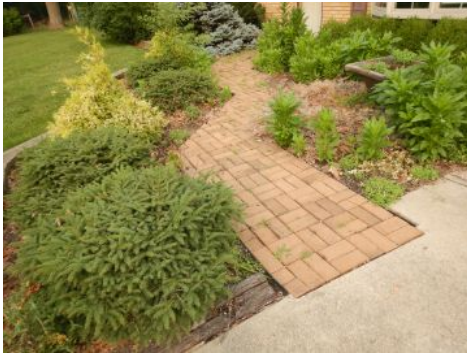
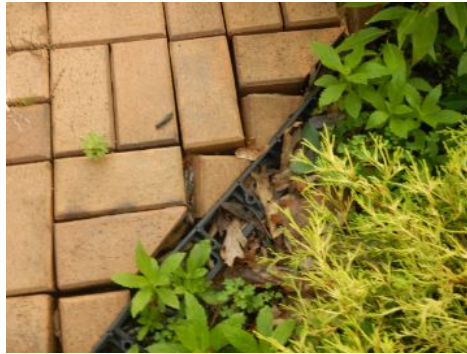
- Walkway constructed from patio /bricks stones, are (mostly) in functional condition. add sand under skewed bricks as needed

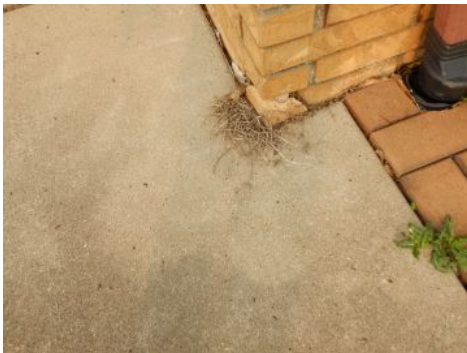
- The exterior walls of the house are covered with brick veneer siding. loose bricks and spalled bricks (primarily along right side) should be repaired/ replaced

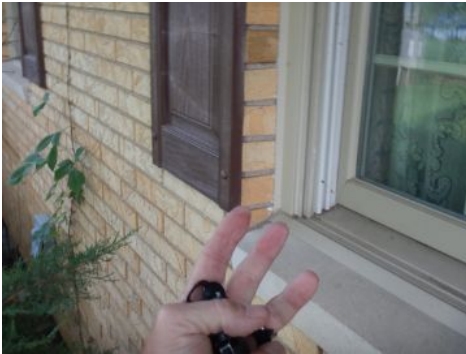
- most windows did not have screens. a box is present in basement/ basement window screens are damaged

missing screens

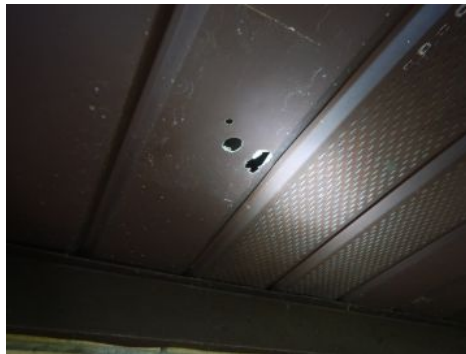
- The fascia board, soffits and trim are in acceptable condition. (seal minor damage)

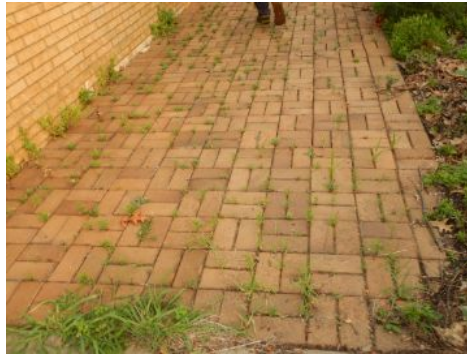
- no significant concerns noted. (along side of garage, possibly for additional parking?)

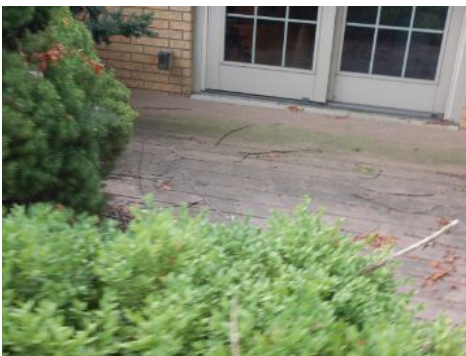
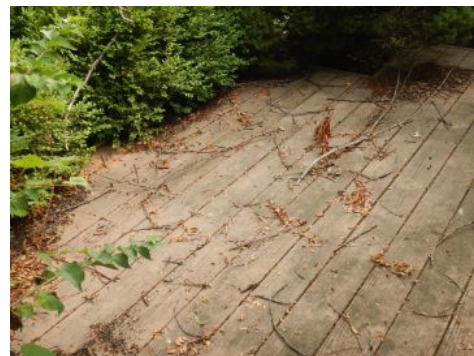
- it is important to keep deck sealed deck with paint or stain to protect water damage, rotting, and warping . With proper maintenance, a deck can last as long as your home
- Underside of deck not visible. Deck framing appears solid when walked. some boards are showing signs of age. replace boards as needed

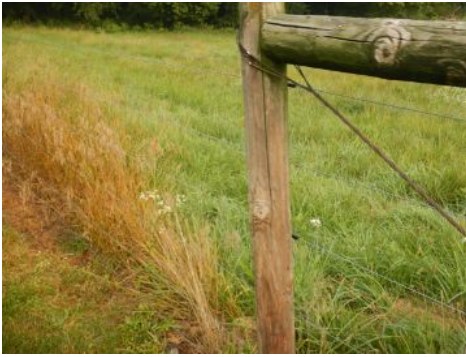
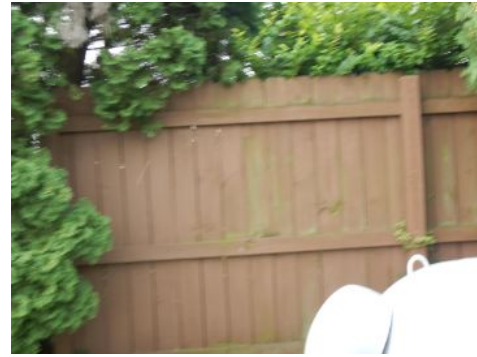
- Wood and wire fence present and reasonably functional.

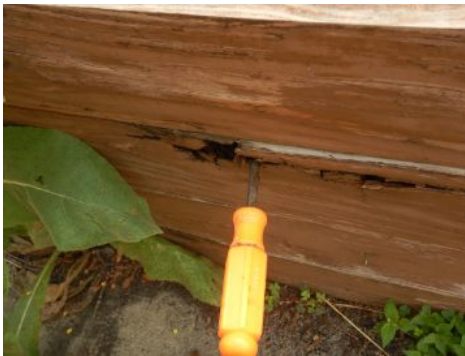
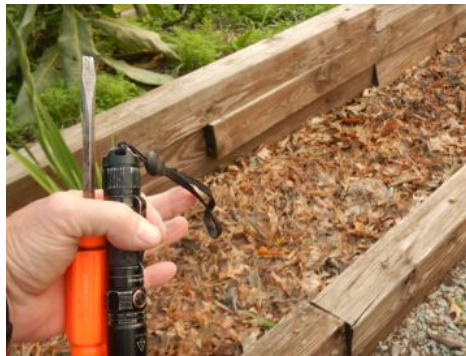
- wood landscaping between house and shed is showing age with a lot of water damage (will not likely cause damage to house or shed)
- **grading has a lot of ground hog damage/ activity that is likely causing a lot of water intrusion into basement and can potentially cause foundation problems in future if not corrected in near future.**

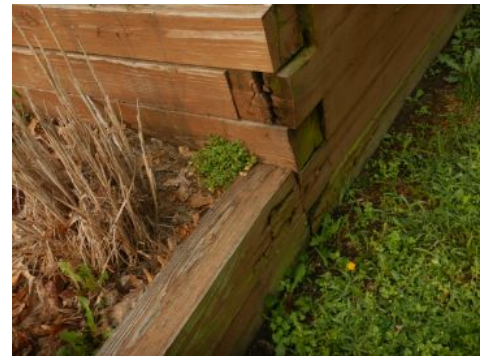
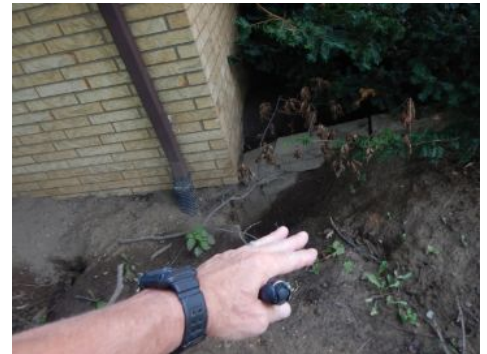
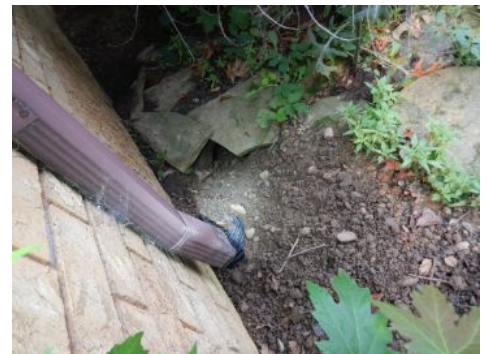
landscaping is showing age  
(6x6s will need replaced in ne

| <b>Exterior</b> | | |
|---|---|---|
| Page 7 Item: 14 | Grading/Surface Drainage | • grading has a lot of ground hog damage/ activity that is likely causing a lot of water intrusion into basement and can potentially cause foundation problems in future if not corrected in near future. |

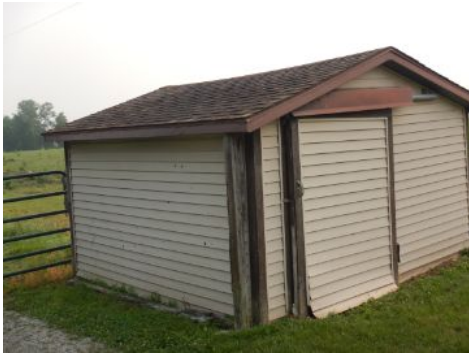
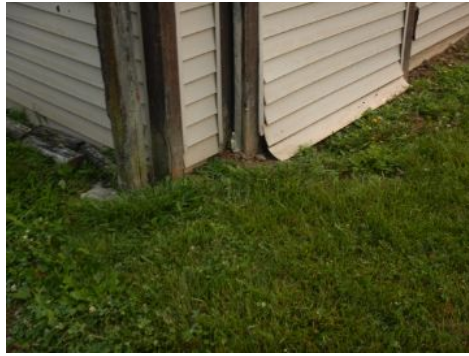
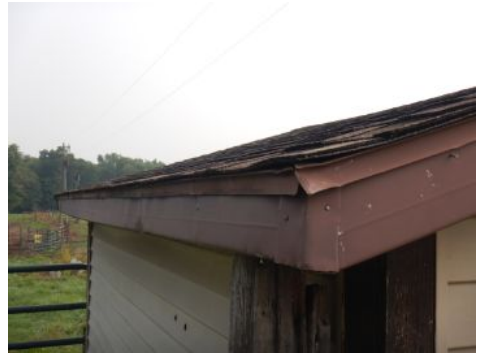
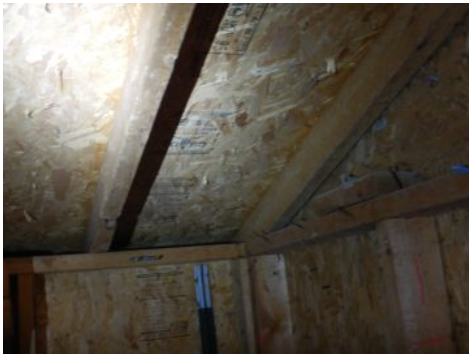
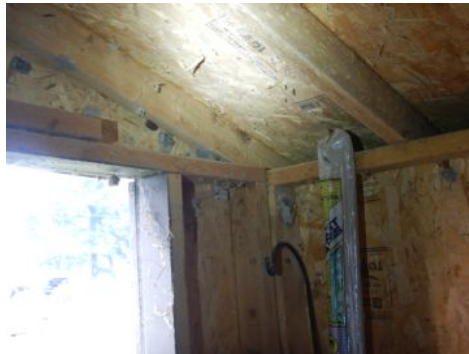
- wood shed present and reasonably functional. (door siding is loose with minor water damage at bottom of door) . vinyl has a lot of small holes

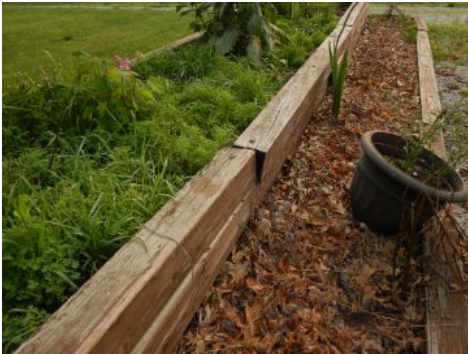
landscaping is showing age  
(6x6s will need replaced in near future)

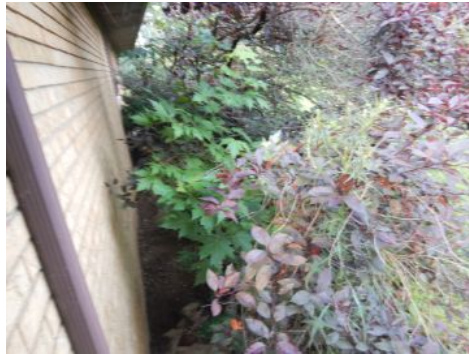
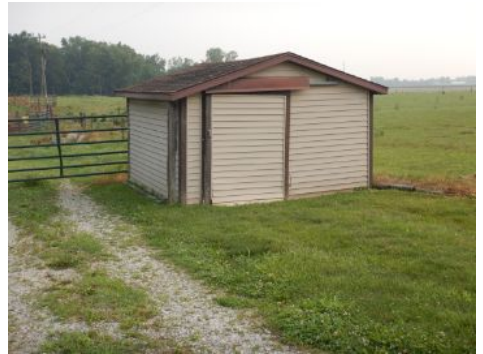
- It is important that landscape vegetation be kept well pruned and not permitted to grow up against or near any part of the home. Plantings and trees too close to the building can cause harm through moisture and root damage to the foundation, as well as providing a path for pest and insect infestations into the home. Vegetation should be trimmed, pruned, or removed to maintain at least 10-12" from the structure.

- Allowing a tree to grow close to house (or driveway, walkway, shed, deck or fence) assumes the potential risk of damage from root growth or high winds

- **I always recommend having qualified tree trimmer or arborist evaluate trees and recommend trimming trees as needed that could potentially cause damage to house, fence, sheds, etc). Trim trees per their recommendations (loose/ dead limbs will likely cause damage to fences and or electrical lines if not cut back in near future)**

| <b>Exterior</b> | | |
|---|---|---|
| Page 9 Item: 16 | Vegetation Affecting Structure | • I always recommend having qualified tree trimmer or arborist evaluate trees and recommend trimming trees as needed that could potentially cause damage to house, fence, sheds, etc). Trim trees per their recommendations (loose/ dead limbs will likely cause damage to fences and or electrical lines if not cut back in near future) |

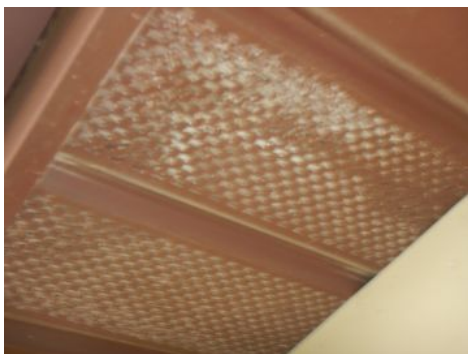
• **Moisture stains in soffits indicate past or present roof leak. check stains for changes periodically as that would indicate if leak is active (I cannot determine if leaks are active, not could I see extensive damage in area from attic)**

soffit stains/ oxidation above bump out

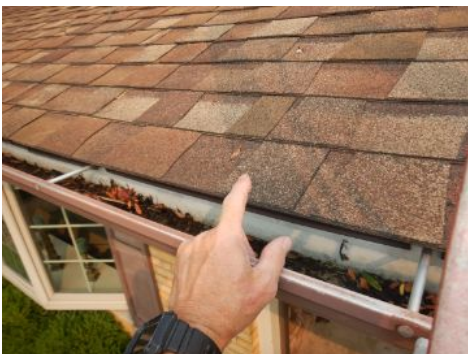
- 1 visible layer of asphalt shingles. Shingles appear to be in middle to late middle stage of useful life cycle. Dimensional shingles are typically 30 year shingles (potentially more). No concerns

One visible layer of asphalt shingles

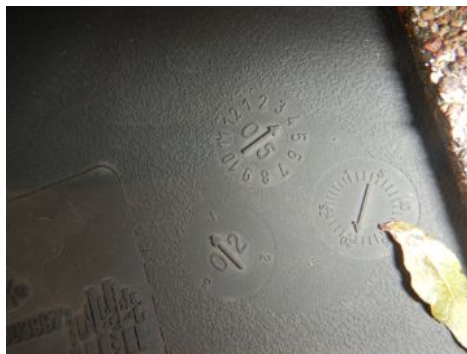
penetration boot is dated 2005

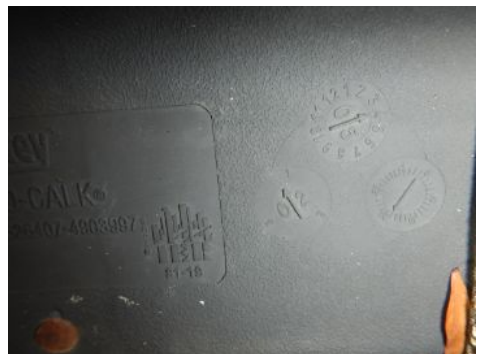
penetration boot is dated 2002

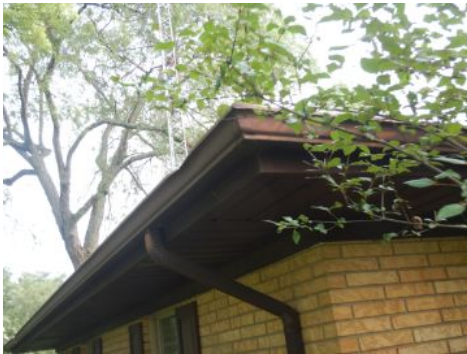
some dents present

- Debris has accumulated in one or more gutters and / or covers . Gutters should be cleaned now and as necessary in the future. Gutters with covers need to be flushed as needed as fine debris accumulates and can cause blockage . reconnect drainage pipes to downspouts

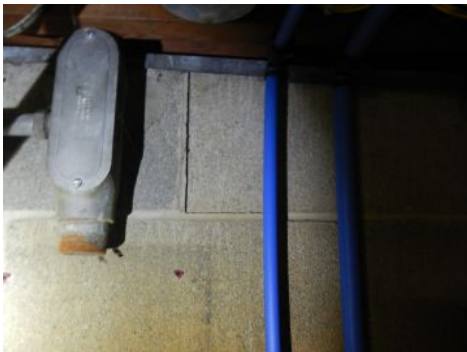
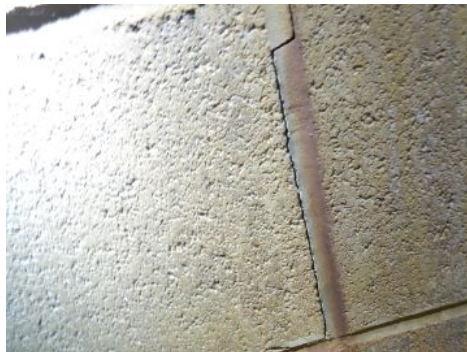
- The house is built on a concrete / block basement. Minor Cracks are common in all concrete products and the condition of this foundation is mostly considered typical or normal for the age of the home. I recommend sealing any cracks in block or mortar to keep water out. Water expands when it freezes and make cracks larger. This is routine maintenance and should be observed periodically and repaired (now and as needed in future). currently cracks are hair line type

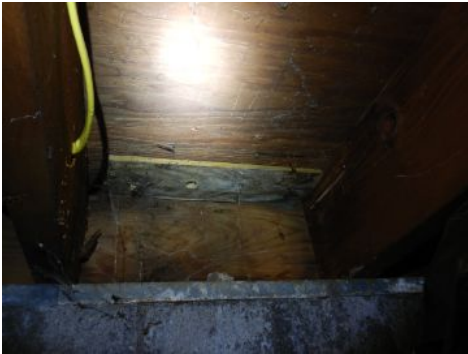
small repair under front door

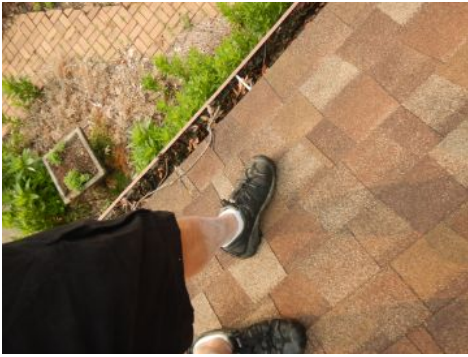
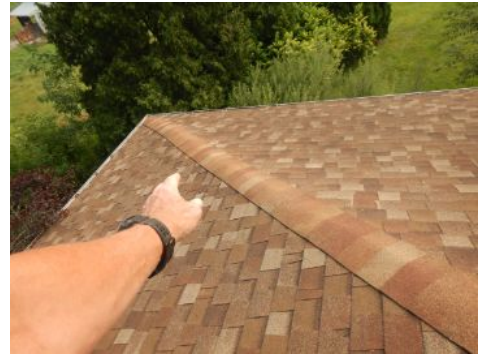
- front roof sheathing over bump out window has soft spots / is spongy but did not show significant water staining or damage from attic (only invasive damage could likely evaluate if repairs are needed or if roof is leaking in this area)

soft spots in roof by eaves (front of house)

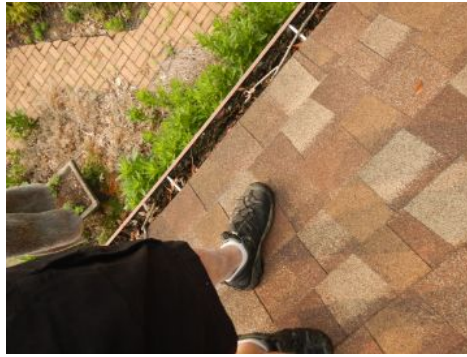
soft spots in roof by eaves (front of house)

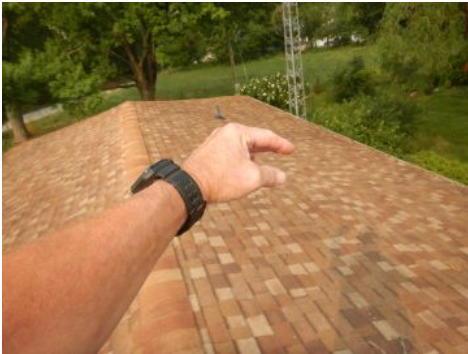
somewhat wavy (likely built this way as no signs of any structural failures)

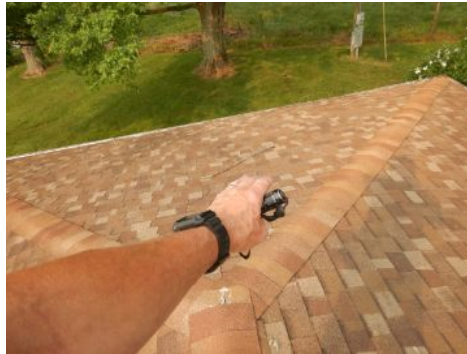
somewhat wavy (likely built this way as no signs of any structural failures)

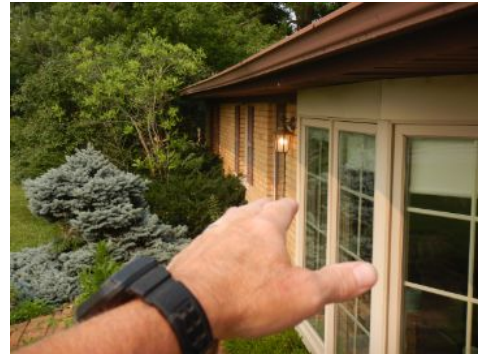
somewhat wavy (likely built this way as no signs of any structural failures)

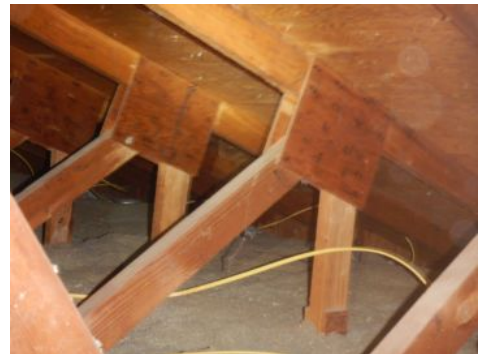
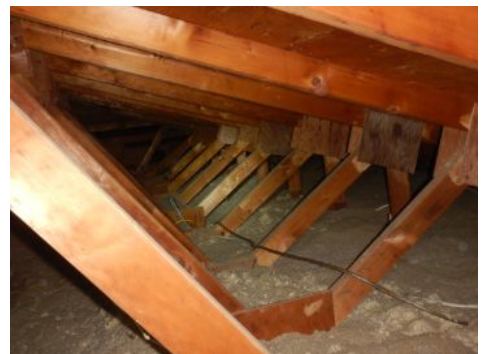
soft spots are above bump out

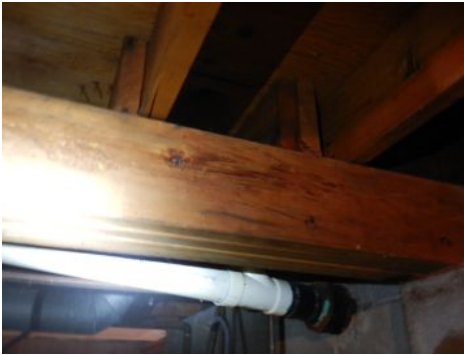
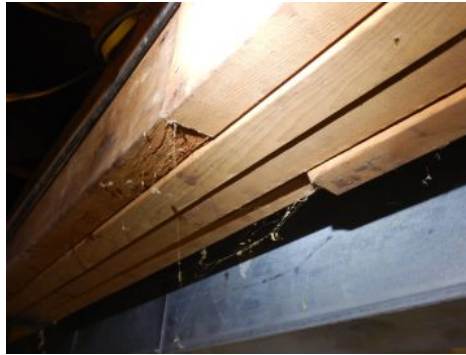
- There was no visible concern with any visible post, beam, or column, which are load bearing components of the building (structurally). See photo comments. as installed, beam is not technically correct, is common, and is not likely to cause concern)

ideally all seams are above supports (common)

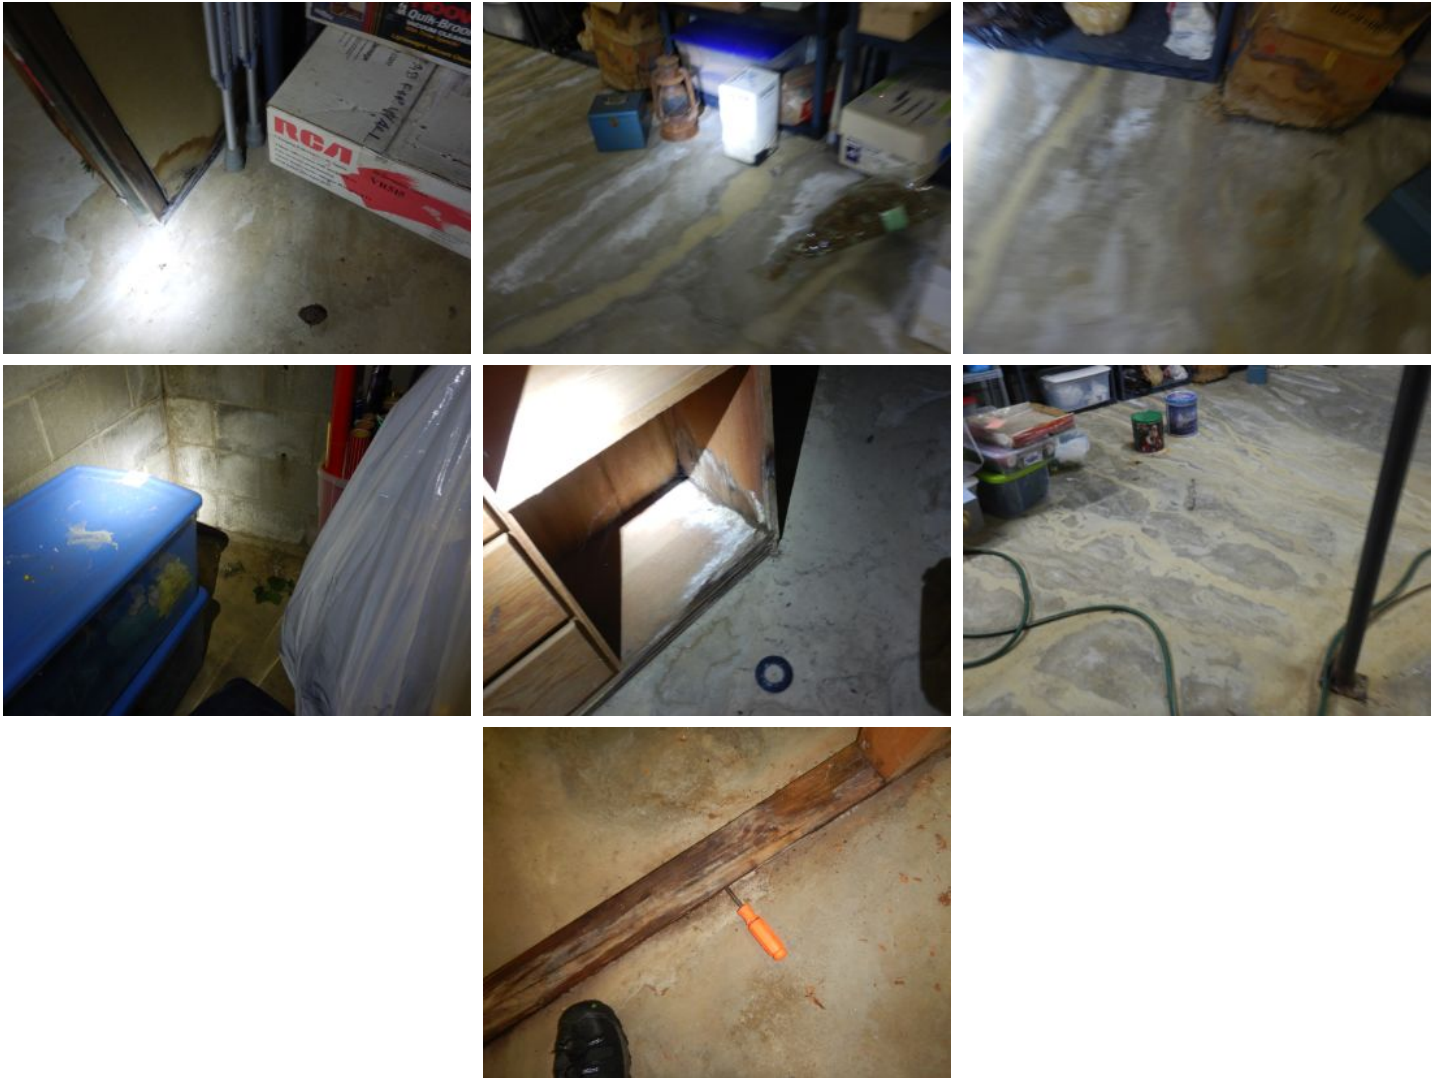
- **Basement is getting a lot of water inside. Floor has functional drain. repair exterior grading first to see if problem is solved. If still getting rain inside, consult with water proofing contractor**
- **wall in basement has water damaged bottom plate (does not appear structural)**
- **Mold like stains should be cleaned per EPA guidelines on their website. For more information see: [www.epa.gov/mold](http://www.epa.gov/mold). (not a lot present, comparatively)**

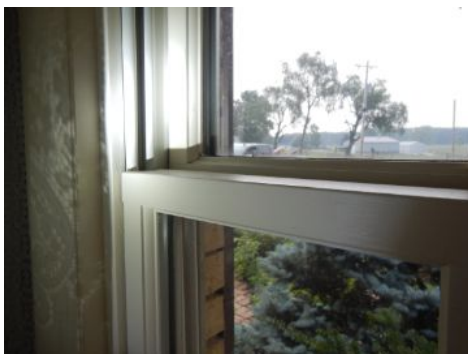
double hung windows present on house

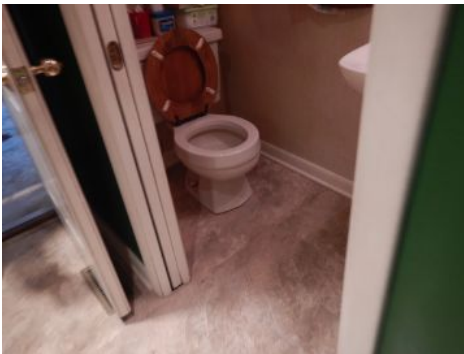
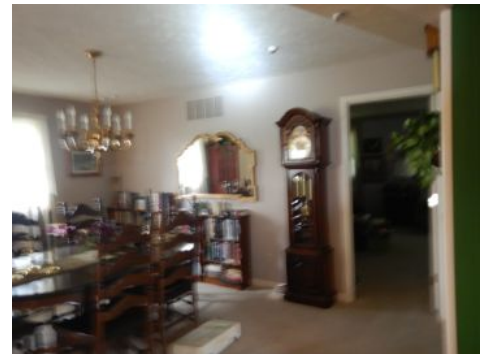
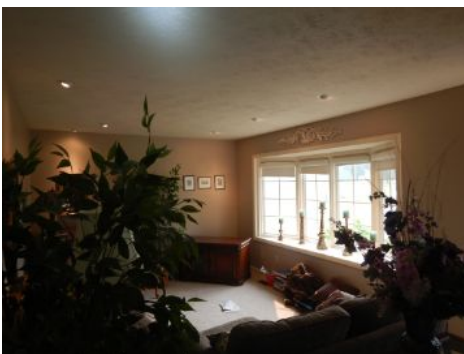
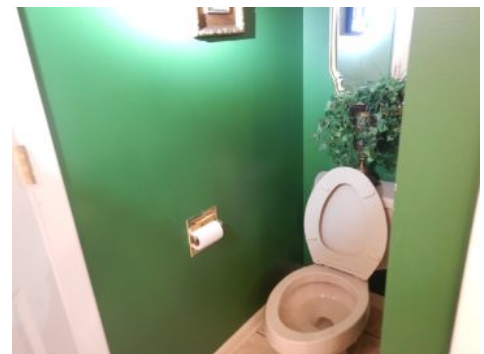
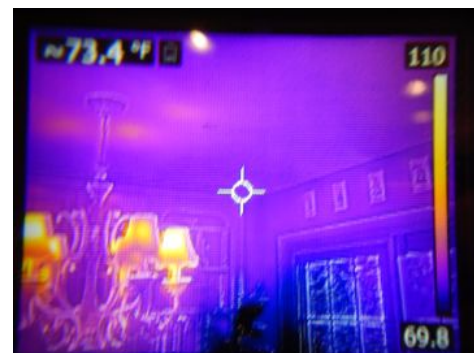
no unusual hot cold spots present when walls and ceilings were scanned with thermal camera

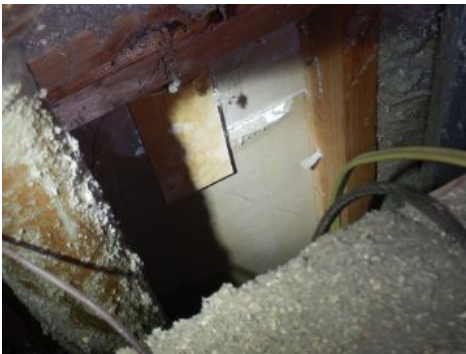
- Visually inspected while I was in the attic. approx 6-8" of blown in **cellulose** insulation present over (most of) visible living space in attic. (10" is recommended in this area by current standards). fluff low spots as needed (from work done in attic). garage ceiling is insulated
- **open wall cavity in attic should be covered with insulation**

insulation should cover open wall cavity in attic

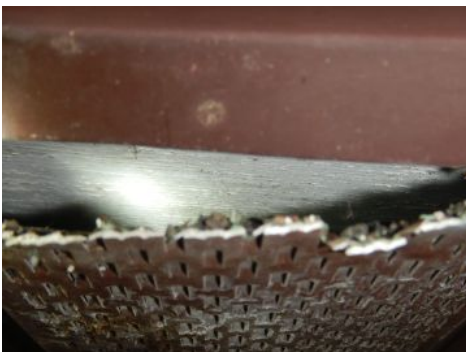
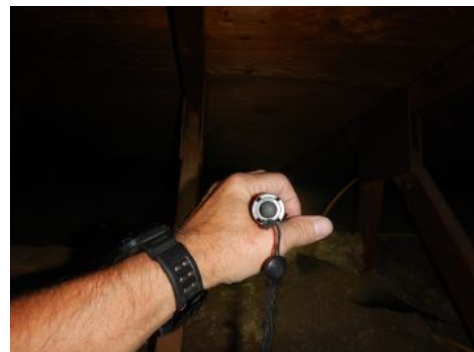
- **soffit vents would improve HVAC efficiency and likely improve shingle life (current standards would require better ventilation). No signs of mold or excessive condensation in attic at time of inspection**

soffits do not appear to vent to attic above perforated panels

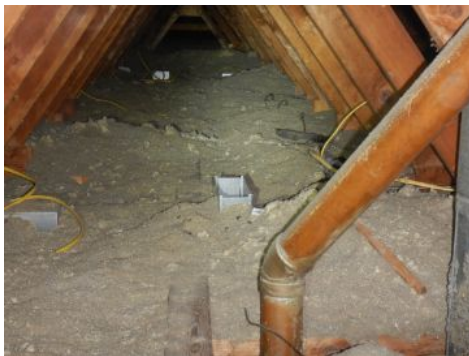
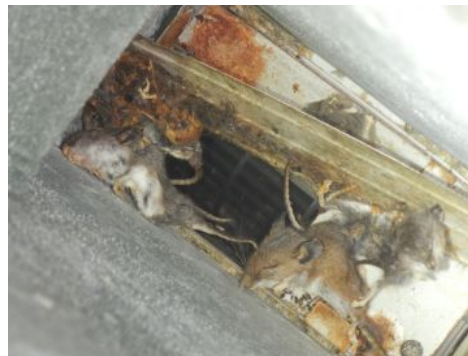
- **kitchen exhaust fan terminates inside the attic. All moisture ducts should terminate outside the home through the roof or through a wall. (dead mice should be cleaned out of duct (odor)**

dead mice in range vent

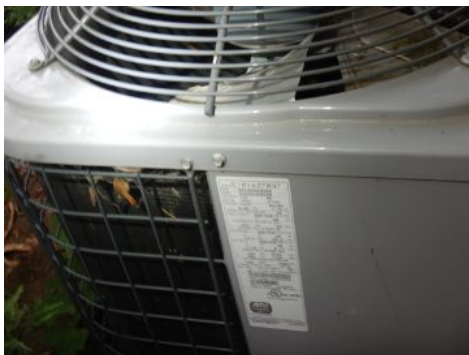
- Air conditioning is provided by dual systems located inside furnace housing and outside of the home.
- Unit functioned as intended on day of inspection

Manufactured in 2010 per data tag (per online sites)

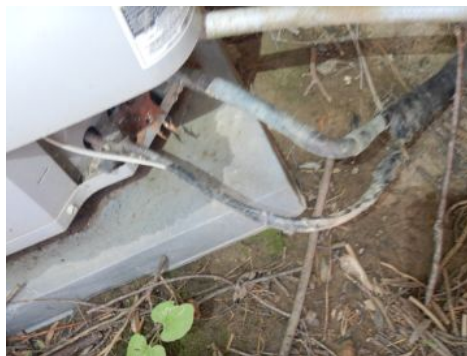
- The refrigerant line to the air handler(s) need insulation repaired to prevent pipe sweat and freezing

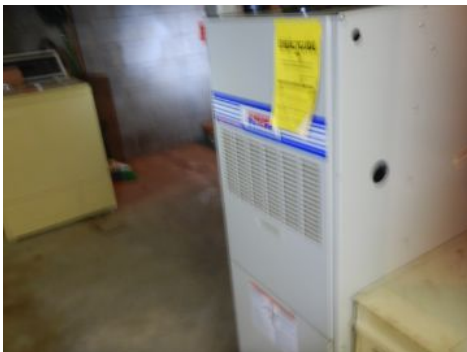
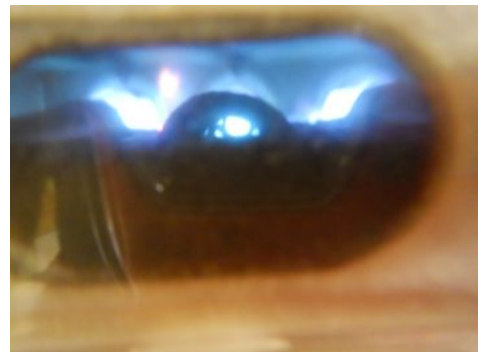
- Type: Gas, Forced Air
- Inspected. Operated as intended on day of inspection

Manufactured in 1996 per data tag (per online sites)

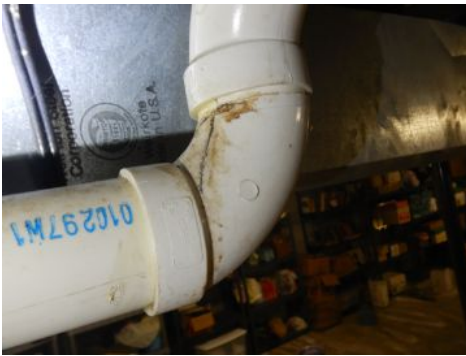
- **PVC** flue has some of drip leak (unknown if repaired. most furnace condensation occurs during cold months. repair in future if needed)

signs of (past?) leaking

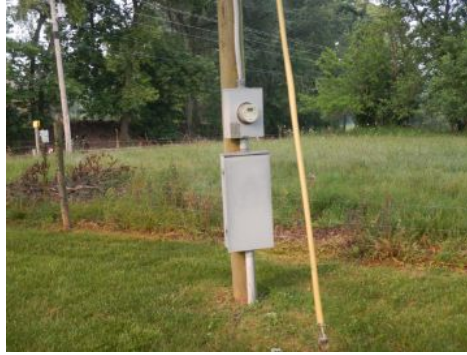
- Main electrical service meter is located on the left side of the house. The distribution panels are located in basement

meter is on pole to left of house

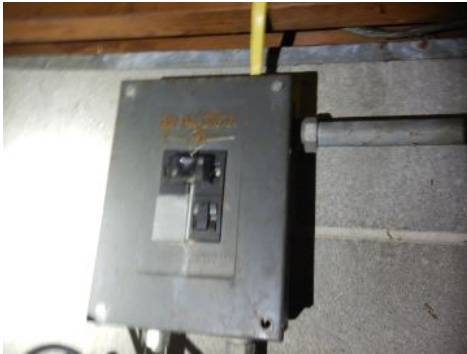
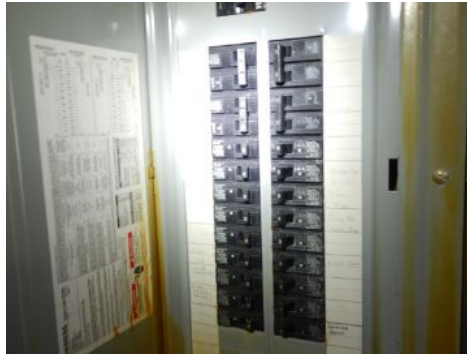
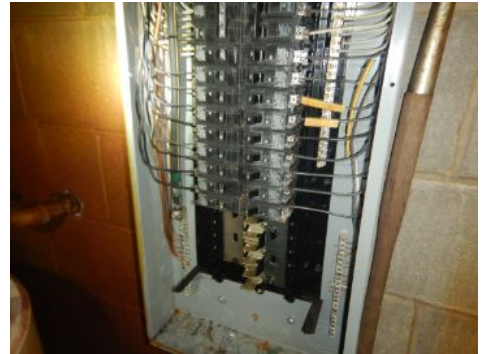
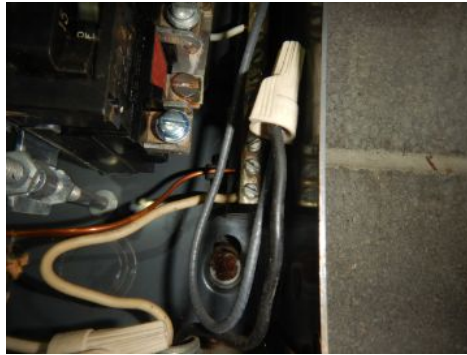
- The main electrical service panel was professionally installed.
- some electricians always recommend replacing pushomatic panels. This brand is not one that home inspectors are trained to call out due to history of problems (such as Zinsco, GE sylvania, stablok)
- **sup panel (small pushomatic panel by main) does not have grounds and neutrals isolated/ separated as current standards require (common)**

grounds and neutral wires  
should be isolated and separated  
at sub panel

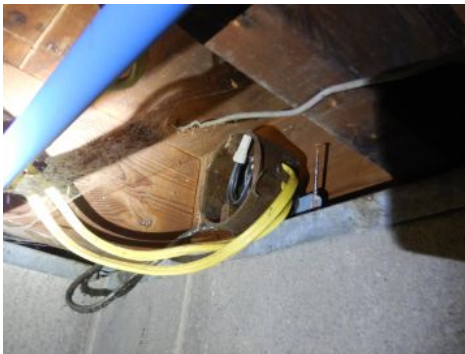
Junction box missing cover

- Branch circuit wires are insulated Copper. The overload devices the wires are connected to are circuit breakers.
- **Open junction boxes should have proper covers installed.**
- **unterminated wires should be removed or placed inside a junction box properly terminated.**
- **wire splices should be inside a proper junction box.**

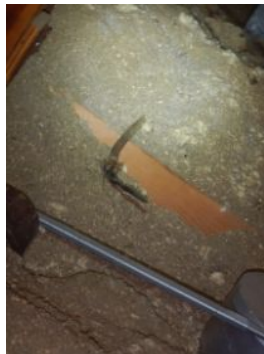
Unterminated wires should be  
properly terminated inside  
junction box or removed

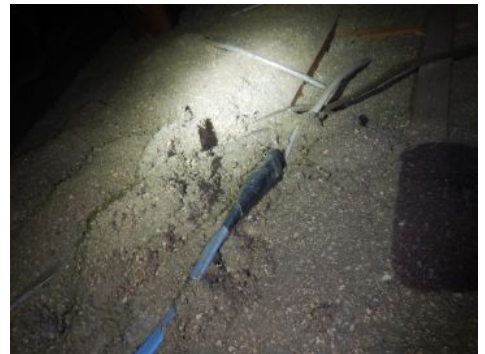
wire splice not in junction box

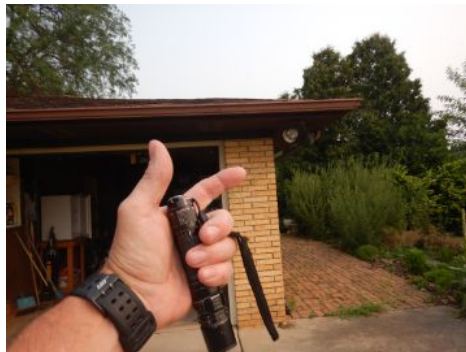
Light did not function at time of inspection

- The visible/ accessible lights, switches, and outlets tested all function as intended, unless noted in this section
- **2 lights did not function on day of inspection (bulb?). I always recommend installing replacement bulbs to ensure wiring and fixtures are functional. See photos for locations.**

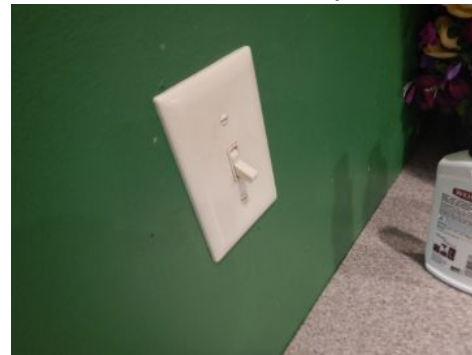
a few switches have no visible function

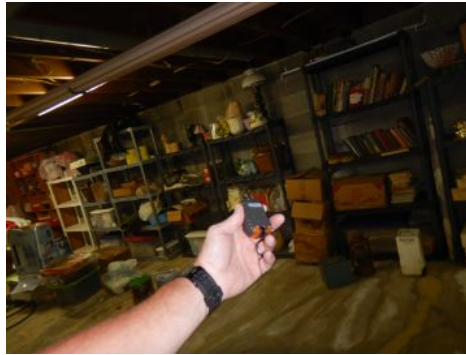
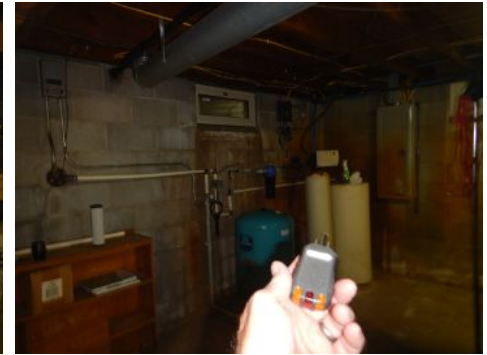
unfinished basement outlet(s) not GFCI protected

- **All outlets in house located within 6 feet of a water source, over kitchen counter tops, bathrooms, garage, sheds, unconditioned porches, laundry, and unfinished basements should have **GFCI** protection installed for safety. I recommend repair (see photos for outlets in need of repair, recommended for GFCI protection). Outlets that current standards would require GFCI protection will be noted in this section, if present**

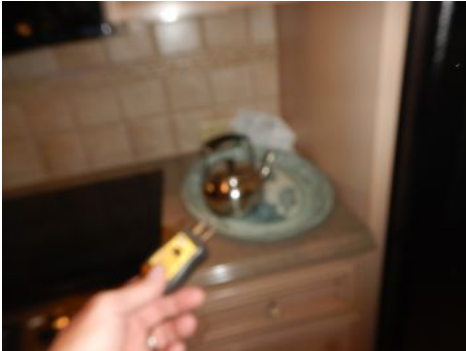
outlets above kitchen counters are not GFCI protected

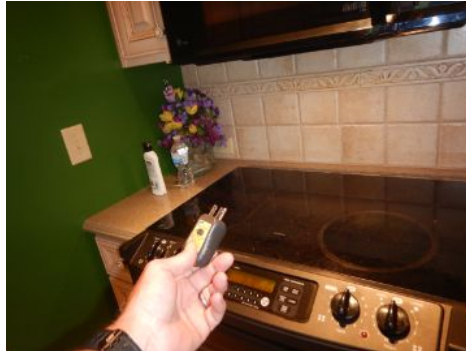
outlets above kitchen counters are not GFCI protected

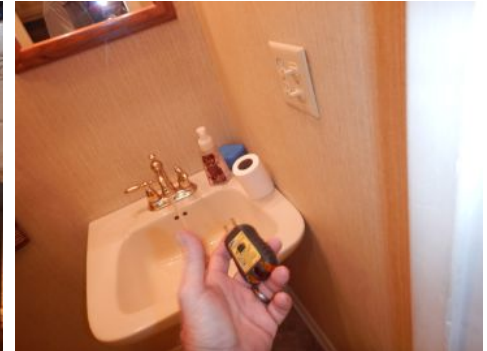
Bathroom outlet(s) not GFCI protected

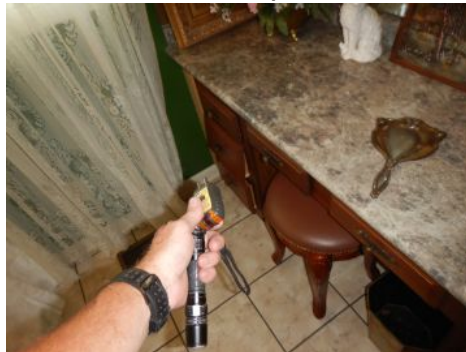
Bathroom outlet(s) not GFCI protected

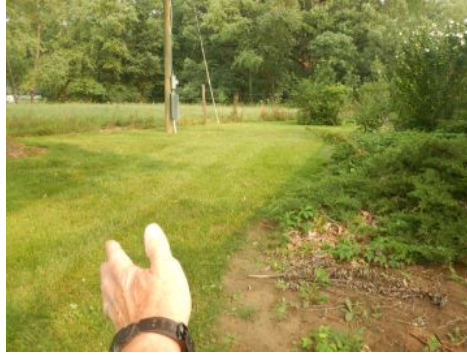
supply comes from left side (well not visible)

- private well
- I always recommend having well water tested to ensure it is safe to drink
- **ask current owner for well location and verify distance from septic is minimum 50'**

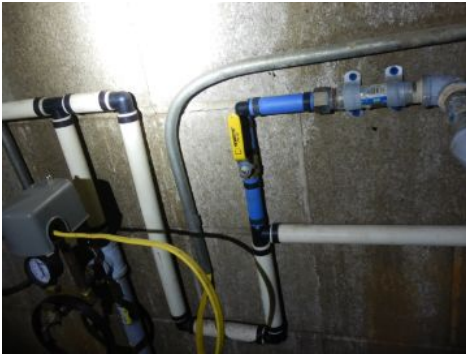
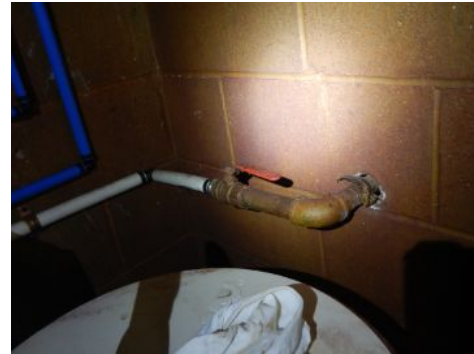
- By pressure tank in basement (2 valves required to turn off all water)

assumed this valve goes to barn

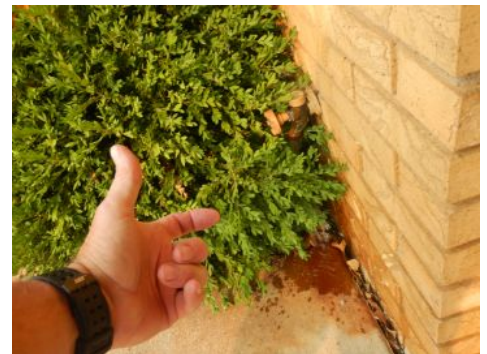
- **front faucet leaks when on**

front faucet leaks when on

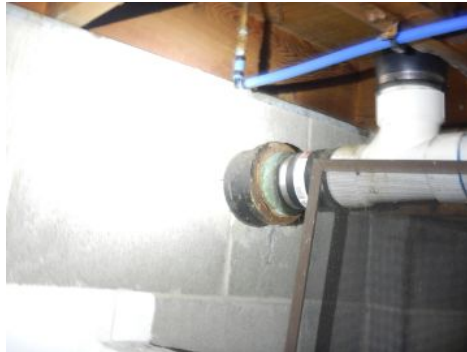
some drains leave basement at floor. some leave elevated

• **Septic tank not visible. Pipes discharge basement at rear, right, and into basement floor. I always recommend having septic inspected by qualified septic contractor (and verify size of tank is adequate for size of house/ number of bedrooms / bathrooms). (In my opinion, all septic tanks/ systems be evaluated as we cannot see what is under ground). Local health department may have records from installation. Note: some drains are at floor level and some are elevated. I suspect some gray water goes to yard somewhere (possibly a drainage tile) and not into septic tank as required in most jurisdictions. I recommend having drain lines scoped by qualified plumber based on age of drains and the fact there are multiple discharges leaving house.**

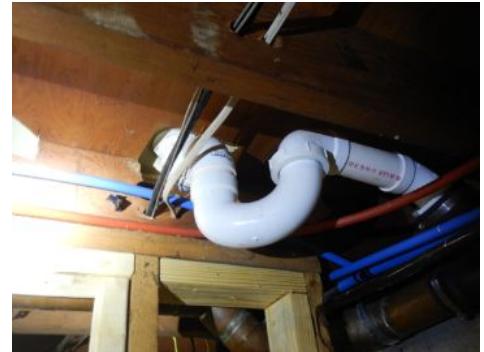
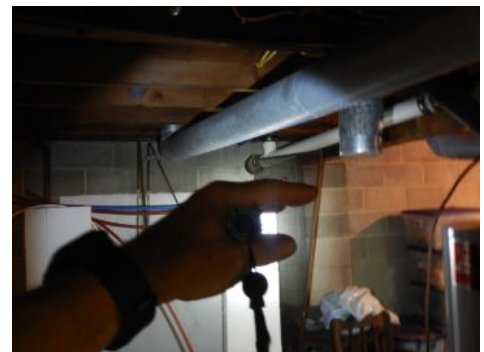
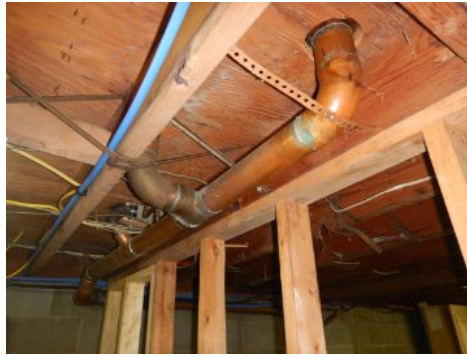
drains go to rear and towards right side (septic not visible)

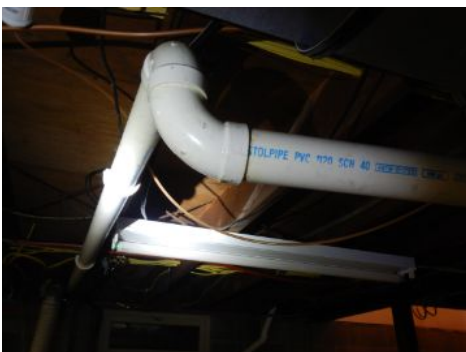
some drains leave basement at floor. some leave elevated

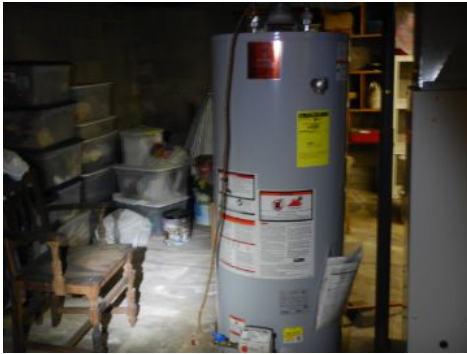
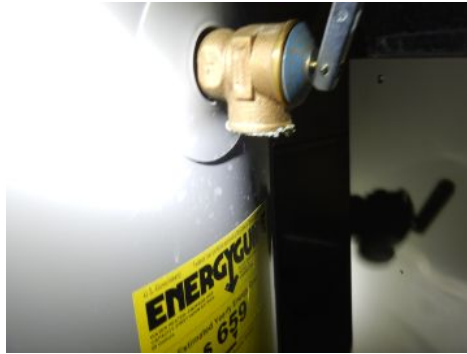
TPRV should be extended down to 4-6" above floor

- Gas heater present and functional. No leaks present on day of inspection
- **PRVs (pressure relief valves) should be extended down to 4-6" above floor. safety concern**

| Page 32 Item: 7 | Water Heater(s) Condition | <ul style="list-style-type: none"> <li>• PRVs (pressure relief valves) should be extended down to 4-6" above floor. safety concern</li> </ul> |

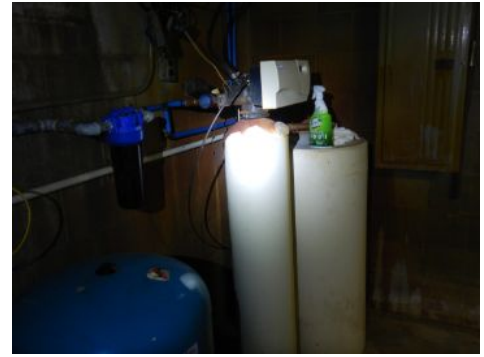
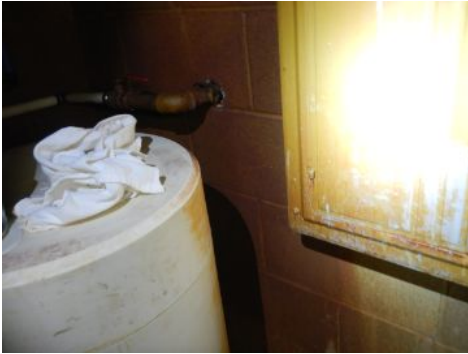
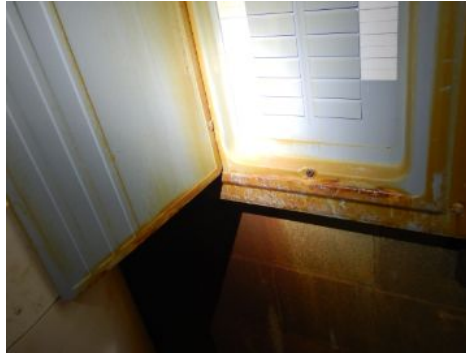
rust/ iron stains from (assumed)  
past leak by water softener

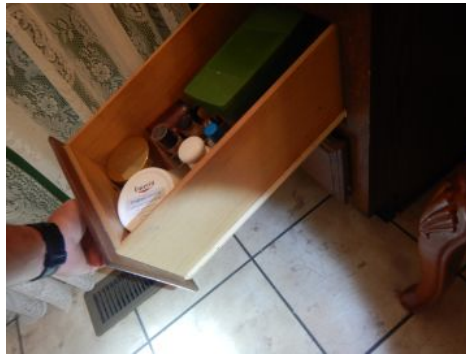
drawer slides are not functional

- The sinks, countertops and cabinets are functional in bathroom.
- one drawer is in need of track repair/ replacement FYI

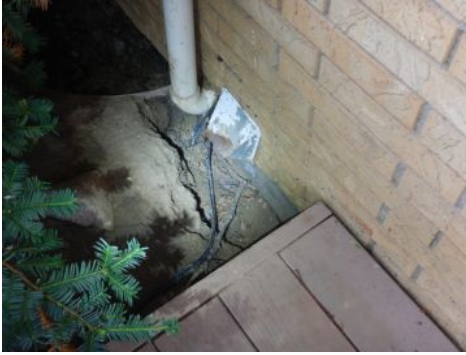
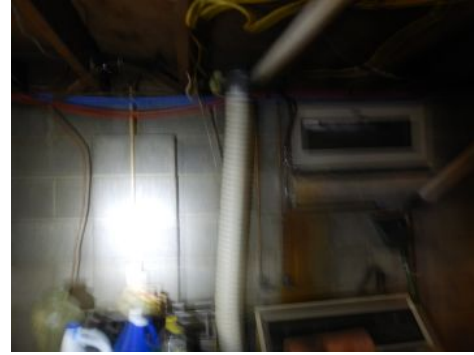
- Vinyl hose is not approved material for dryer vent use. (I often find holes in vinyl hoses)
- **discharge should be raised or changed to horizontal type as ground will choke flow**

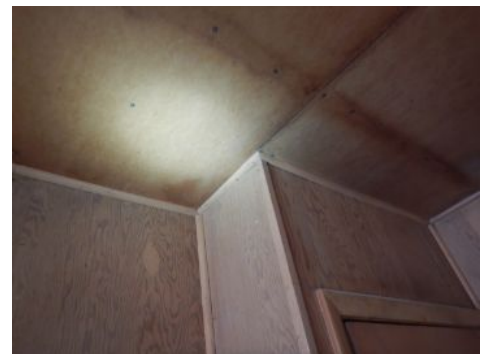
- Visible walls and ceiling are mostly in functional condition. (seal loose tape/ minor damage as needed as it affects smoke/ fire separation requirements)
- Floor is in functional condition.
- **Current garage wall and ceiling requirements are 1/2" drywall for all of ceiling and all walls with living space opposite. seams in drywall require drywall tape and at least one coat of joint compound.**

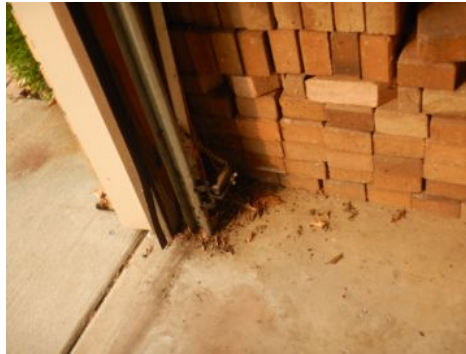
Electronic safety eyes present and functional

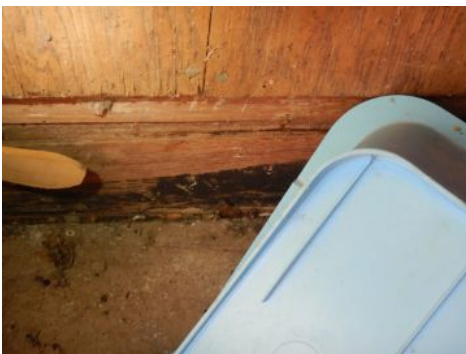
old termite treatment stains?
