SELLER'S DISCLOSURE NOTICE

BUY WISE INSPECTION SERVICES, LLC 9404533644 buywiseinspectionservices@gmail.com

TREC REI 7-6

285 Saddle Creek Trail Stephenville, TX 76401

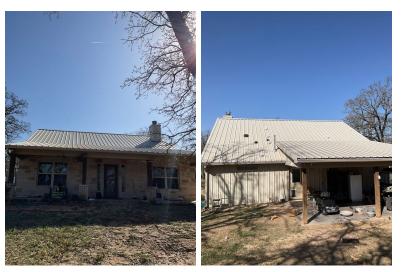
□ C. Roof Covering Materials Types of Roof Covering: Metal

Viewed From: Ground using binoculars *General Photos:*

By design, penetrations through a metal roof create an area that over time may be prone to leaking because they are not layered like a shingle roof would be. It is important to maintain a good seal around the penetrations with regular caulking maintenance.

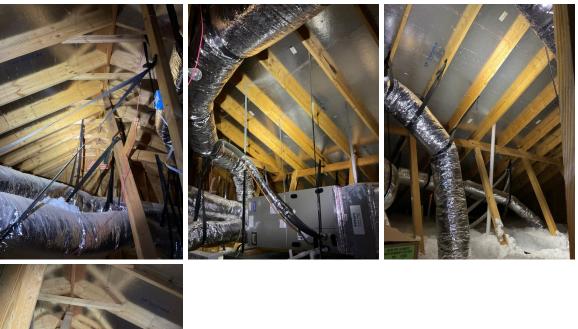
Viewed From: Interior of Attic Visibility: Partial Approximate Average Depth of Insulation: 12 Inches General Photos:

1: Insulation - Missing
✓ Maintenance Item
Observed insulation not present over living area. Recommend repair

Recommendation: Contact a qualified professional.

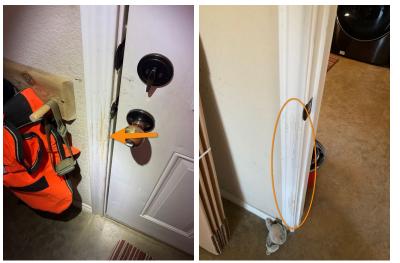
5: Interior Trim - Damaged Commendation

Observed general damage to interior trim in one or more areas. Recommend repair

Back Door

Back left bedroom

Recommendation: Contact a qualified professional.

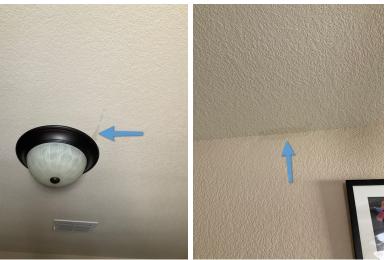
1: Ceiling Drywall - Moisture Stain

Observed moisture stain on ceiling in one or more areas. Recommend finding source of moisture and making repairs.

Laundry Room

Back left bedroom

Recommendation: Contact a qualified handyman.

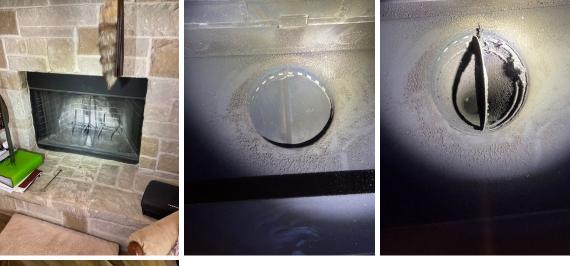
Type: Wood burning with gas starter

1: Dirty Flue ASafety Hazard

Observed built up creosote and sout in flue. Failure to clean may result in a fire. Recommend cleaning before any use.

As a matter of safety, Buy Wise Inspection Services recommends that ALL fireplaces, with the exception of new construction, be cleaned by a professional chimney sweep prior to any use by a new homeowner.

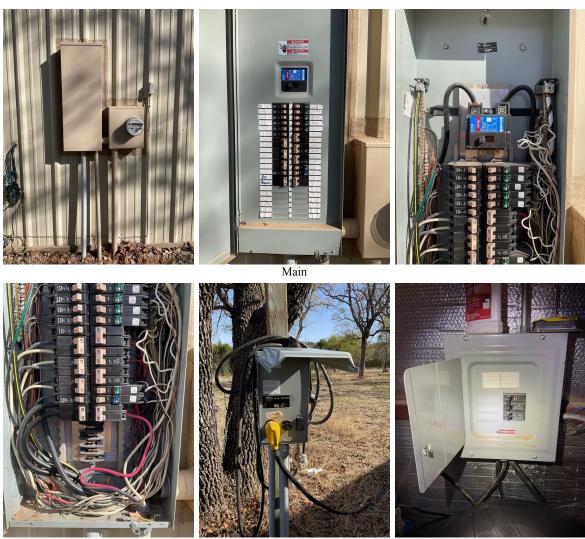
Image: Service Amperage: 200

RV

Well

1: Panel - Not Properly Labeled ASafety Hazard

Service panel is not labeled, or not properly labeled. Recommend a qualified electrician test and properly label all breakers.

Recommendation: Contact a qualified electrical contractor.

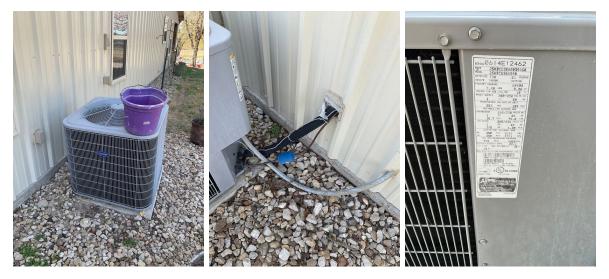
Type of Systems: Central Air Conditioner, Heat Pump *Condenser Manufacture Year(s):* 2014 *Refrigerant type:* R410A *Temperature Differential at Return and Supply Closest to Unit - Unit 1:* 18 Degrees *General Photos:* Photos provided for reference

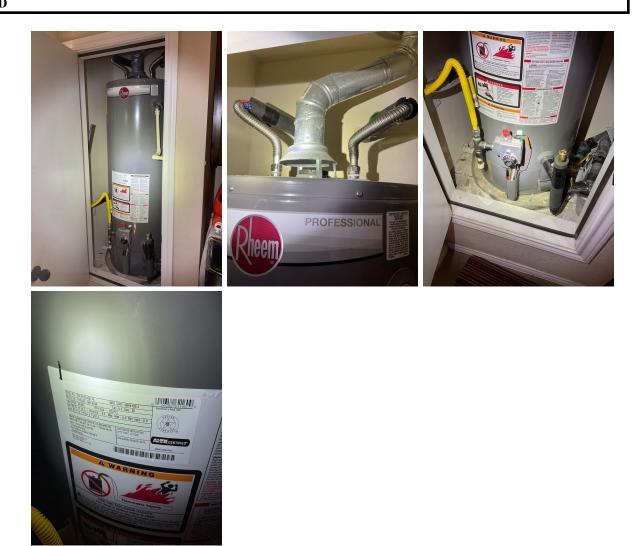
Energy Sources: Propane *Capacity:* 50 Gallons *Water Heater Manufacture Year (if known):* 2014 *General Photos:*

1: Recirculating Pump Deficient

Observed a recirculating pump in place. The housing appears to be damaged and the valves on the line it is connected to are off. Recommend repair.

Recommendation: Contact a qualified plumbing contractor.

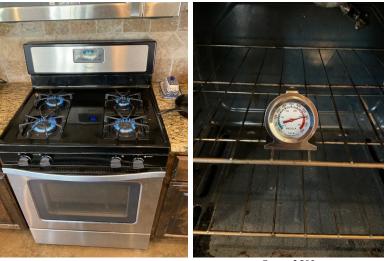
Set to 350°

1: Inadequate temperature differential Recommendation

Upon completion of the preheat cycle the temperature differential should be no more than 25°F. Set to 350°. Recommend repair.

Recommendation: Contact a qualified appliance repair professional.
