Inspection Report

6217 N. 295th. St.
Valley NE

Date: 5/6/2024	Time:	Report ID: 2024-4895
Property: 6217 N. 295th. St. Valley NE	Customer: Pre - Inspection	Real Estate Professional: Brad Zach Zachland Real Estate

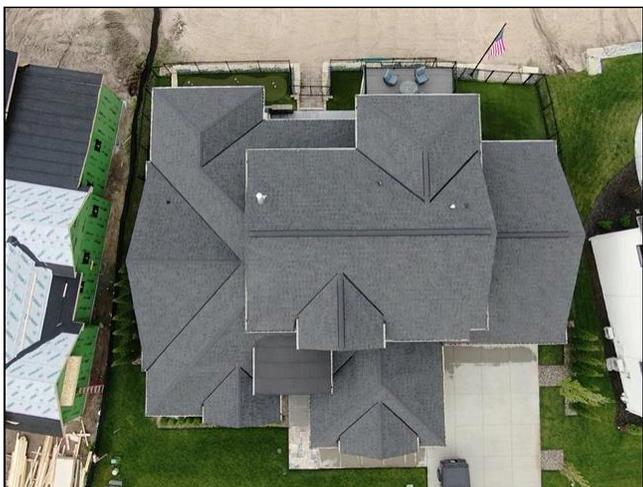
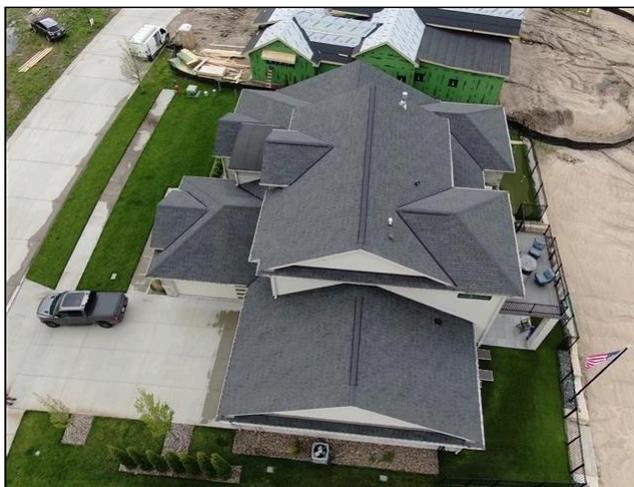
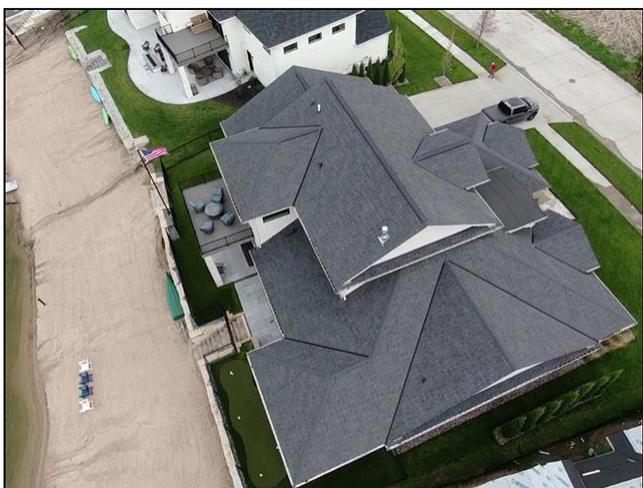
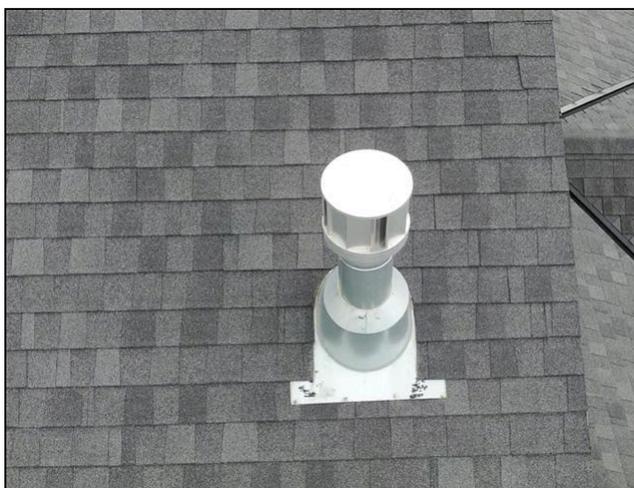
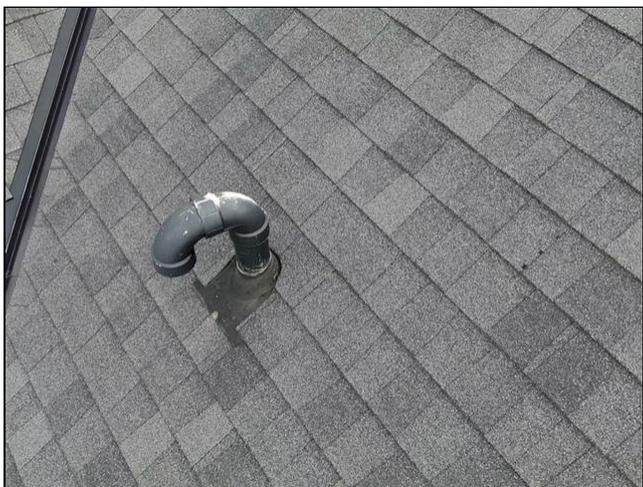
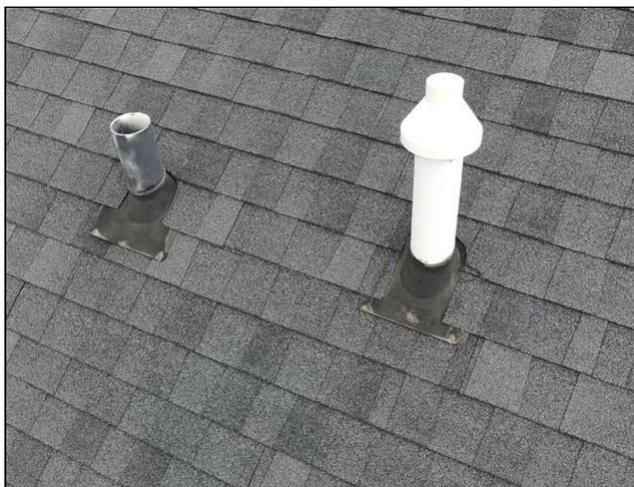
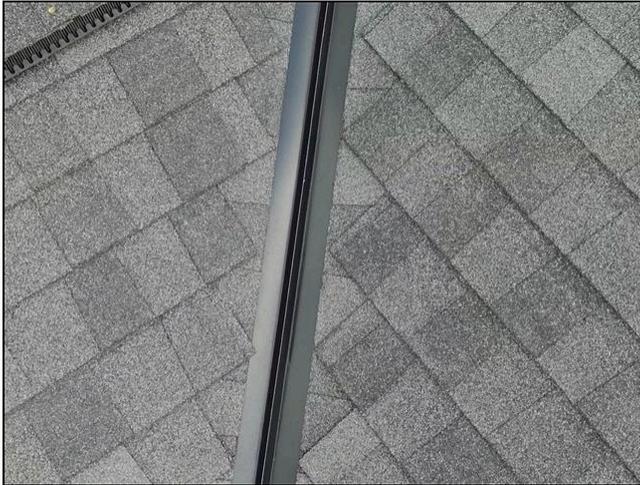
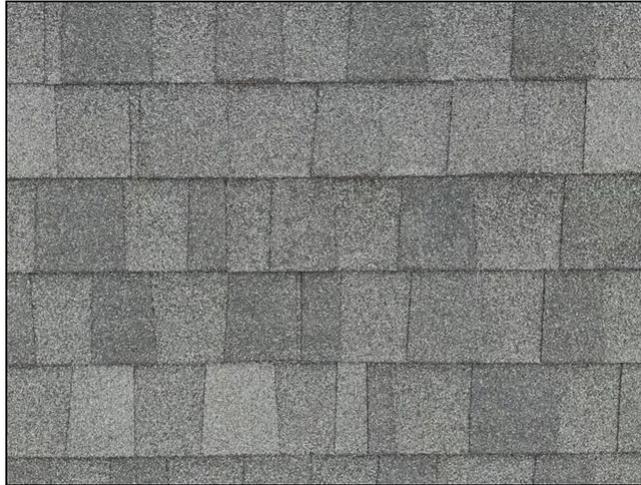
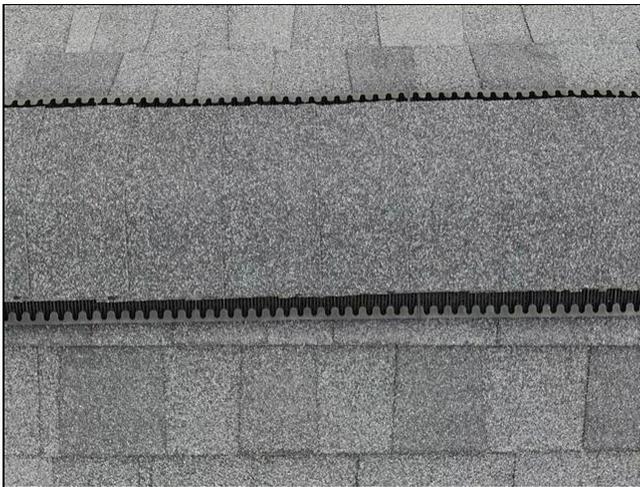
1.0 Roofing is a laminate shingle newer installation in excellent condition, properly installed and flashed.

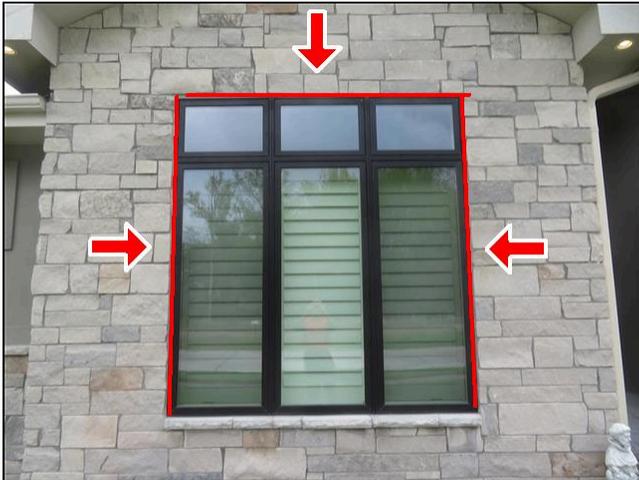
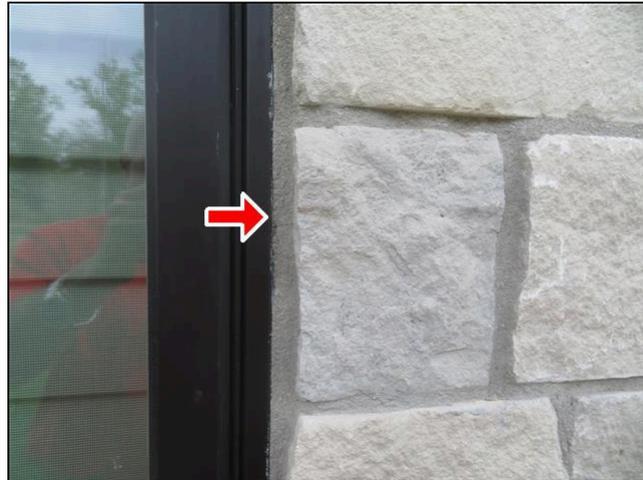
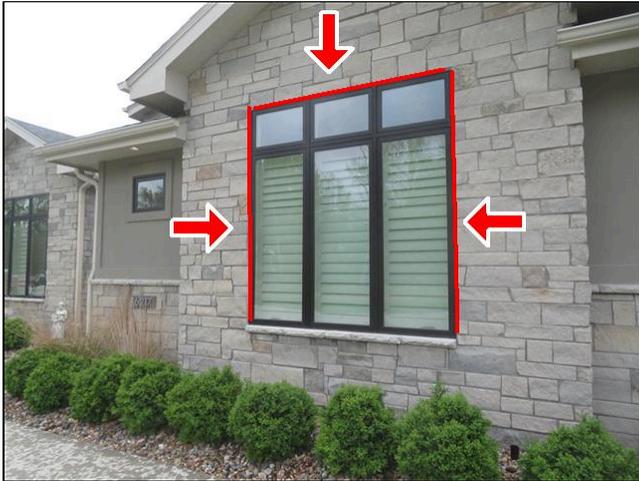
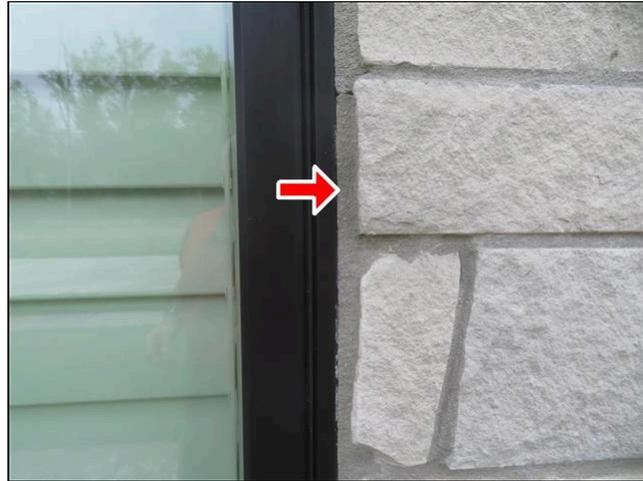
2.2 Technically a 3/8" caulk joint should have been allowed around window associated with the stone facade for expansion / contraction of the stone to avoid damage to window structure. The home is over 2 years old and the exposure is a north exposure so thermal load has not been detrimental to the window. Based on this modification would not be encouraged unless future issues with window occurs.

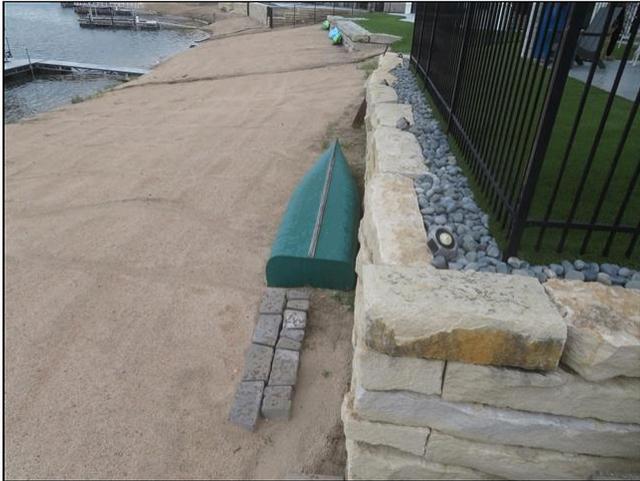
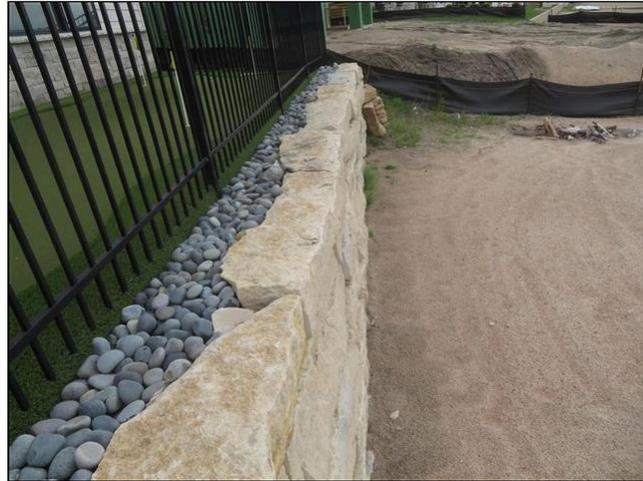
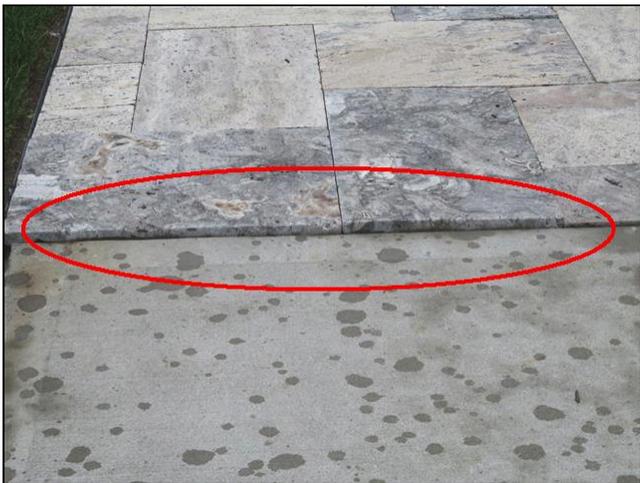
2.4 Stone retaining wall systems are stable.

This area of front entry sidewalk have elevation differences that may be a potential trip hazard. Repair / modify as needed.

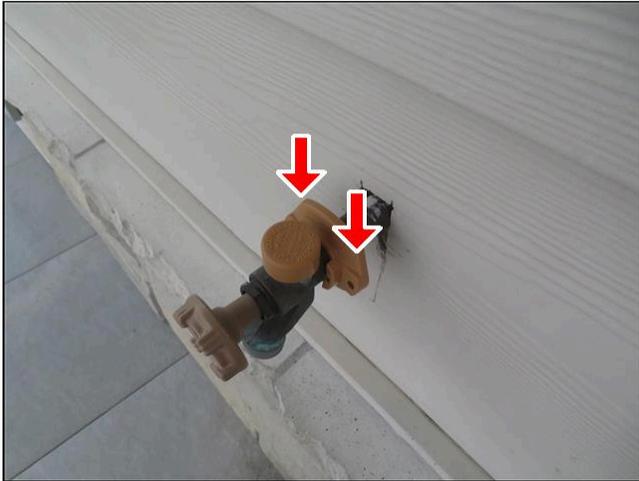
6.1 Item 1(Picture)

6.1 Recommend this exterior rear frost free faucet be properly secured to the wall system.

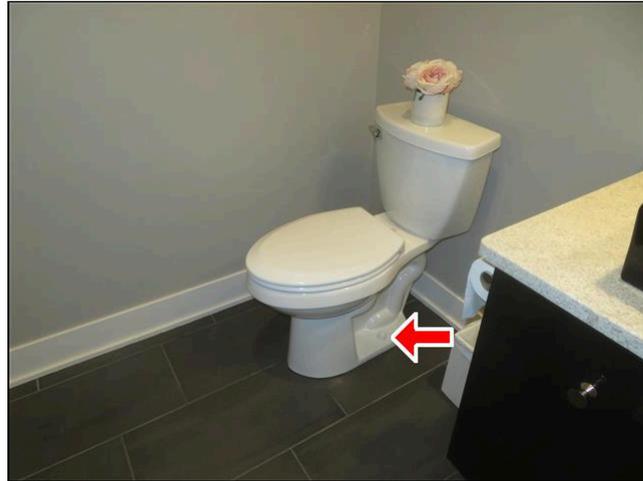
6.1 Item 2(Picture) Main Floor Powder Room

Multiple toilets (2) were found to be loose on the flange. Recommend a plumber evaluate and secure as needed.

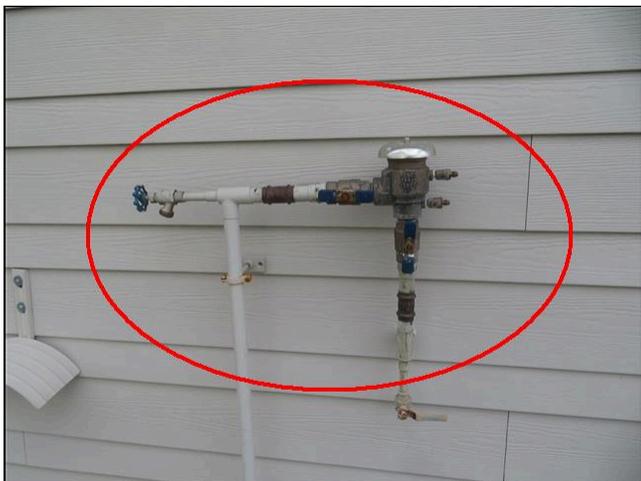
6.7 Item 1(Picture)

6.7 The sprinkler system zones are functioning, various heads may need adjustment, cleaning or general maintenance.

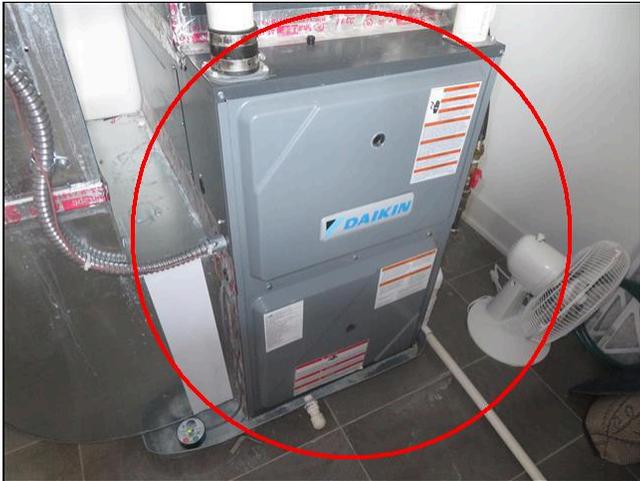
8.0 Item 1(Picture)

8.0 Thermal temperatures at the register are proper for effective heating and no indications of elevated CO were detected. Recommend seasonal service by HVAC professional prior to next heating season.

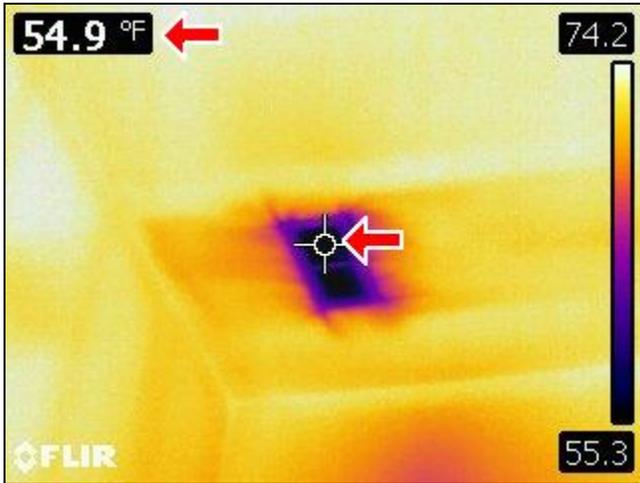
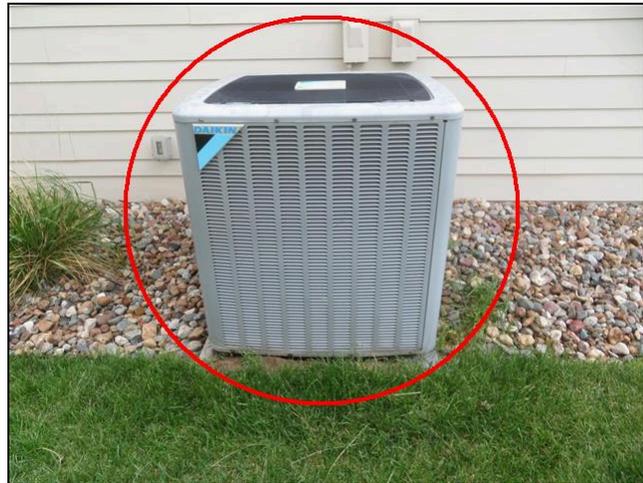
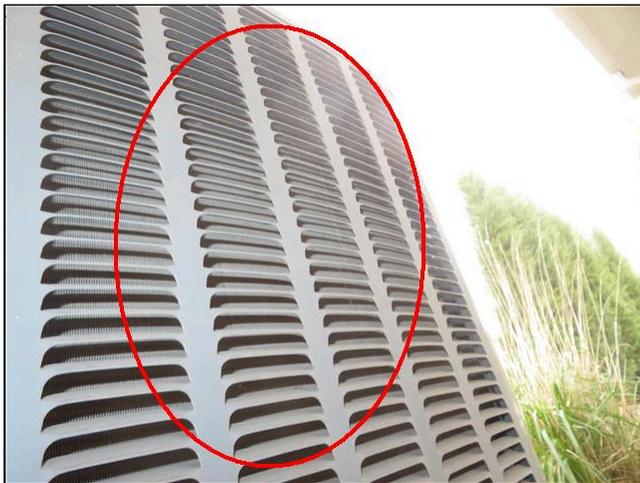
8.7 Air conditioning system is operating well upon testing. Thermal temperature readings are appropriate for effective cooling. Recommend cleaning exterior units cooling fin assembly with a garden hose. This will be a semi-annual maintenance item to perform.

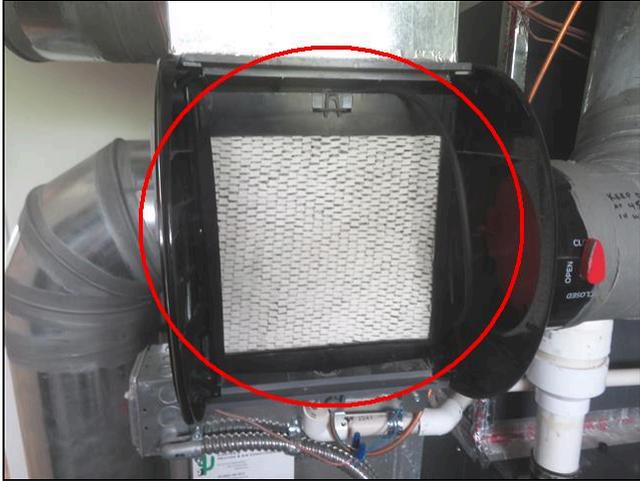
8.10 Item 1(Picture)

8.10 Replace water panel. This is a yearly maintenance item to perform. Do not over humidify the indoor environment when exterior temperatures drop significantly.

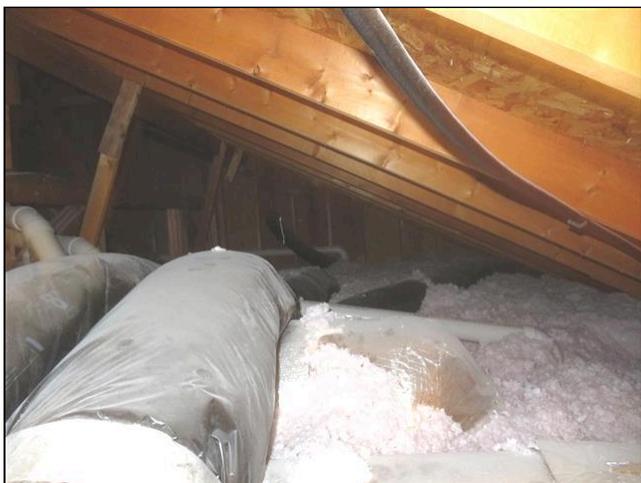
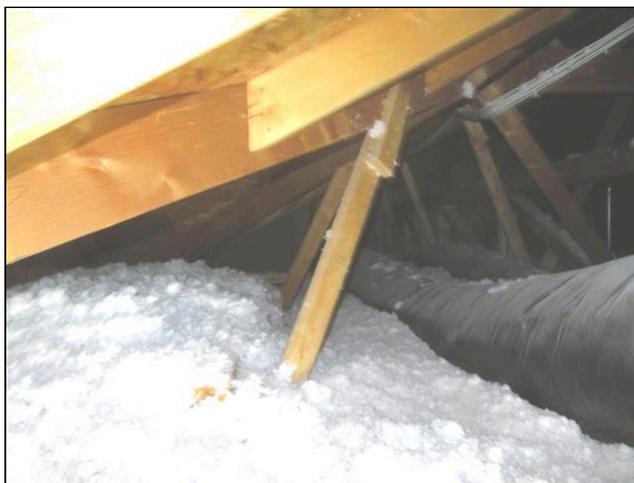
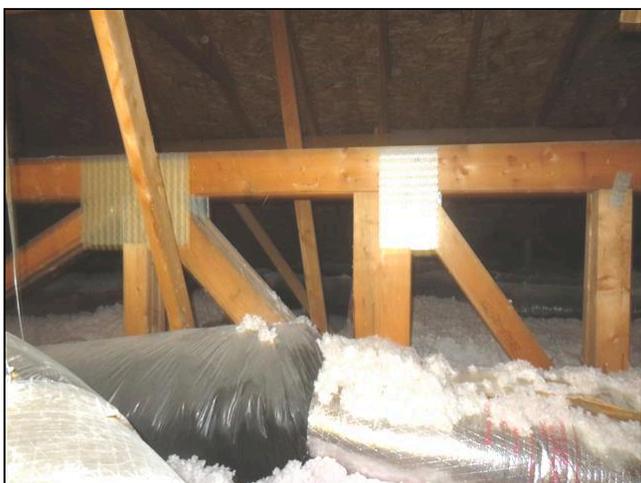
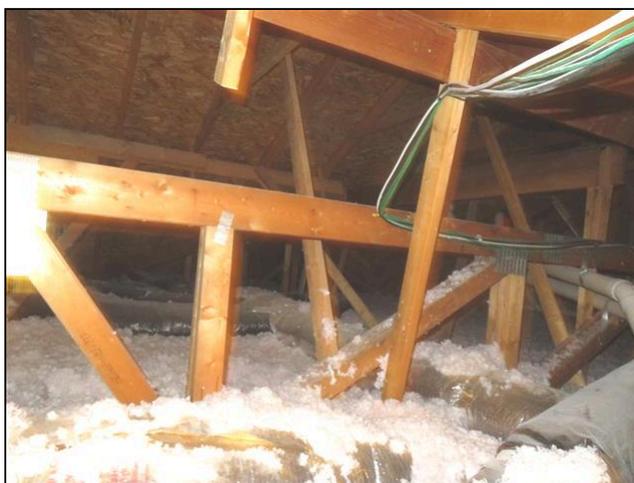
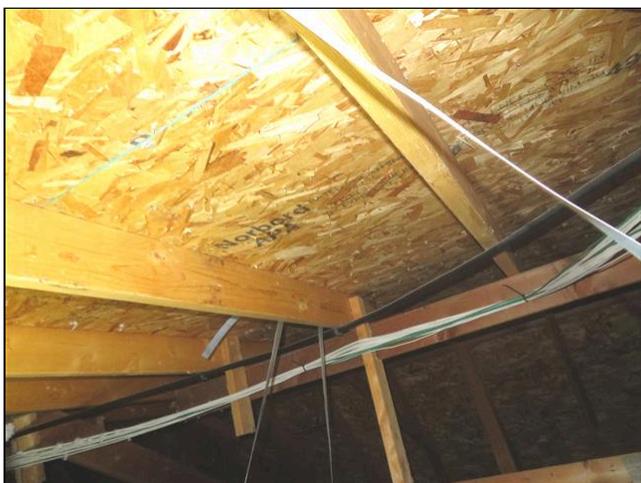
9.0 Attic is adequately insulated, ventilated, dry and has no signs of pest or rodent infestation.

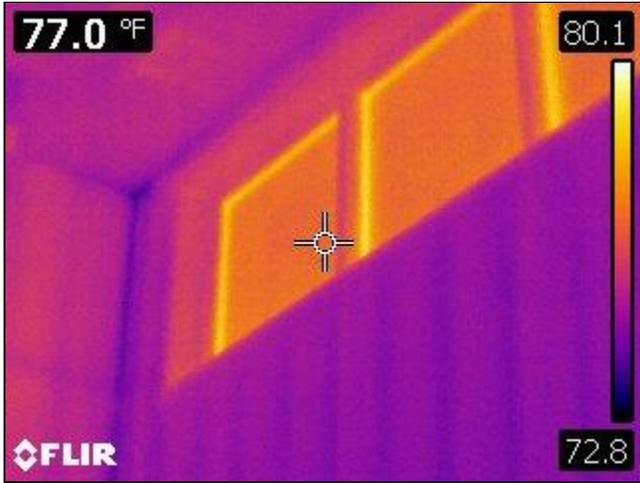
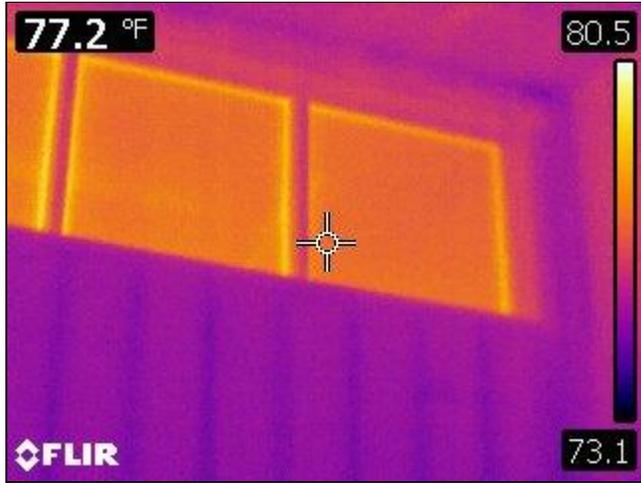
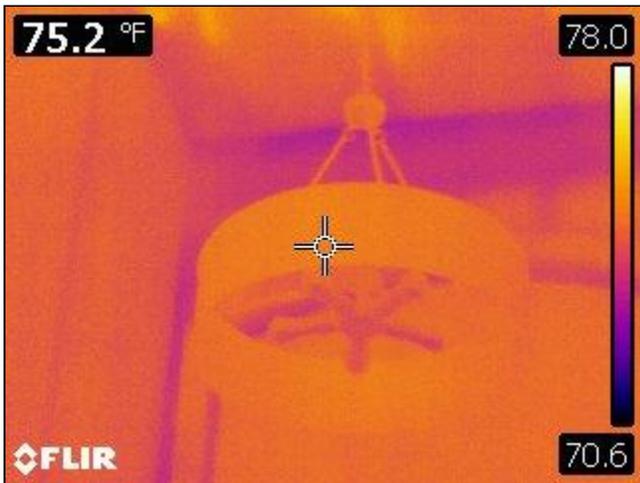
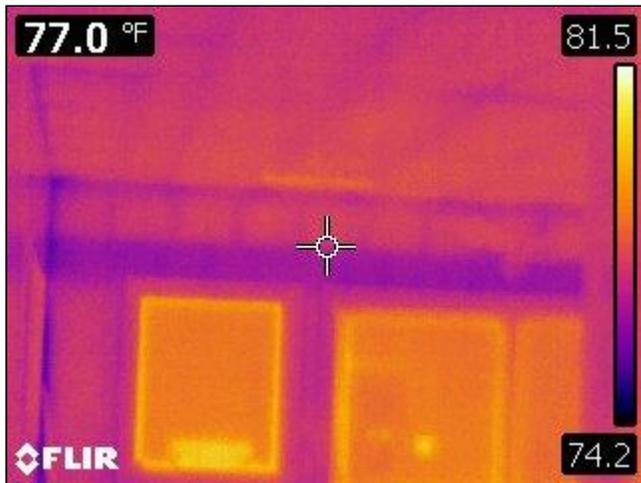
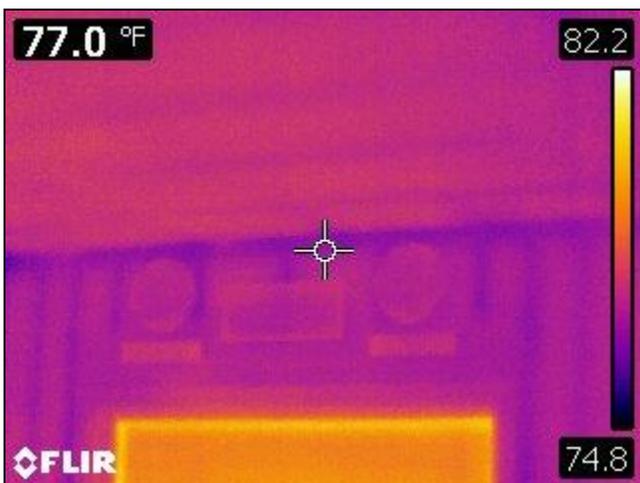
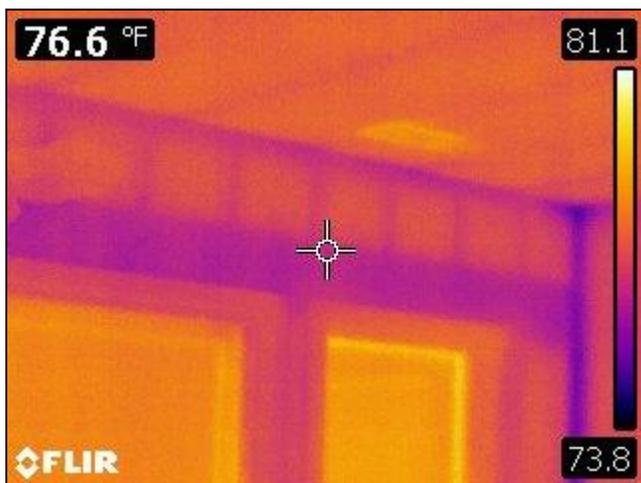
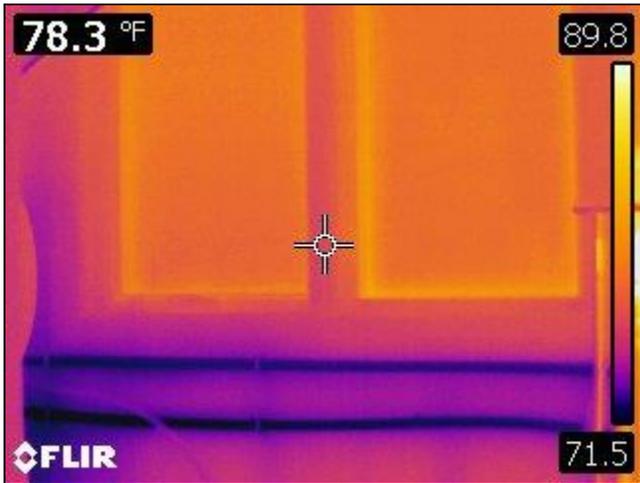
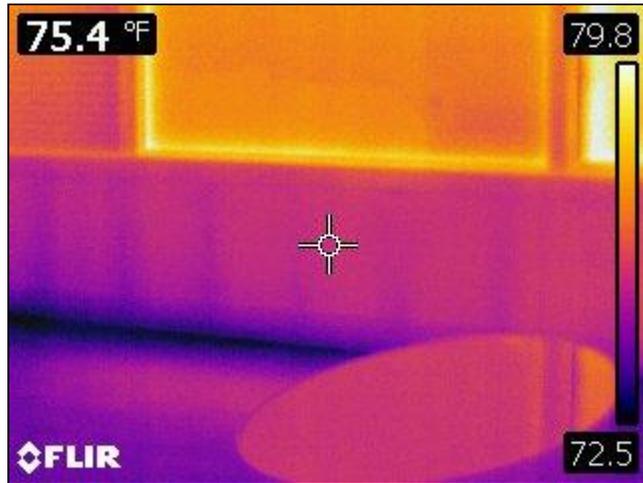
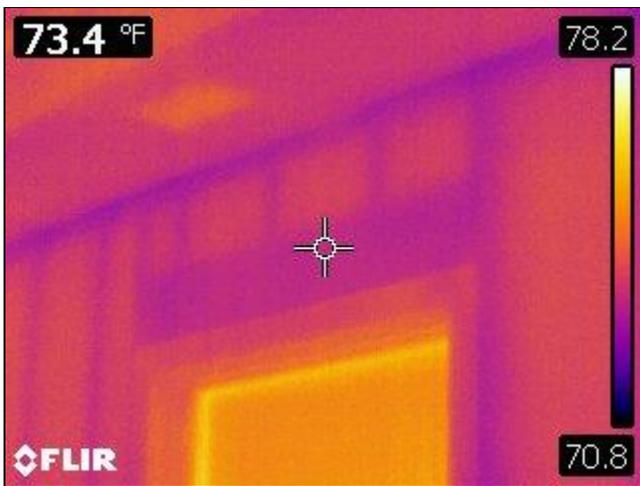
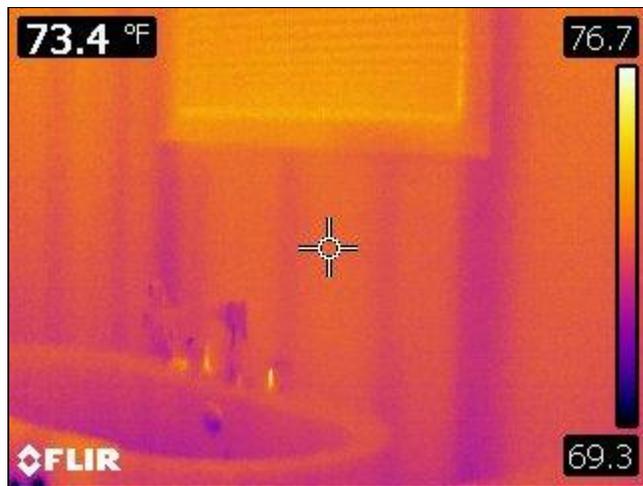
9.5 Thermal scans indicate no lack of insulation or presence of moisture in the wall cavity at the time of inspection.

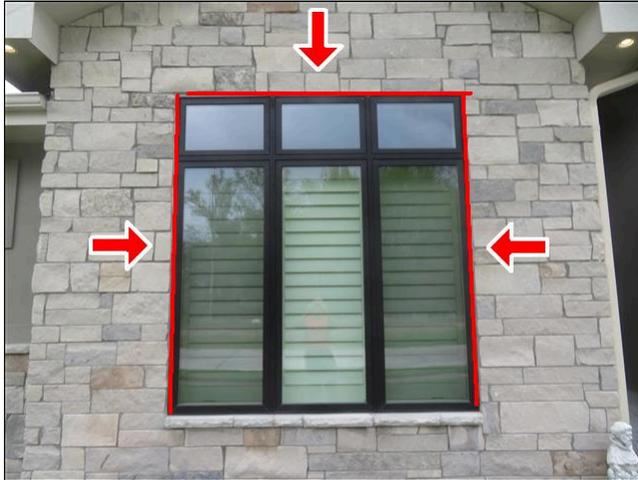
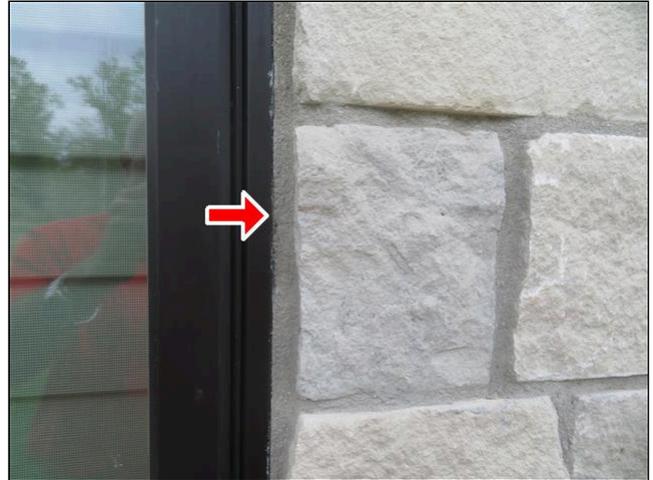
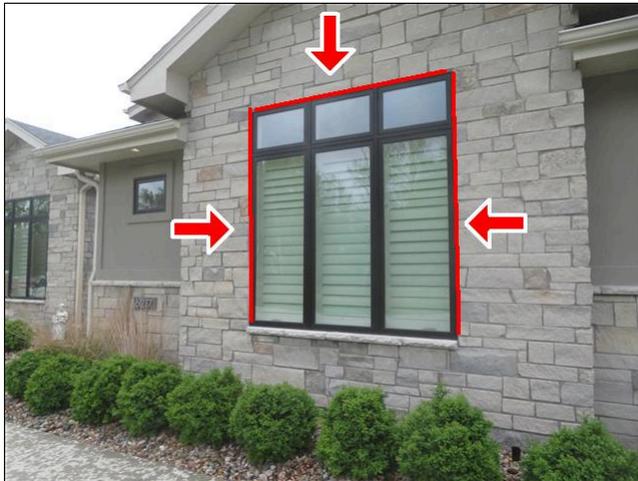
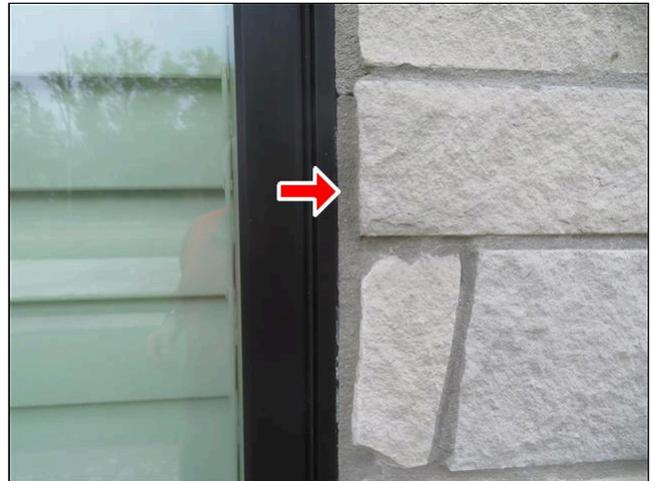
Technically a 3/8" caulk joint should have been allowed around window associated with the stone facade for expansion / contraction of the stone to avoid damage to window structure. The home is over 2 years old and the exposure is a north exposure so thermal load has not been detrimental to the window. Based on this modification would not be encouraged unless future issues with window occurs.

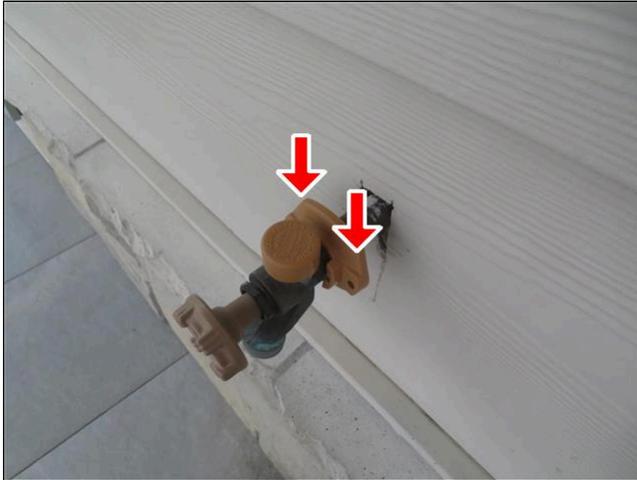
6.1 Item 1(Picture)

Recommend this exterior rear frost free faucet be properly secured to the wall system.

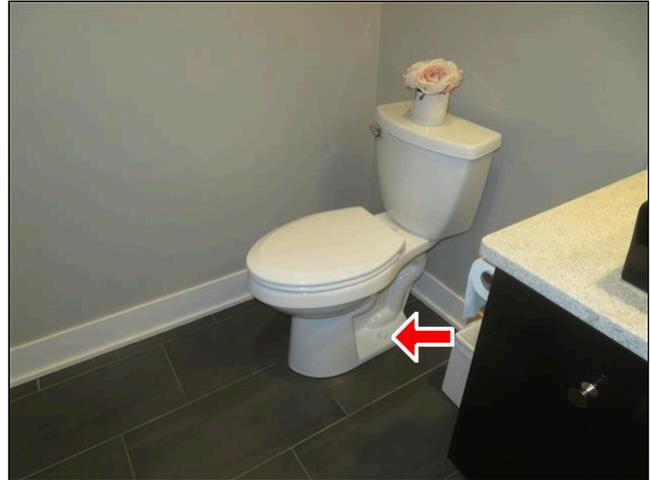
6.1 Item 2(Picture) Main Floor Powder Room

Multiple toilets (2) were found to be loose on the flange. Recommend a plumber evaluate and secure as needed.

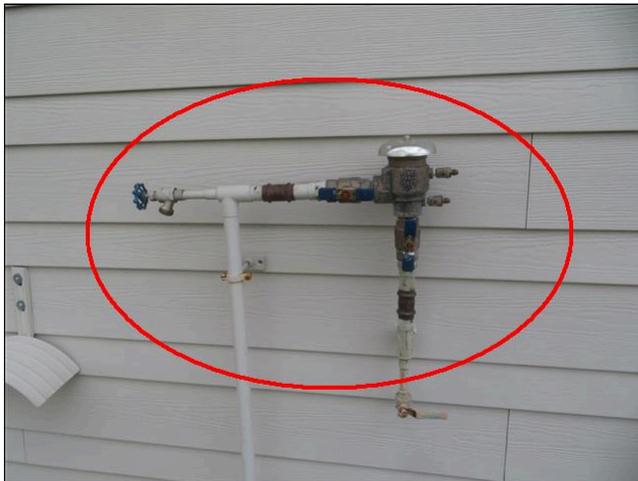
6.7 Item 1(Picture)

The sprinkler system zones are functioning, various heads may need adjustment, cleaning or general maintenance.

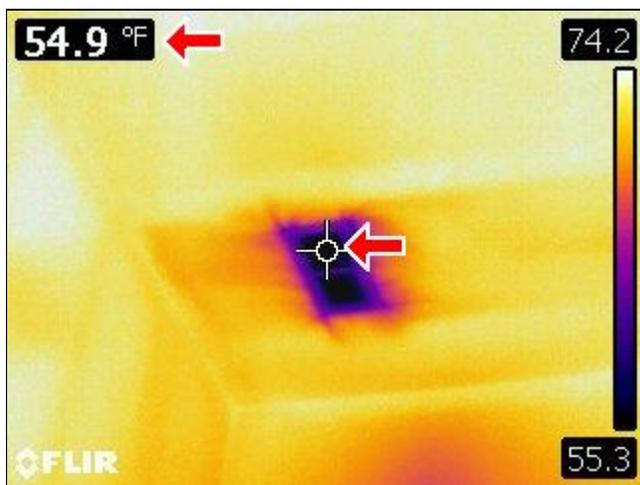
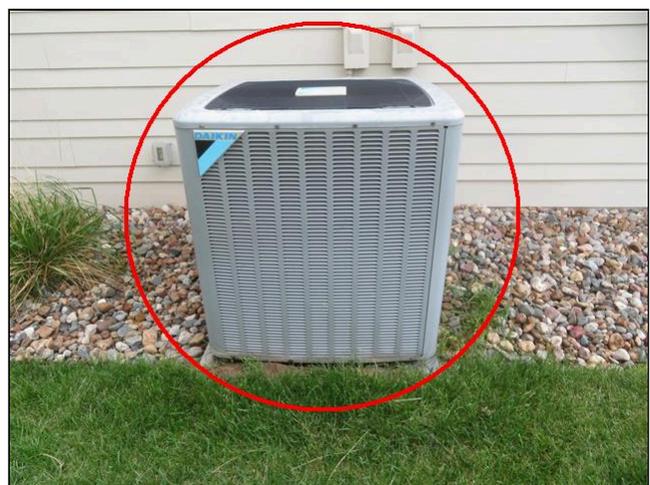
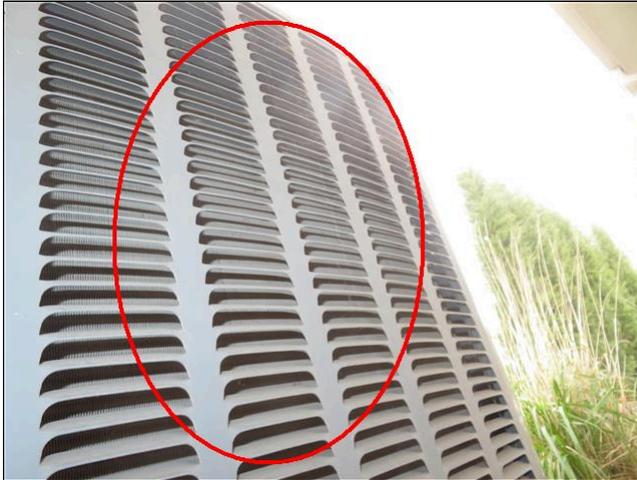
Air conditioning system is operating well upon testing. Thermal temperature readings are appropriate for effective cooling. Recommend cleaning exterior units cooling fin assembly with a garden hose. This will be a semi-annual maintenance item to perform.

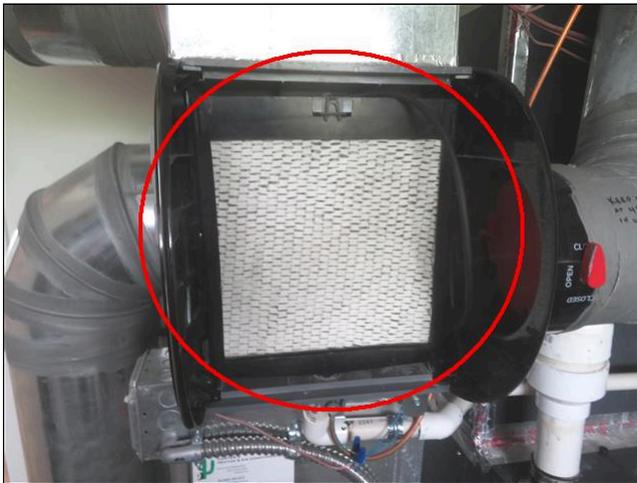
8.10 Item 1(Picture)

Replace water panel. This is a yearly maintenance item to perform. Do not over humidify the indoor environment when exterior temperatures drop significantly.
