TREC REI 7-6

285 Saddle Creek Trail  
Stephenville, TX 76401

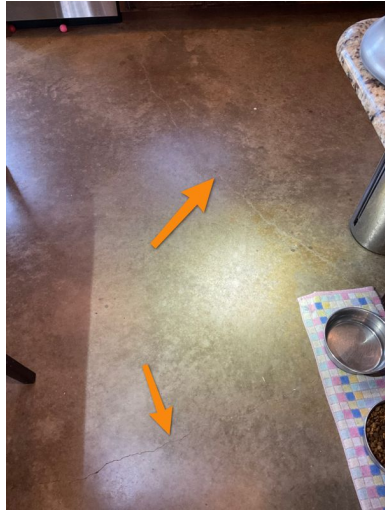
Kitchen

#### 1: Foundation Cracks - Minor

Minor cracking was noted at the foundation. This is common as concrete ages and shrinkage surface cracks are normal. Recommend monitoring for more serious shifting/displacement.

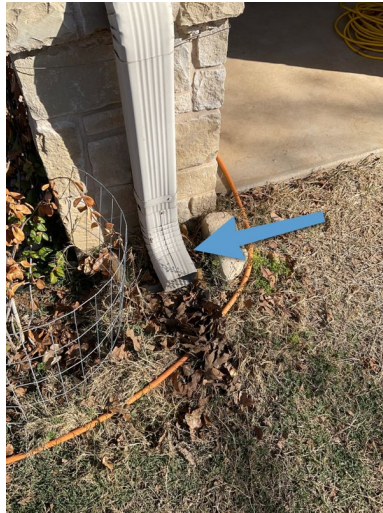
Example

One or more gutter terminations are insufficient. Water should be moved 3-5 feet away from the foundation in order to prevent excessive water and erosion near the foundation. Recommend repair

Recommendation: Contact a qualified professional.

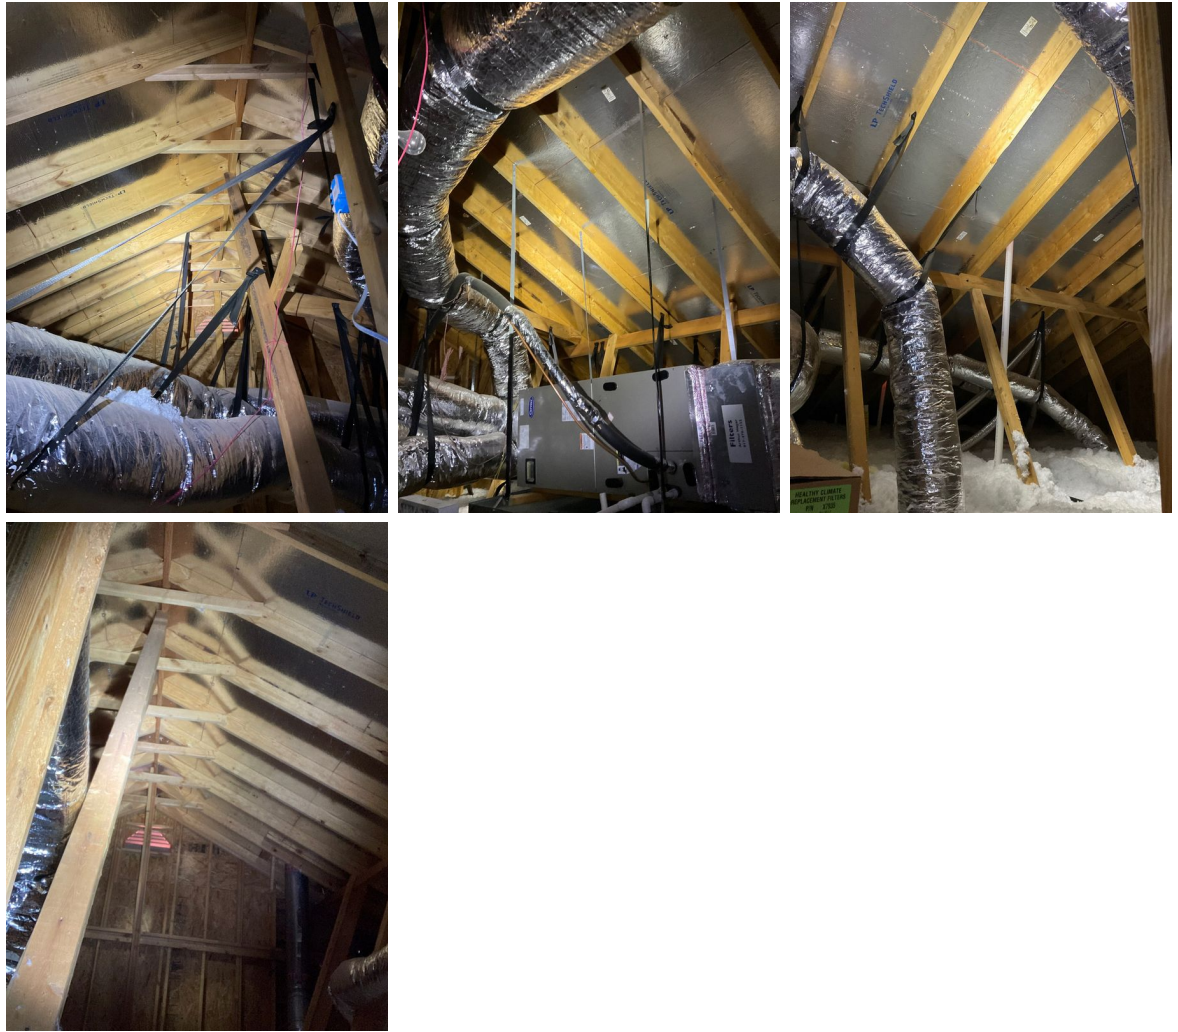
**1: Insulation - Missing**

Observed insulation not present over living area. Recommend repair

Recommendation: Contact a qualified professional.

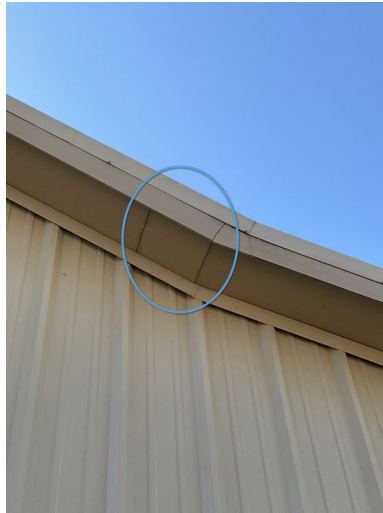
Left

Observed one or more areas of exterior trim in need of caulking maintenance. Recommend repair

Recommendation: Contact a qualified professional.

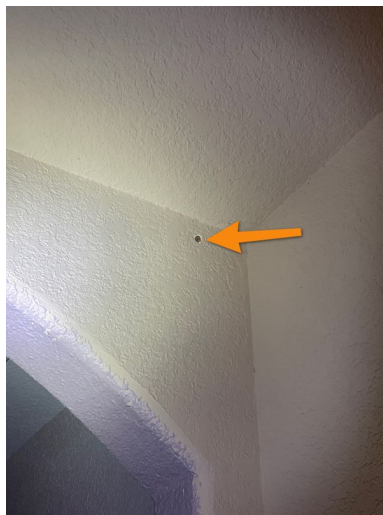
Laundry Room

Observed one or more nail pop(s) on interior walls. Recommend repair

Recommendation: Contact a qualified professional.

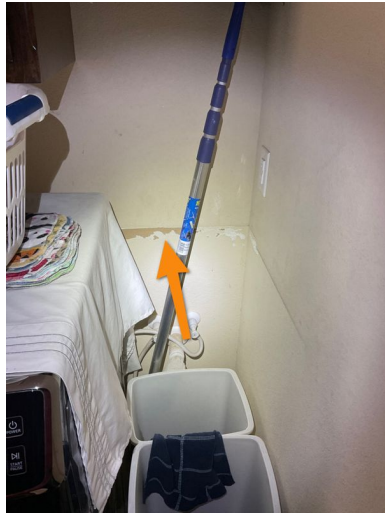
Laundry Room

### 4: Drywall - Damage

Observed one or more areas of damaged drywall. Recommend repair

Recommendation: Contact a qualified professional.

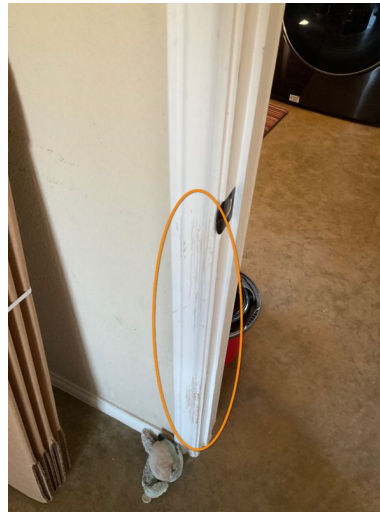
#### 5: Interior Trim - Damaged

Observed general damage to interior trim in one or more areas. Recommend repair

Recommendation: Contact a qualified professional.

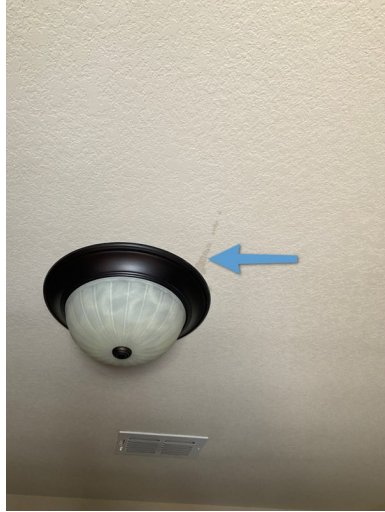
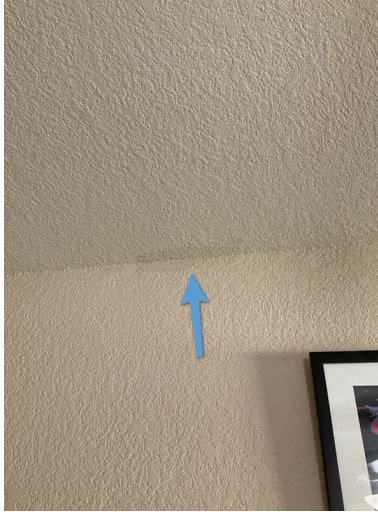
#### 1: Ceiling Drywall - Moisture Stain

Observed moisture stain on ceiling in one or more areas. Recommend finding source of moisture and making repairs.

Recommendation: Contact a qualified handyman.

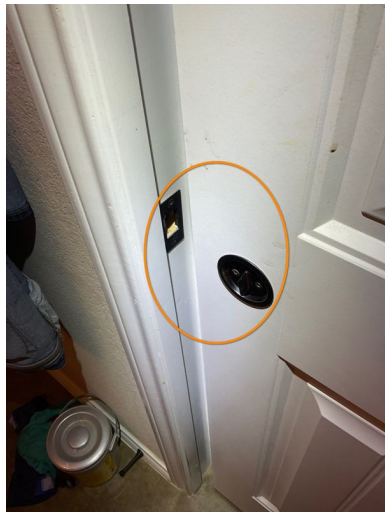
Left Bathroom

Observed one or more interior doors with inoperable locks. Recommend repair

Recommendation: Contact a qualified professional.

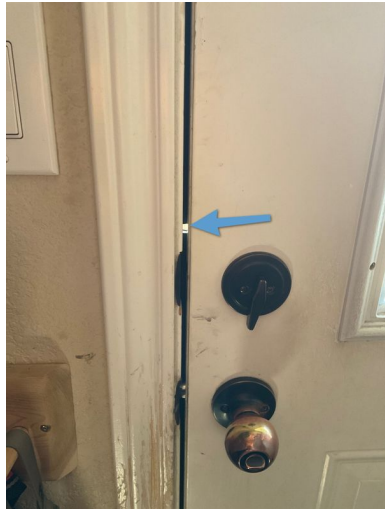
Back Door

**2: Exterior Door - Missing/Damaged Weatherstripping**

Observed missing, damaged, or insufficient weather stripping around exterior door. Failure to repair can result in energy loss and pest/water intrusion. Recommend repair

Recommendation: Contact a handyman or DIY project

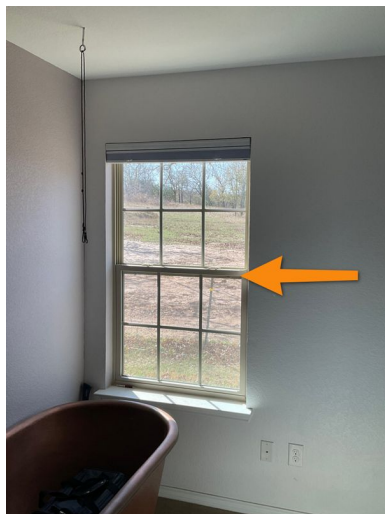
Master Bedroom

When raised, one or more windows did not stay open. Recommend repair

Recommendation: Contact a qualified professional.

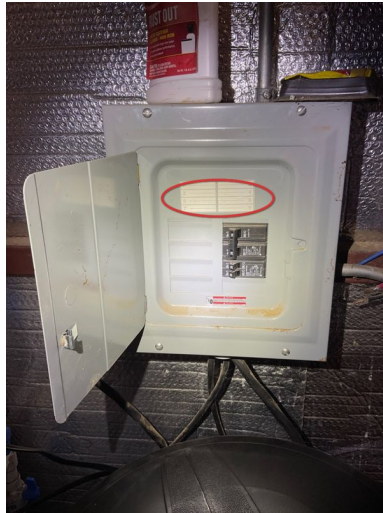
Well

**1: Panel - Not Properly Labeled**

Service panel is not labeled, or not properly labeled. Recommend a qualified electrician test and properly label all breakers.

Recommendation: Contact a qualified electrical contractor.

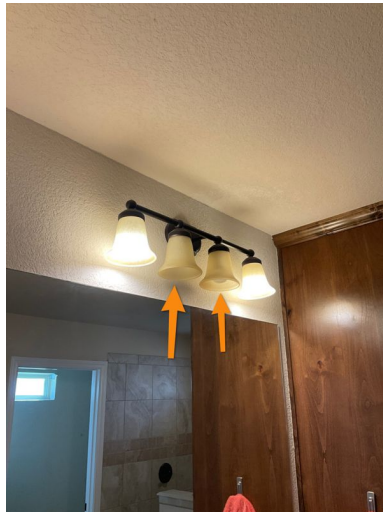
Master Bathroom

One or more lights are not operating. New light bulb possibly needed. If replacement of bulbs does not correct the problem contact a licensed electrician.

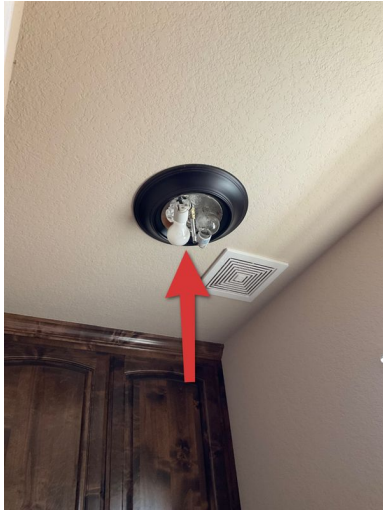
Master Bathroom

**2: Light Fixture - Unprotected**

Observed one or more light fixture with no protective covering. Recommend repair

Recommendation: Contact a qualified professional.

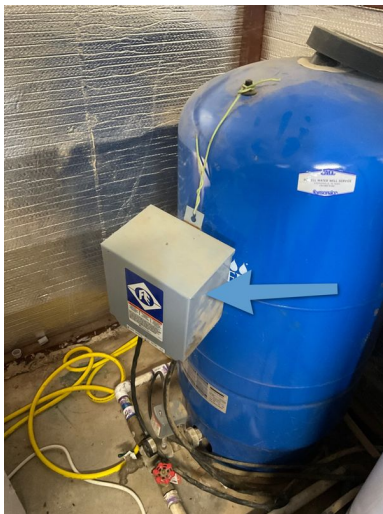
Well

### 3: Unmounted box

Observed an electrical box not mounted. Recommend repair.

Recommendation: Contact a qualified electrical contractor.

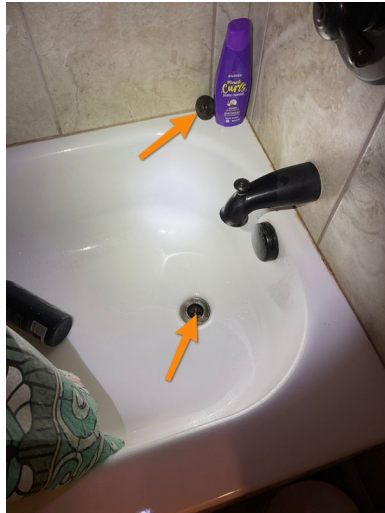
Left Bathroom

**1: Drain - Missing, broken, or Non-Functional Stop**

Observed one or more missing, broken, poorly functional, or non-functional drain stop. Recommend repair.

Recommendation: Contact a qualified professional.

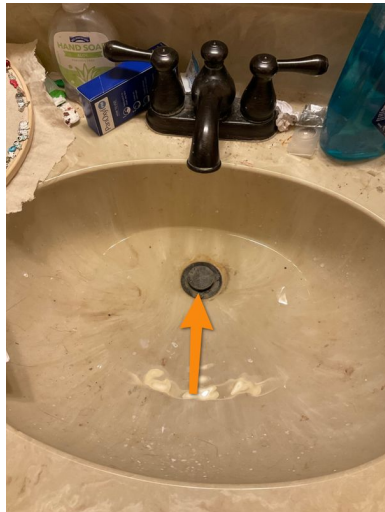
Left Bathroom

## 2: Drain - Slow

Poor/slow drainage was observed at time of inspection. Recommend a qualified plumber evaluate and repair.

Recommendation: Contact a qualified plumbing contractor.

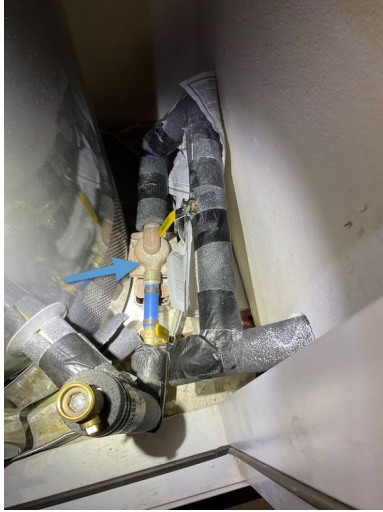
#### 1: Recirculating Pump Deficient

Observed a recirculating pump in place. The housing appears to be damaged and the valves on the line it is connected to are off. Recommend repair.

Recommendation: Contact a qualified plumbing contractor.

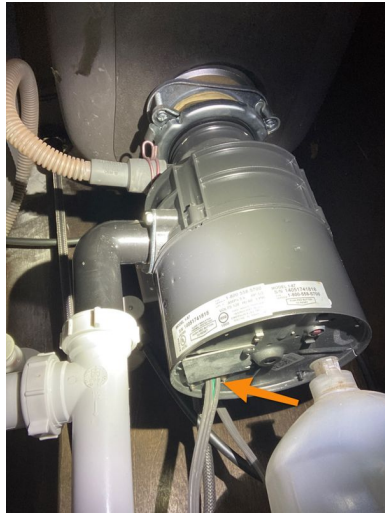
**1: Wiring not properly secured**

Observed the wiring not properly secured to unit housing. Recommend repair

Recommendation: Contact a handyman or DIY project

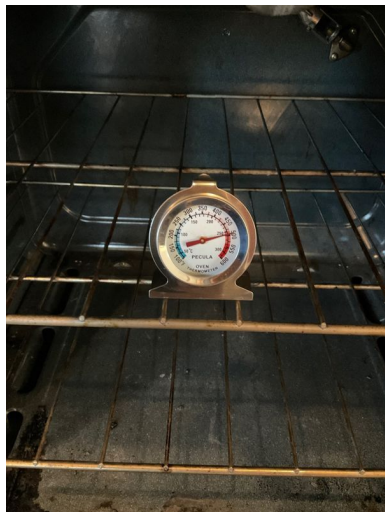
**1: Inadequate temperature differential**

Recommend repair.

Recommendation: Contact a qualified appliance repair professional.

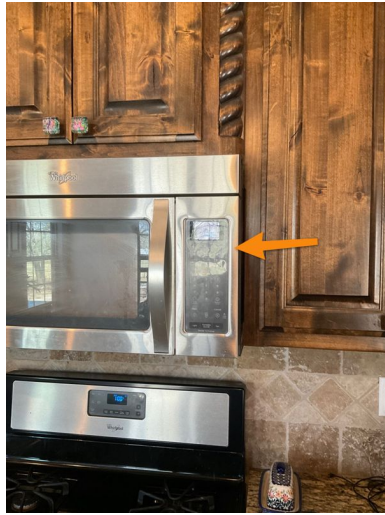
**1: Loose Hardware**

Observed loose hardware on unit. Recommend repair

Recommendation: Contact a qualified professional.

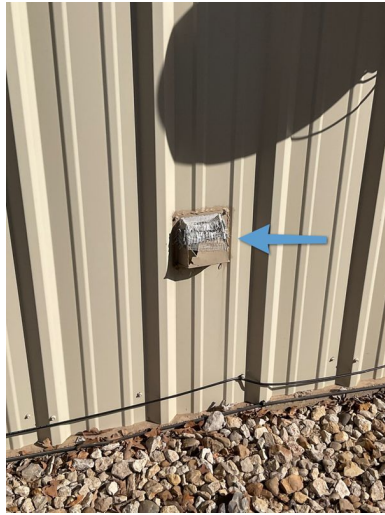
**1: Broken/Missing Exterior Vent Housing**

The exterior vent cover/housing is broken or missing. Recommend repair

Recommendation: Contact a handyman or DIY project
