RE: Waters of the United States Delineation  
Charles Hardy Parkway Site  
South of Charles Hardy Parkway  
Dallas, Paulding County, GA  
Terracon Project No. 49237685

# Waters of the United States Delineation

Charles Hardy Parkway Site

Dallas, Paulding County, GA

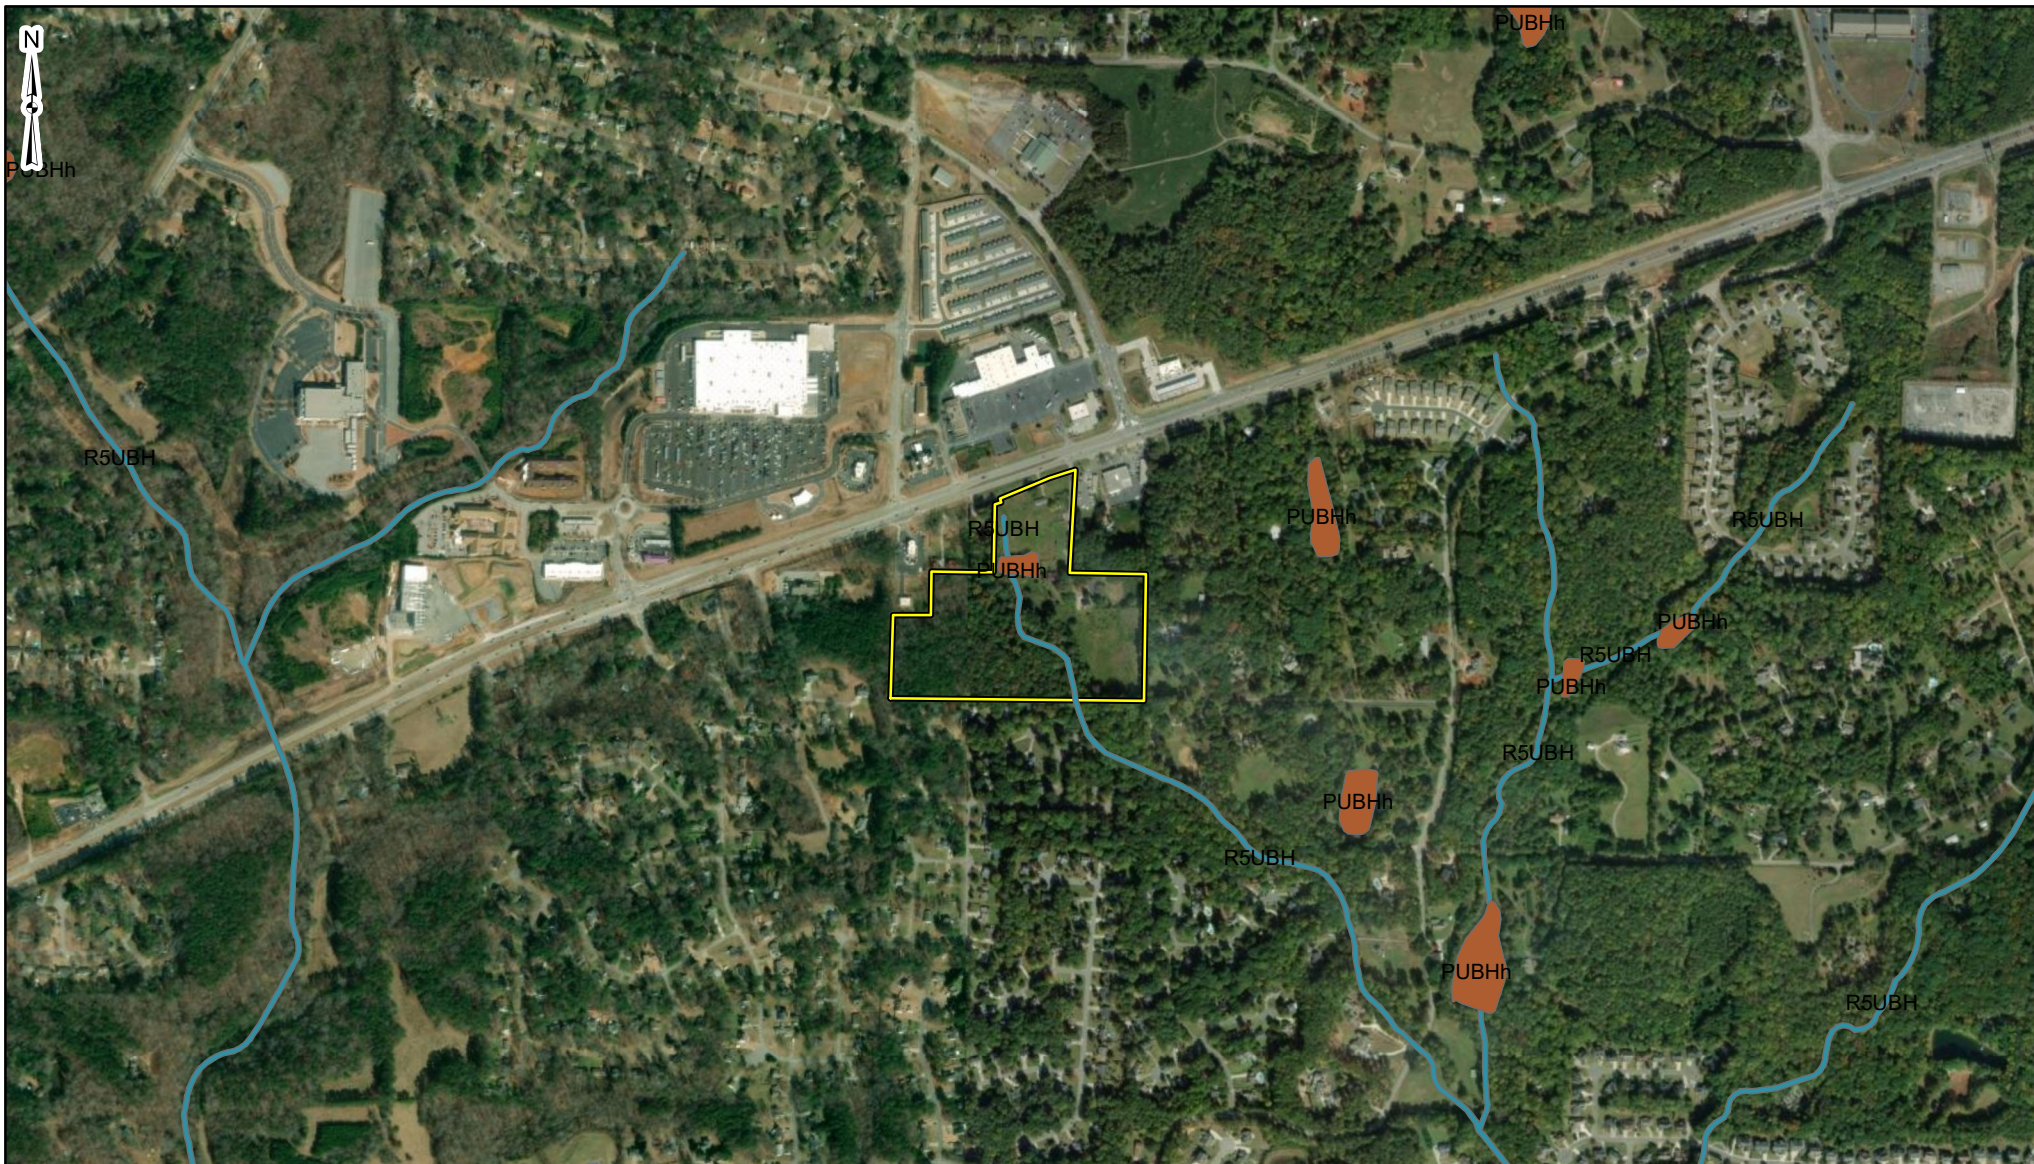
The USFWS NWI map was reviewed to identify wetland areas on the site and in the immediate vicinity. The NWI map depicts suspect wetland areas and waterbodies based on stereoscopic analysis of high-altitude aerial photographs. The NHD is used to portray surface water. The NHD represents the drainage network with features such as rivers, streams, canals, lakes, ponds, coastline, dams, and streamgages. A NWI/NHD map is included as Exhibit 4 in Appendix A.

The review of the NWI map indicates the presence of a stream and pond onsite consistent with the topographic map.

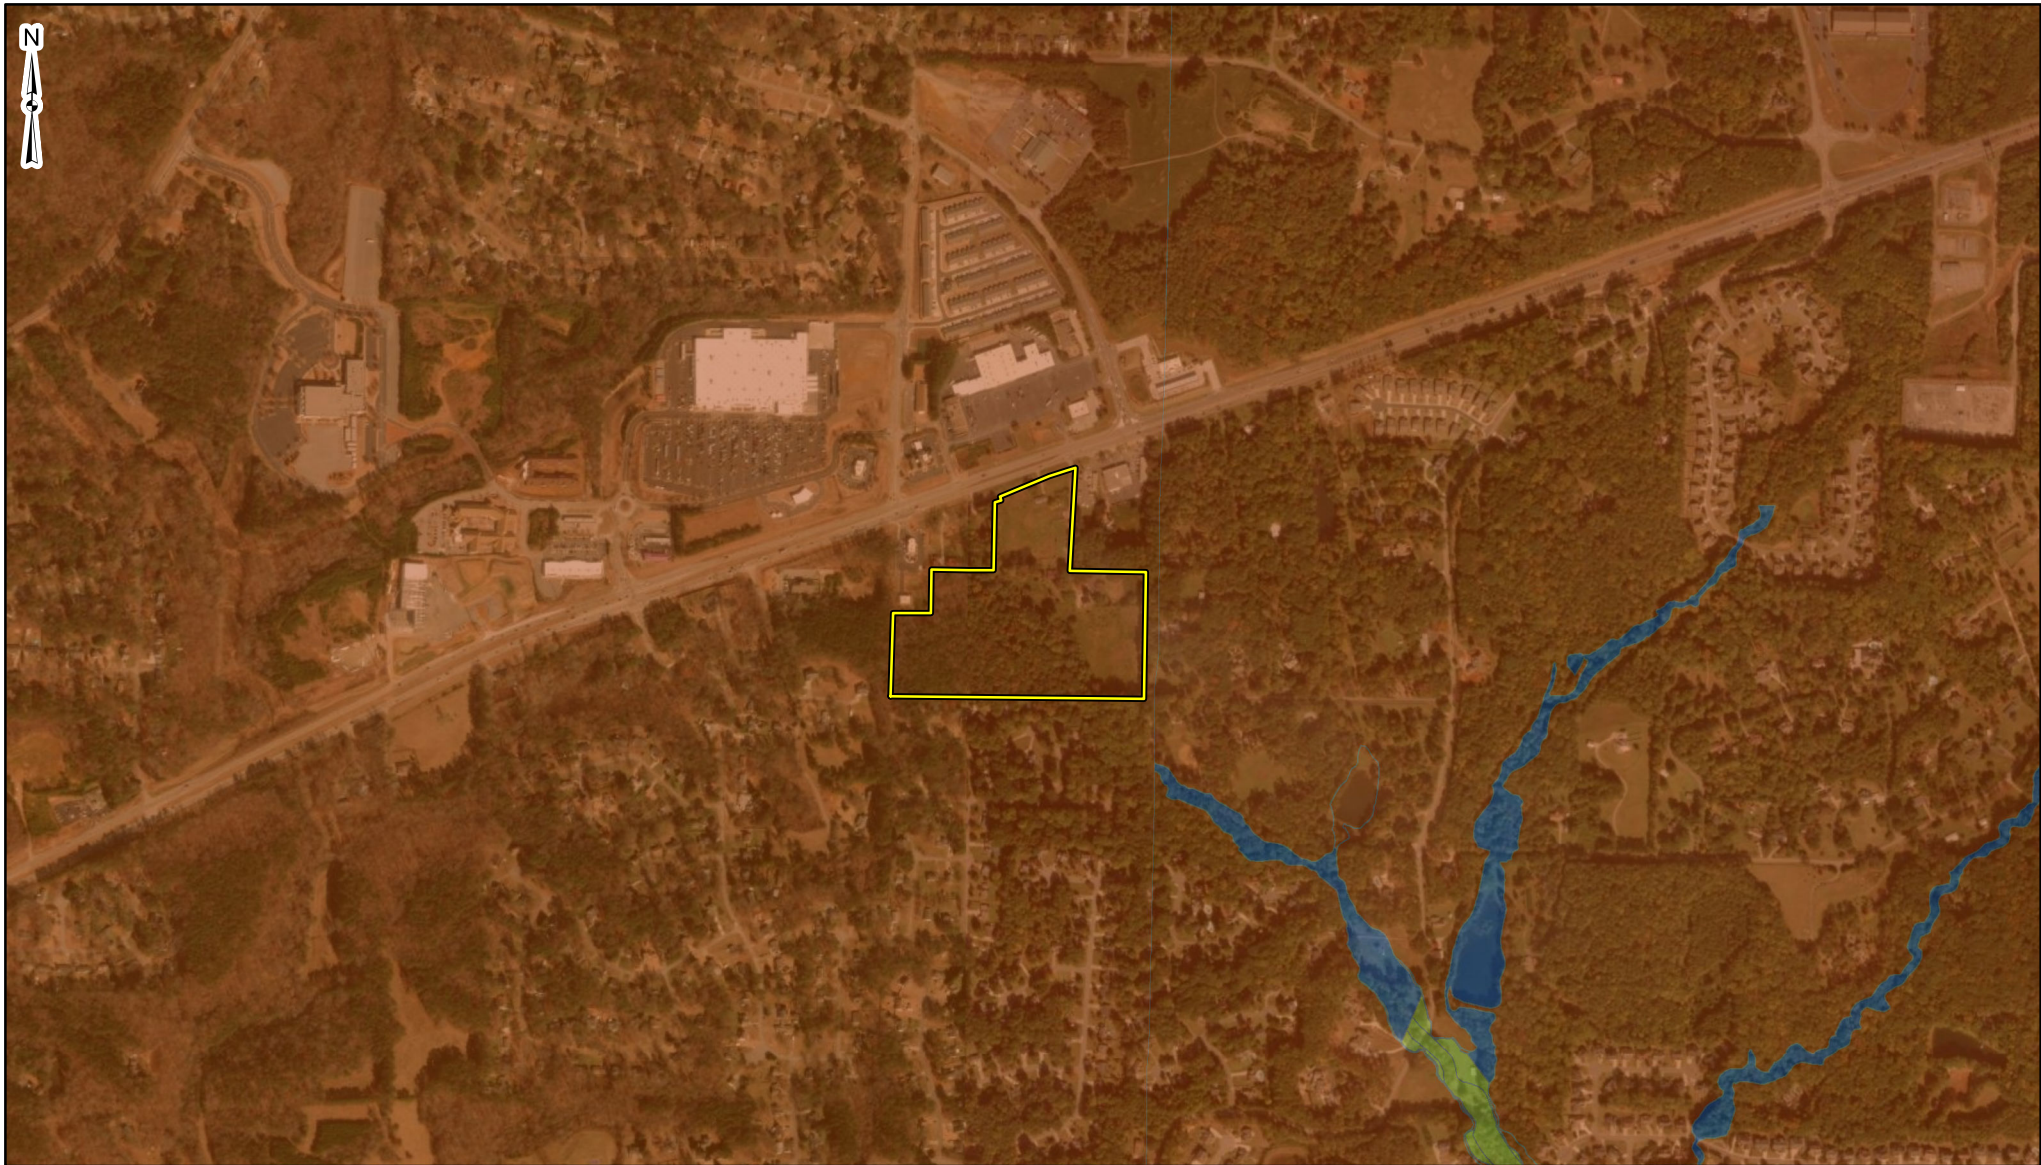
**5**

Terracon downloaded and reviewed Federal Emergency Management Agency (FEMA) Flood Insurance Rate Map (FIRM) Panel Number 13223C0161C eff. 9/29/2006. According to the FIRM panels, the site is located in Zone X which is outside of the FEMA designated 100-year and 500-year floodplain zones. The FEMA map is included in Appendix A Exhibit 5.

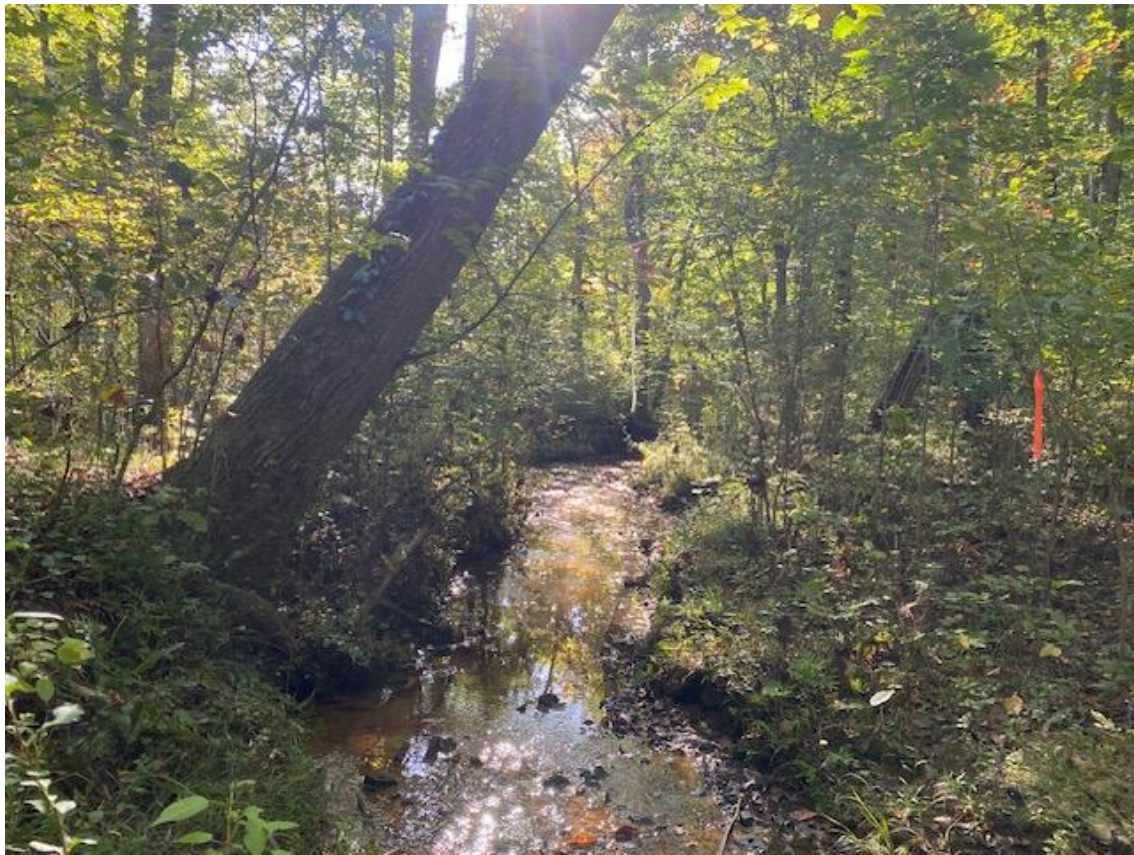
Terracon observed one potentially jurisdictional tributary on-site. The stream was classified as perennial and totals approximately 998 LF. The perennial stream displayed moderate bed and bank characteristics, with a silty to cobbly bottom. The streams flows offsite and therefore is classified as likely jurisdictional. However, these classifications are preliminary and only the USACE can confirm these findings. Table 4 contains a summary of the tributary identified on site during the Field Delineation.

**Photo 1:** View of Perennial Stream A (PSA) in near the western site boundary.

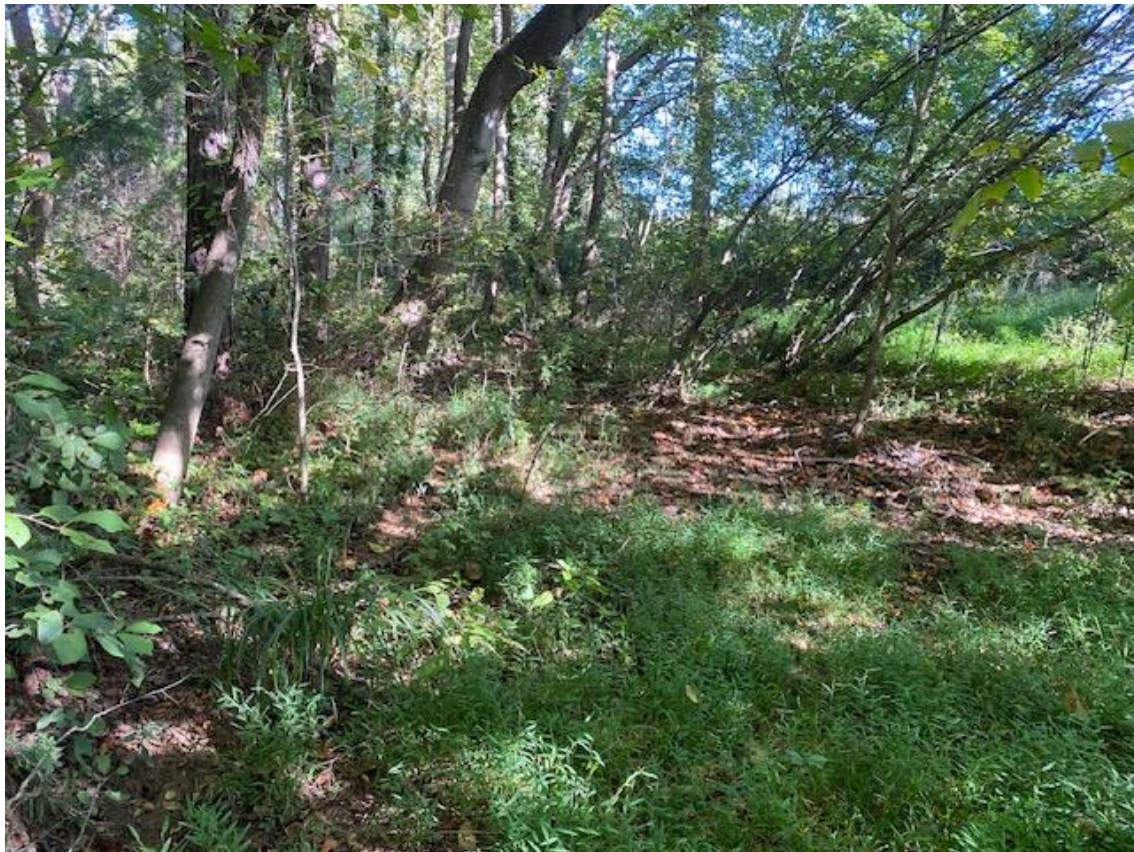
Terracon observed one potentially jurisdictional wetland on site totaling 0.27 acres. Wetland A was observed as forested. The canopy included sweetgum (*Liquidambar styraciflua*), red maple (*Acer rubrum*), and yellow poplar (*Liriodendron tulipifera*); the dominant midstory vegetation included Chinese privet (*Ligustrum sinense*); and the ground cover primarily consisted of Japanese stilt grass (*Microstegium vimineum*). A portion of Wetland A directly abuts a perennial stream that flows offsite and therefore will likely be considered jurisdictional. Hydric soil and hydrology indicators were observed within the wetlands as indicated in the Data Forms included in Appendix B. Table 3 contains a summary of the potentially jurisdictional wetland identified on site during the Field Delineation.

**Photo 2:** View of Wetland A in the central portion of the site.

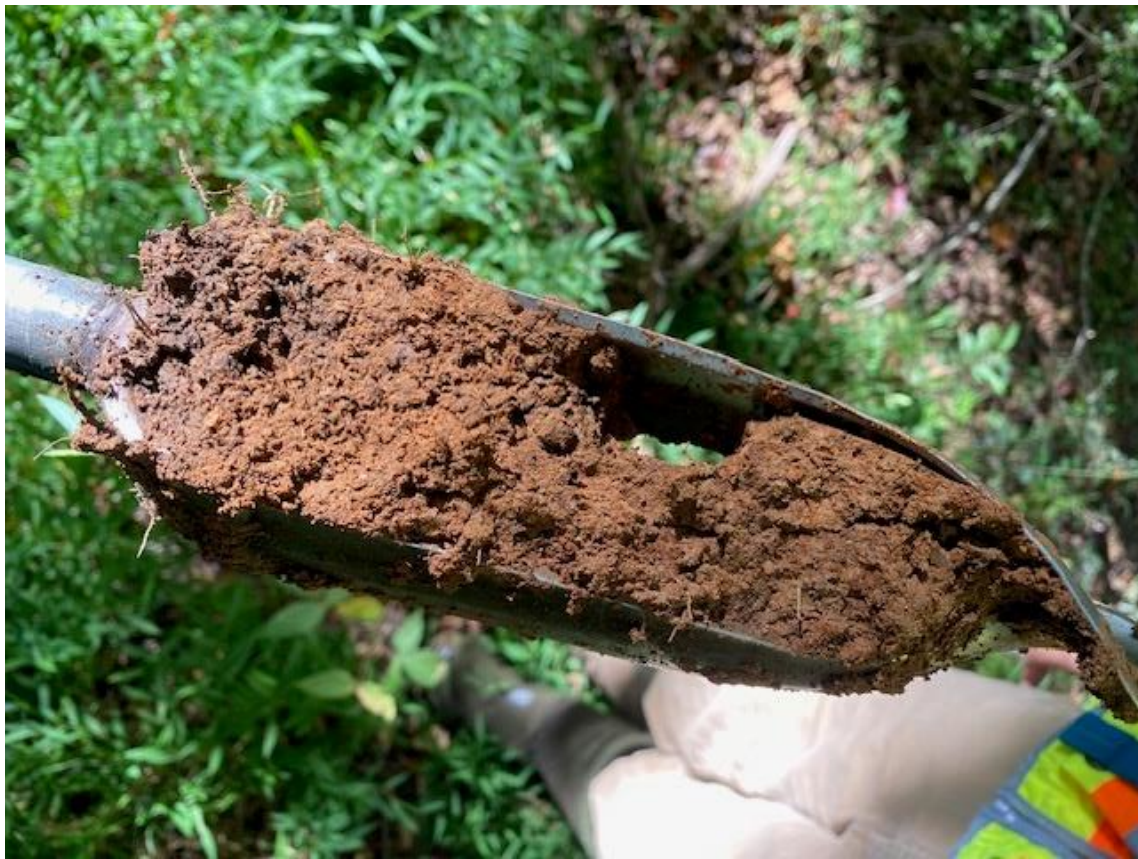
**Photo 3:** Photo of hydric soil sample collected in Wetland A.

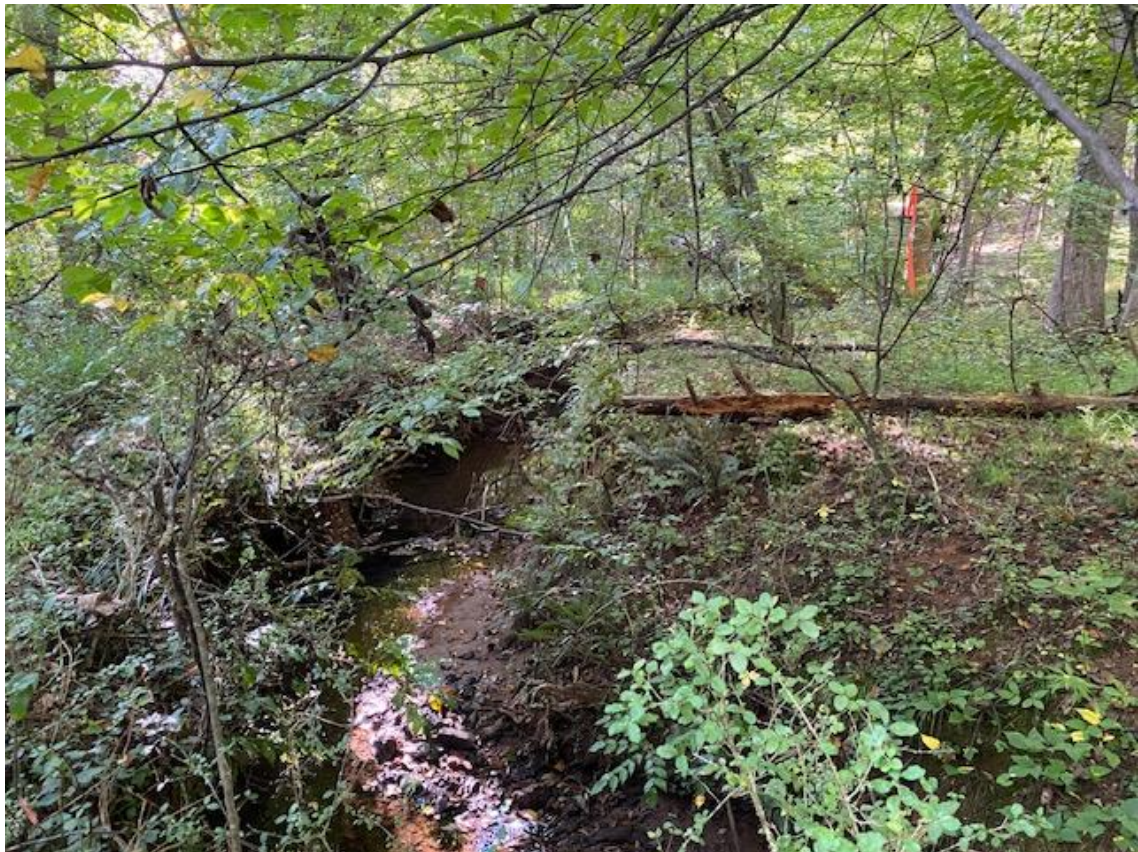
**Photo 4:** View of PSA in the southern portion of the site before it flows offsite.

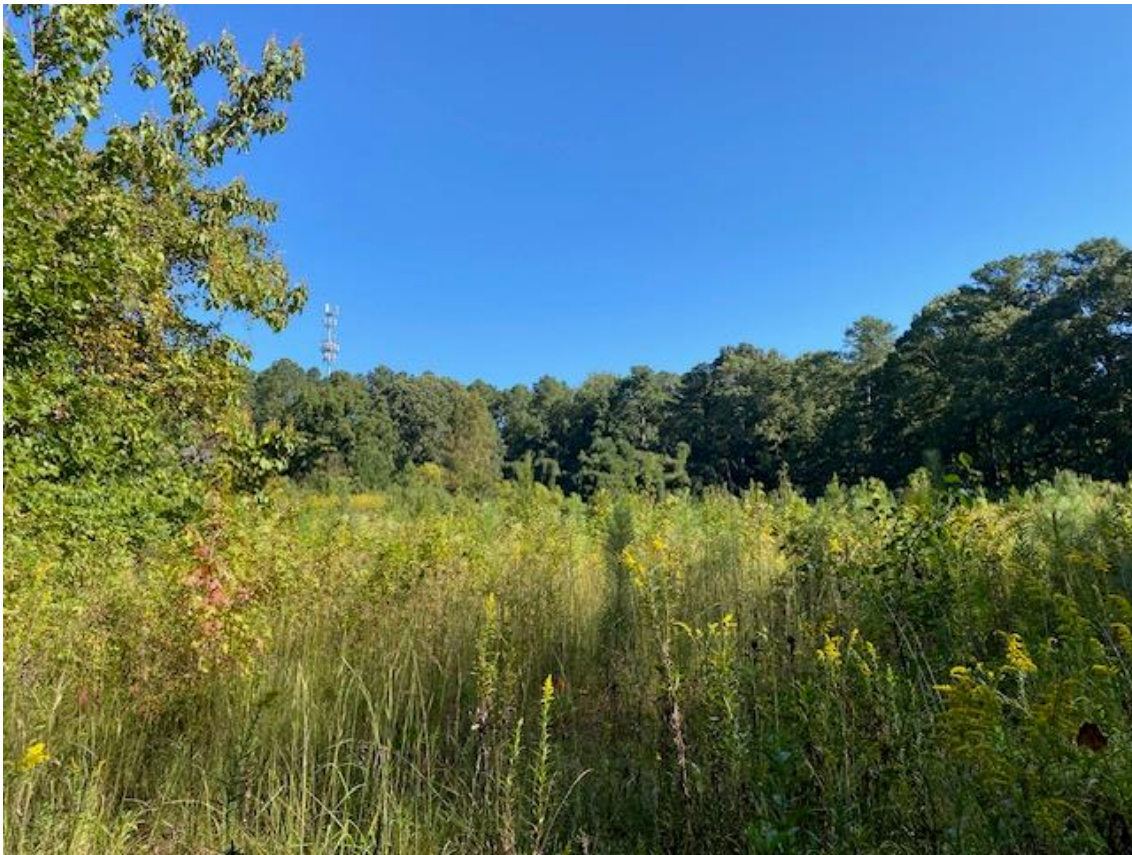
**Photo 5:** View of the upland fields located in the eastern portion of the site.

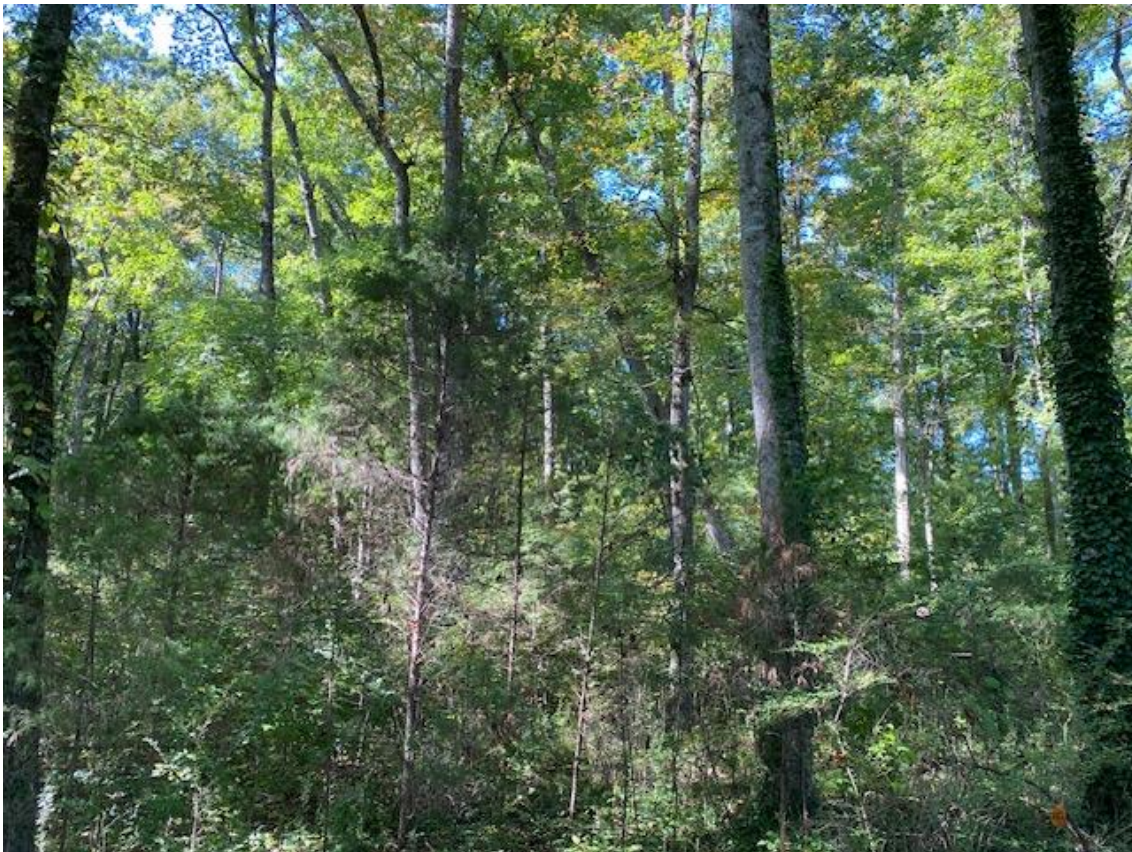
**Photo 6:** View of upland wooded areas in the western portion of the site.

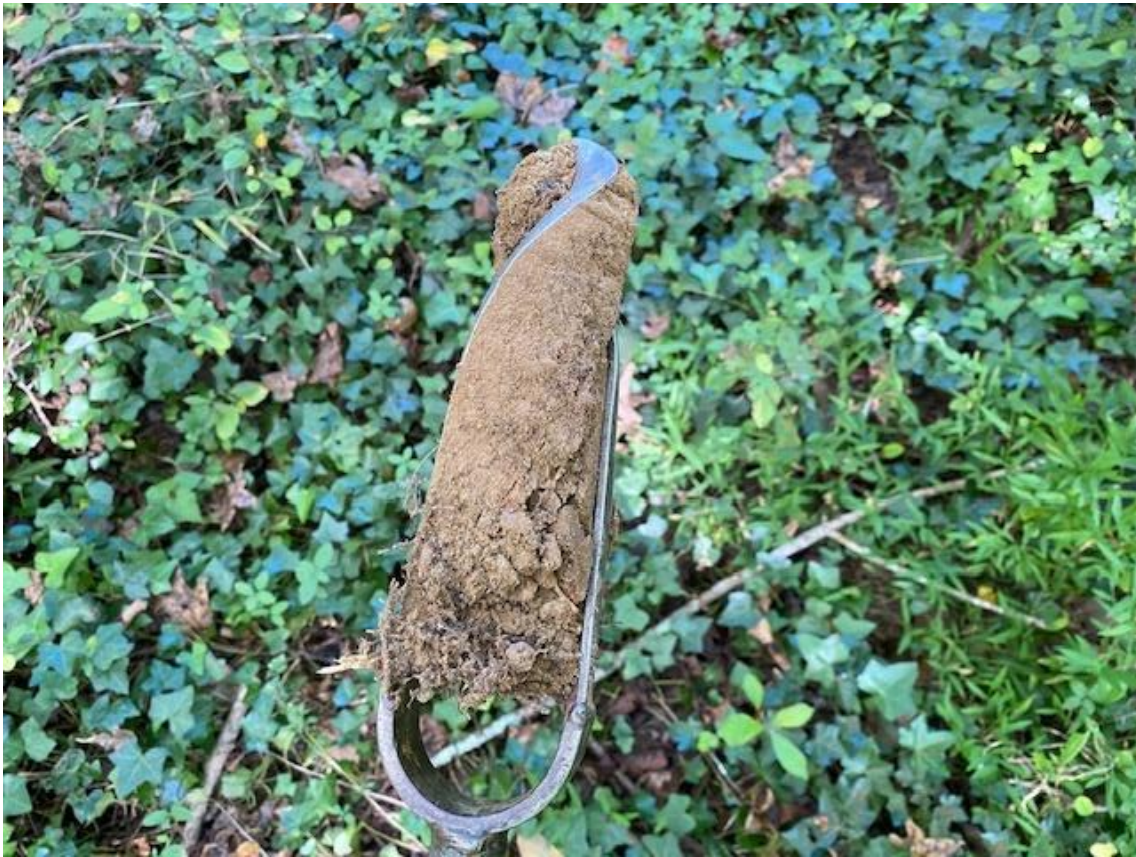
**Photo 7:** View of upland soils collected in the upland mixed hardwood-pine forest portions of the site.

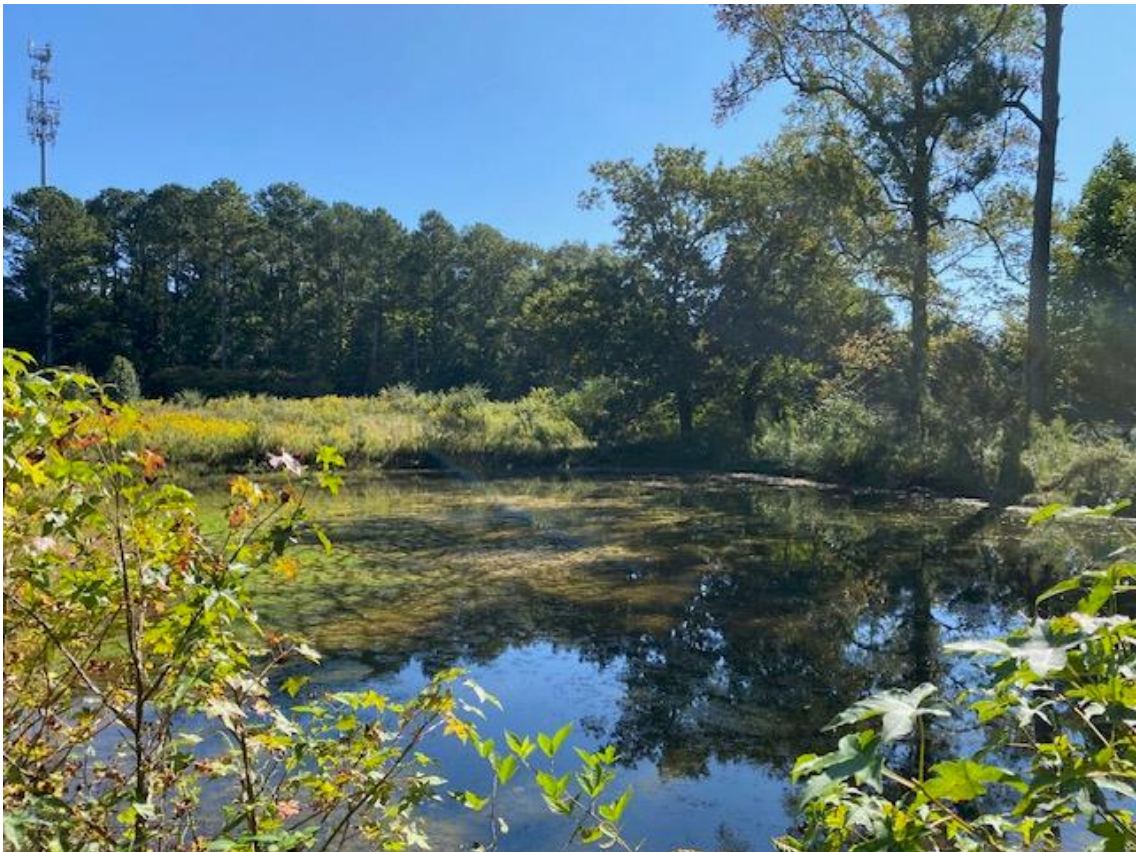
Terracon observed one potentially non-jurisdictional pond in the north/central portion of the site totaling 0.29 acres. No evidence of the pond discharging, such as pipes or outflows, were observed downslope from the pond. Because the pond is not connected to any other aquatic features, Terracon has classified the pond as potentially non-jurisdictional. However, this classification is preliminary and only the USACE can confirm these findings.

**Photo 8:** View of the pond located in the north/central portion of the site.

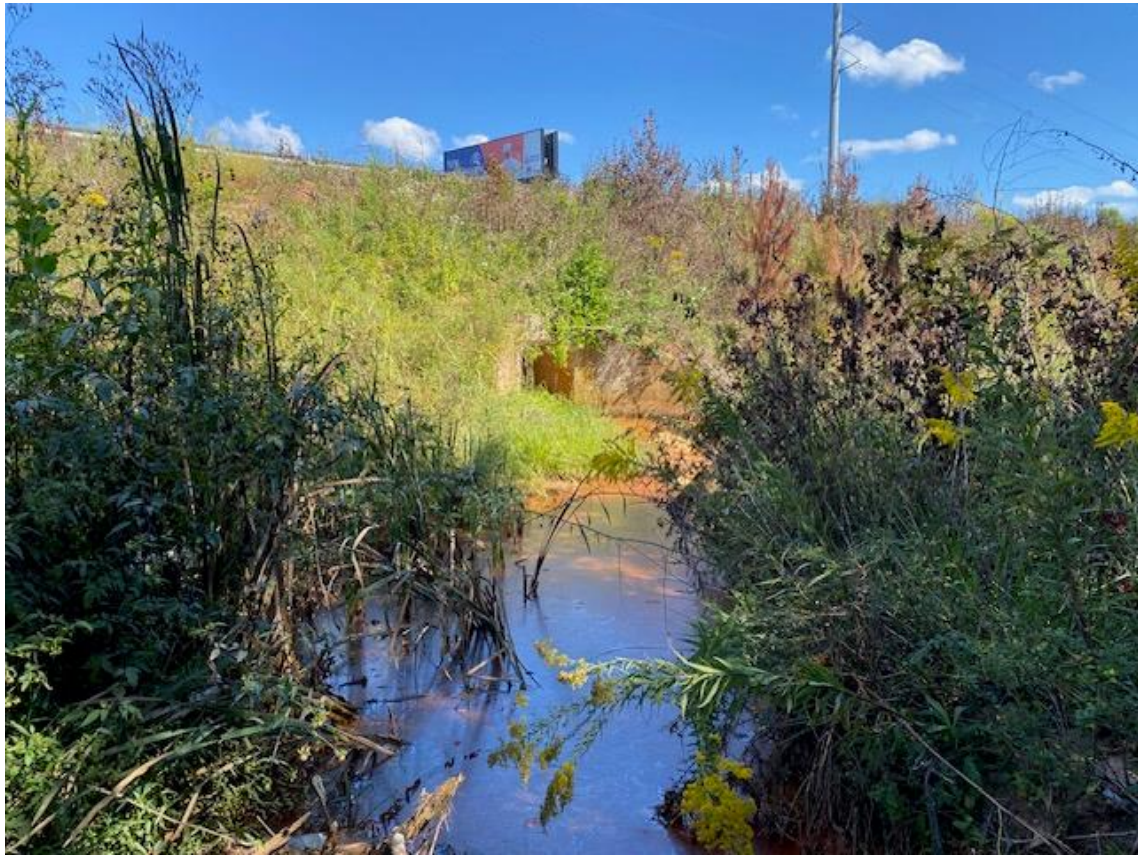
**Photo 9:** View of naturally flowing portion of the offsite stream located west of the site.

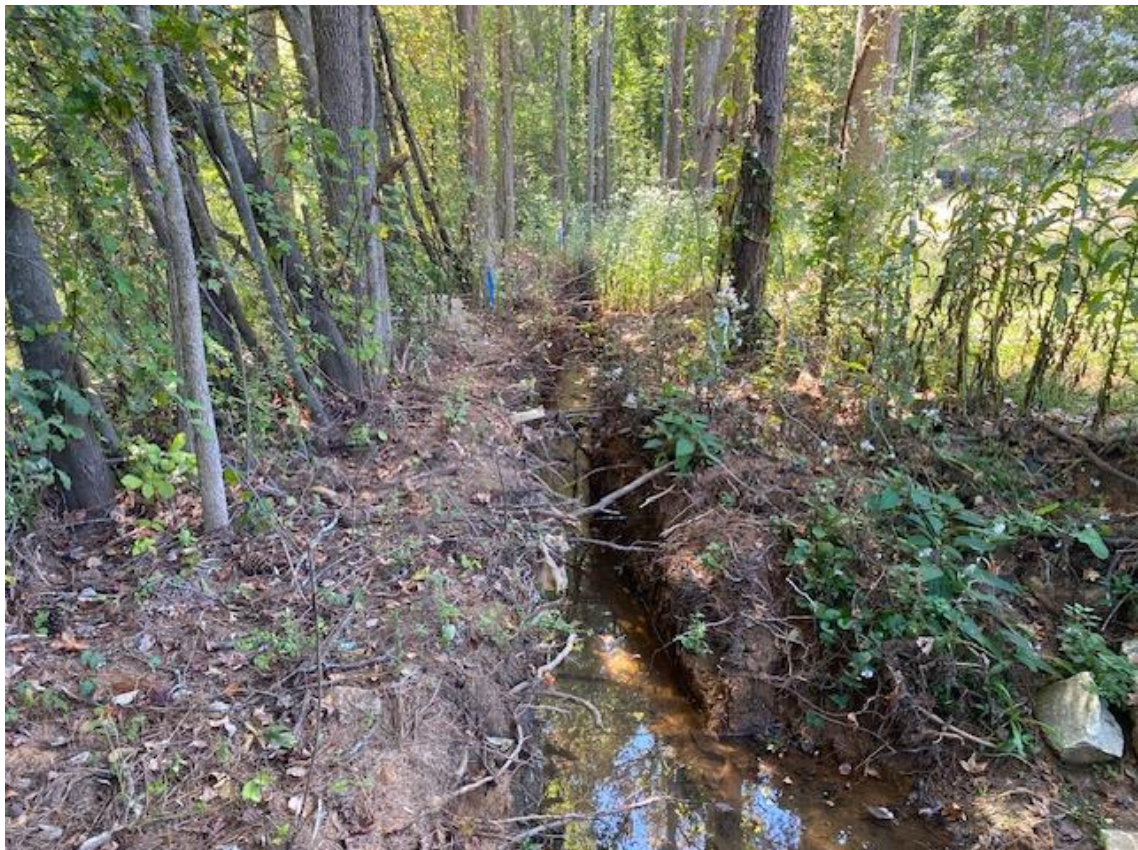
It should be noted that an additional tributary was observed west of the site boundary. The stream was classified as perennial; however, a portion of the tributary was classified as an intermittent ditch because the channel appears to have recently been excavated in an upland area. It should be noted that the excavation appeared to be limited to 176 LF and this is what distinguishes this portion of the stream from

**Photo 10:** View of the transition area from the naturally flowing stream to the recently excavated ditch.

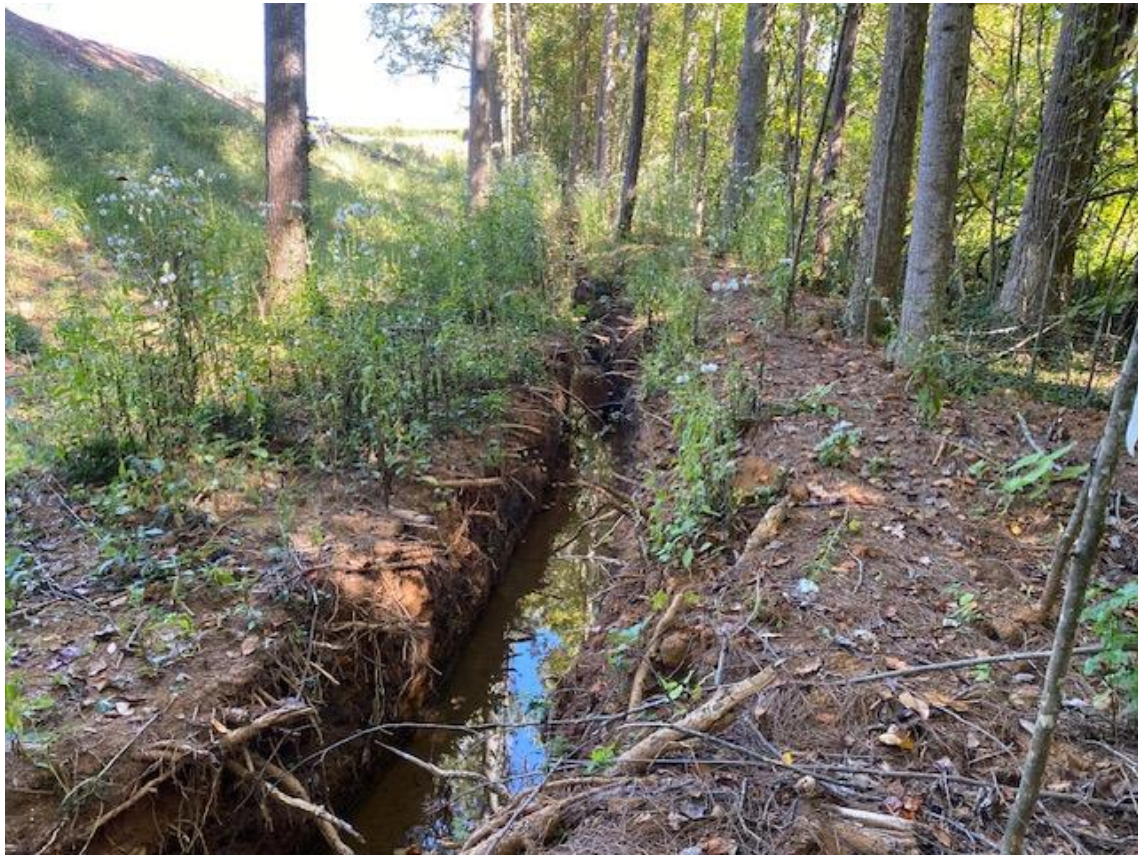
**Photo 11:** Photo of the recently excavated intermittent ditch located along the west of the site boundary.
