ONSITE WASTEWATER TREATMENT SYSTEM (OWTS) ASSESSMENT FOR REAL ESTATE TRANSACTIONS  
ASSESSMENT SUMMARY

Date of Assessment: 09/23/25 Type of Assessment: ☒ Evaluation ☐ Inspection ☐ Re-Inspection  
Site Address: 3157 Horstman Road Berger MO 63014  
STREET CITY ZIP  
Inspector ID No.: 51053 Inspector Initials: JR Job#: 92325

ONSITE WASTEWATER TREATMENT SYSTEM (OWTS) ASSESSMENT FOR REAL ESTATE TRANSACTIONS  
SITE INFORMATION

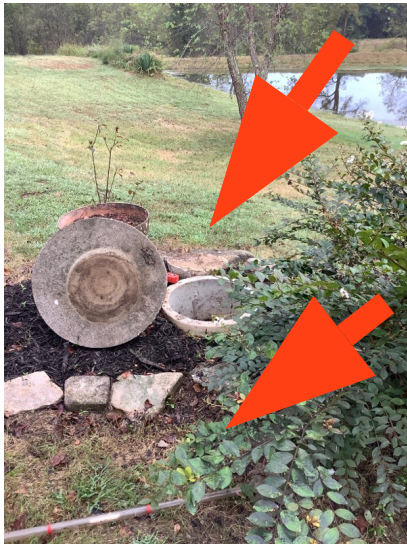
The septic tank is missing the inlet and outlet inspection ports. Unable to see if the tank has Inlet/outlet tees or baffles. Have a state licensed septic installer install the inspection ports. If the baffles/tees are missing install them at that time.

Tank missing inspection ports.

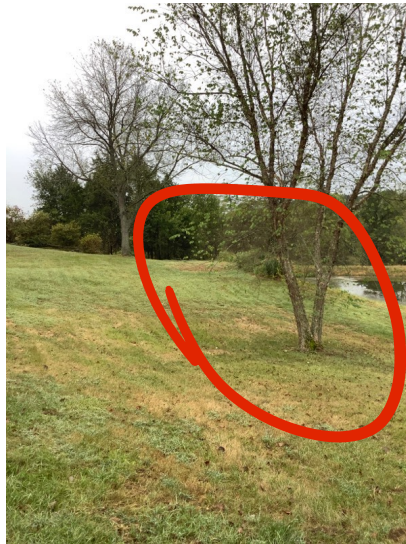
A hydraulic test was not preformed due to the home being vacant longer than 60 days. It was disclosed the location of the septic field. On the hill behind the detached garage. According to diagram there are three lines that run towards the dam, with a over flow on the other side of the dam. There should not be a overflow pipe. It appears to be a non typical septic field, check with the county to see if permits were pulled/ if it was approved by the county. Have a state licensed septic installer further evaluate and make repairs if necessary.  
A hydraulic test should be preformed 90 days after moving in to check the field for leaks.

Disclosed septic field is on hill behind detached garage.

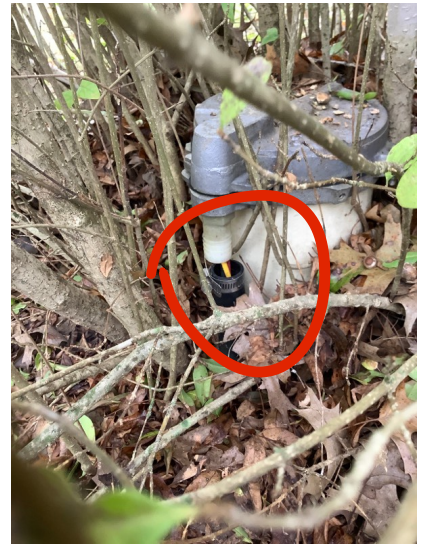
The well cap is not vented and the conduit has pulled apart from the cap. Recommend a well professional replace the cap with a vented cap and reconnect the conduit to the cap.  
Water results are pending.

Well conduit pulled apart.
