# Wetland Delineation and Chesapeake Bay Preservation Report

Jenkins Neck Road

Gloucester County Tax Map #: 53-216B

August 28, 2023

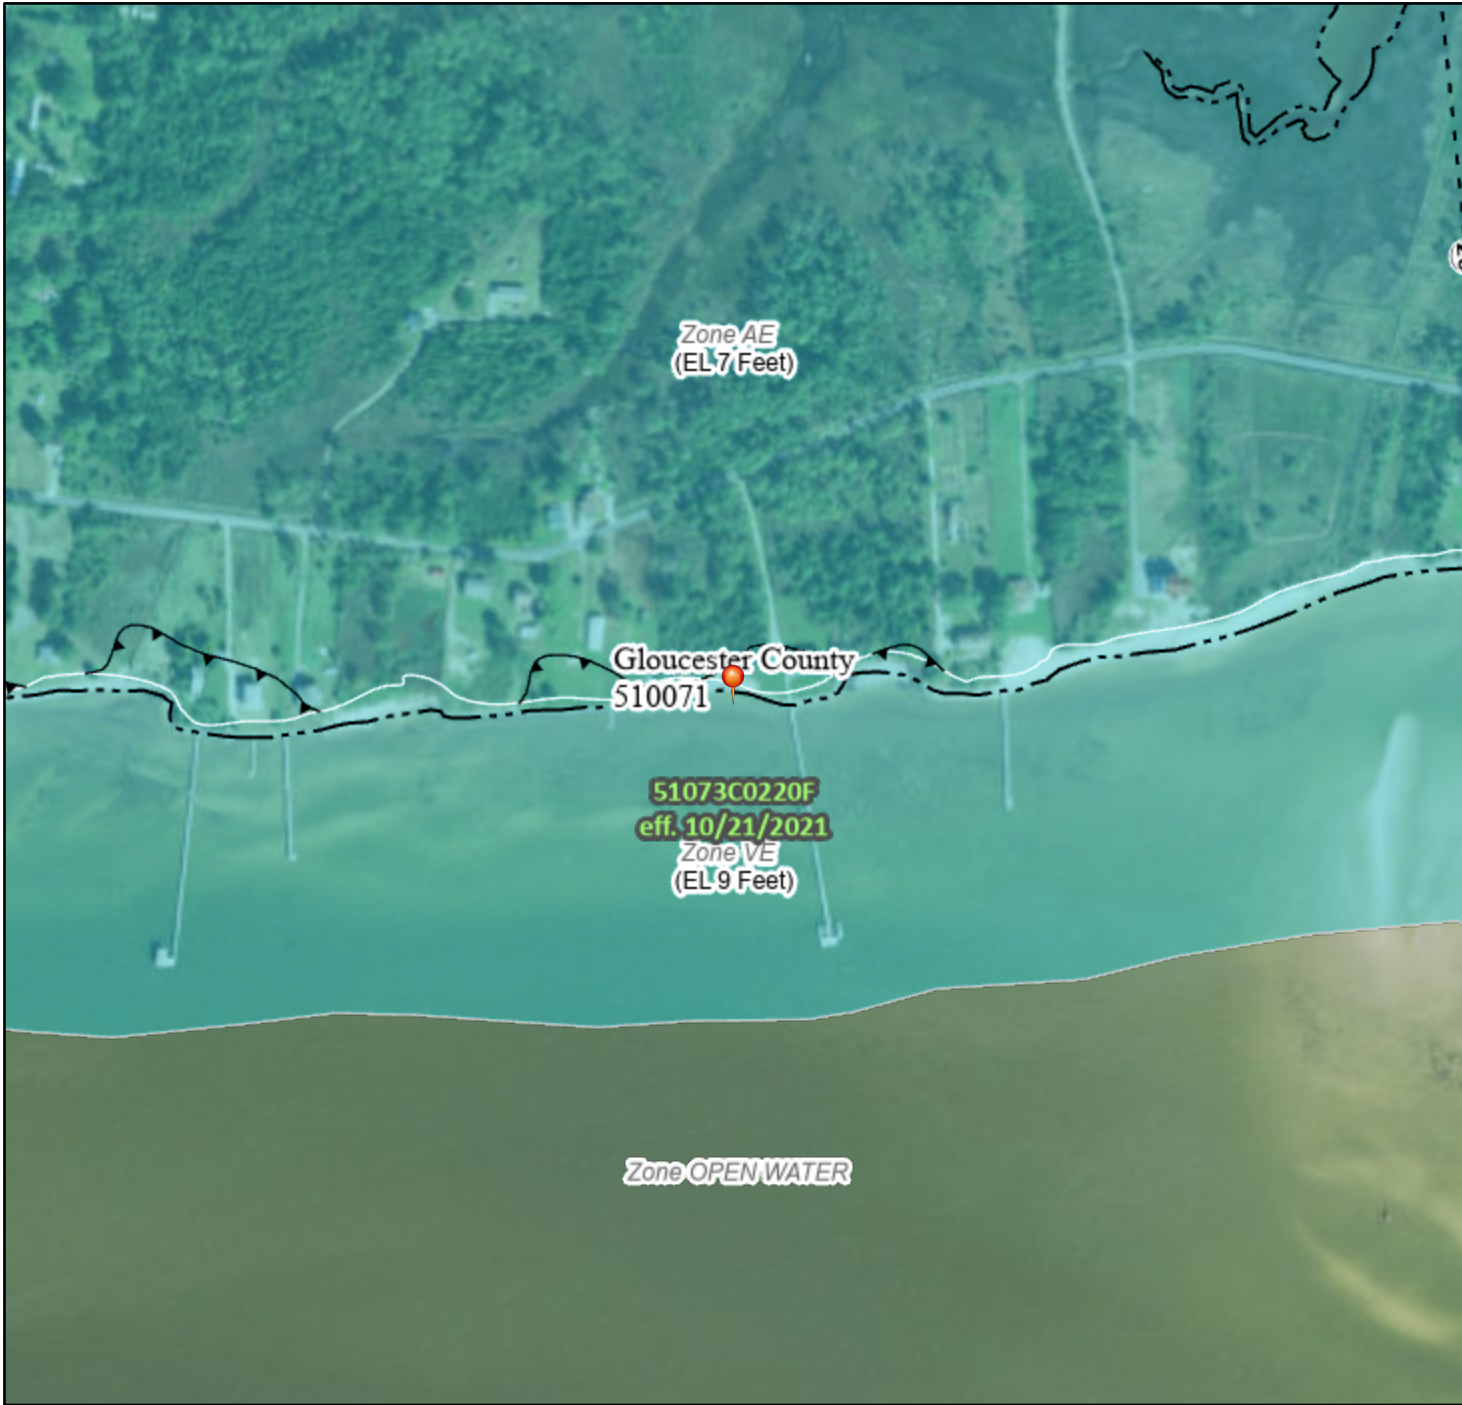
# National Flood Hazard Layer FIRMMette

As depicted on the Federal Emergency Management Agency's (FEMA) on-line Flood Insurance Rate Map #51073C0220F, effective on 10/21/2021, the study area is located within Zone AE, characterized as an area of high flood hazard with a base flood elevation of 7 feet.

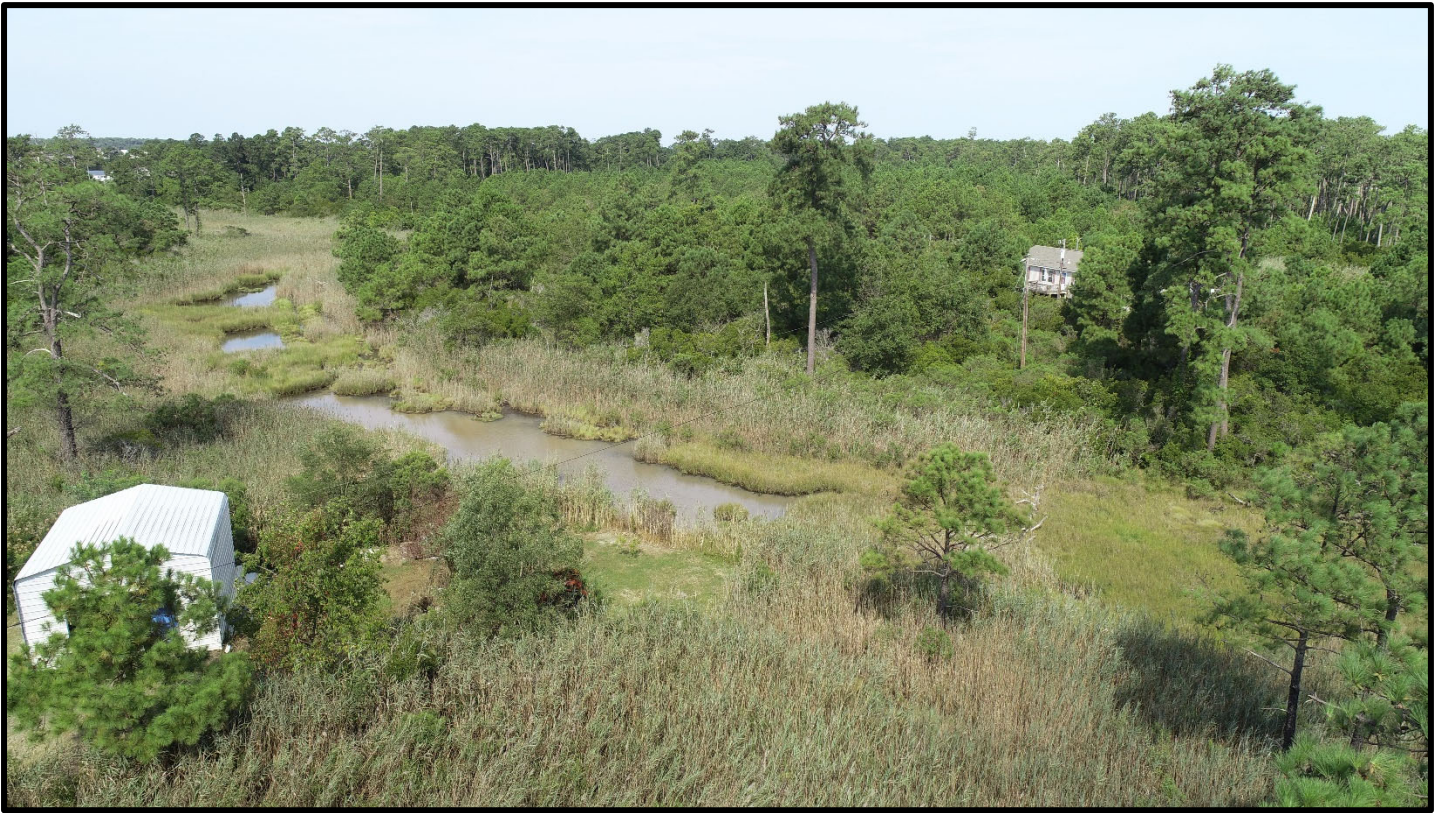
Photograph 7: Aerial drone imagery of the tidal drainage feature along the northern study area boundary

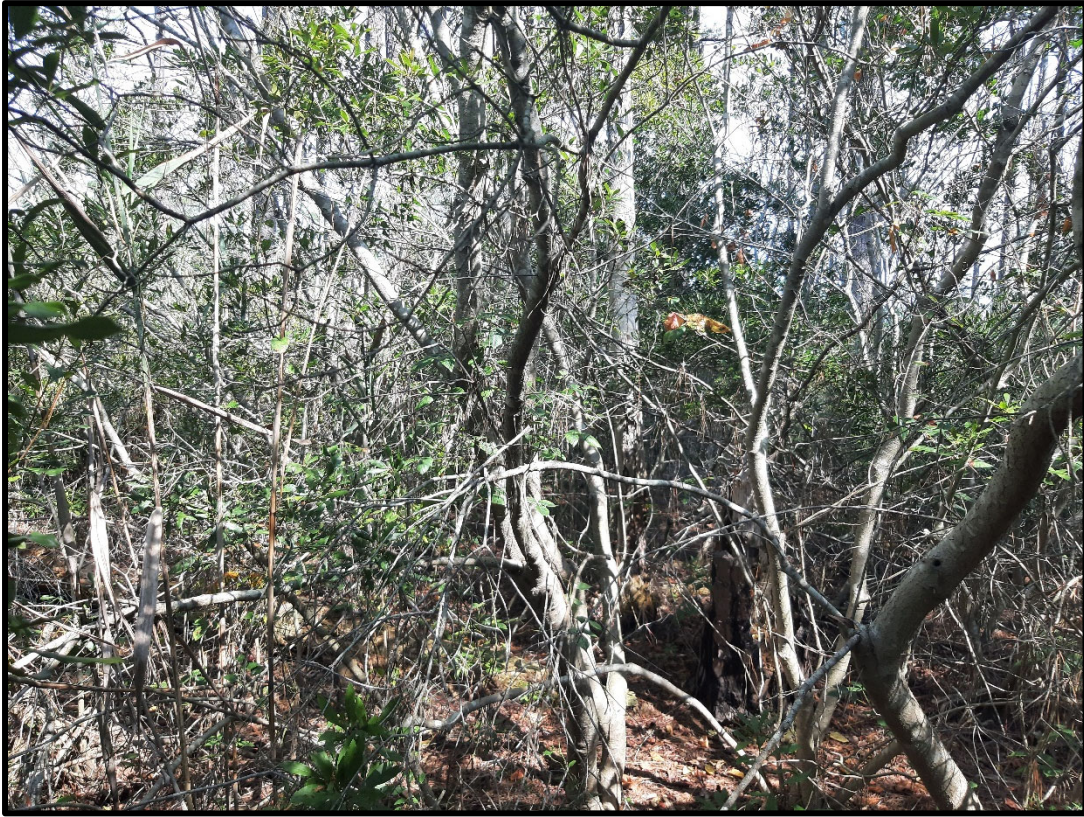
The wetland delineation field investigation resulted in identifying approximately 0.15 acres of uplands observed throughout the southeast portion of the study area. The uplands were forested and dominated by needle-leaved evergreen vegetation within the tree stratum and the understory was densely vegetated within the shrub stratum with wax myrtle (*Morella cerifera*). The uplands were located upon a slightly convex landscape that was gently sloped and situated a couple feet higher than the wetlands adjacently located to the north. The convex landscape in this area appeared to be man-made via former fill activities. A remnant ditch was observed adjacently to the west that appeared to at least partially drain the immediate vicinity. The upland soil profile displayed both high and low chroma colors throughout the upper 11-13 inches of the soil surface and only low chroma colors below. Redoximorphic features were observed beginning between 13 to 15 inches below the soil surface. The upper 16 to 18 inches of the soil surface exhibited variations in the soil matrix colors and textures, suggesting potential soil disturbance formerly occurred in this area.

The dominant vegetation within the forested uplands consisted of loblolly pine (*Pinus taeda*), wax myrtle (*Morella cerifera*), poison ivy (*Toxicodendron radicans*), and greenbrier (*Smilax rotundifolia*). The dominance test hydrophytic vegetation indicator was met throughout the forested uplands and therefore qualified for the hydrophytic vegetation parameter. No hydric soil indicators were observed throughout the forested uplands and the hydric soil parameter was not met. No primary or secondary wetland hydrology indicators were observed throughout the forested uplands and the wetland hydrology parameter was not met.

Photograph 9: Representative view of the forested uplands within the study area

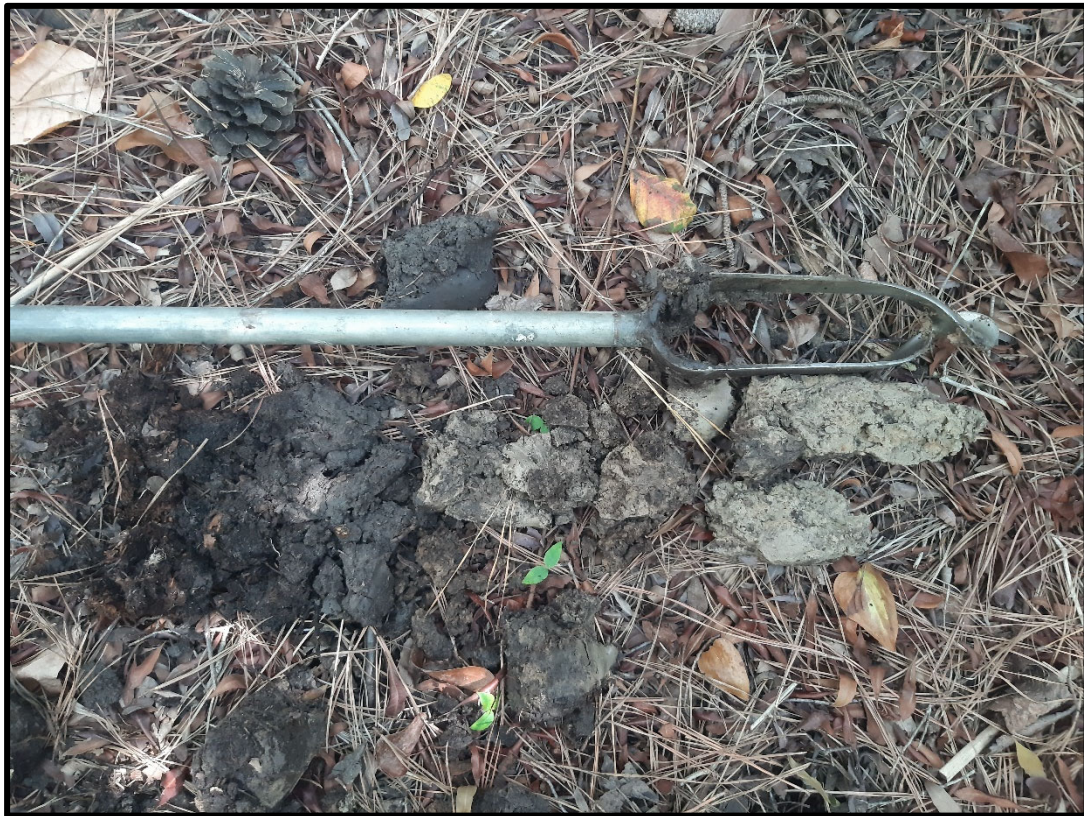
Photograph 10: Representative view of the soil profile within the study area's forested uplands

The soil profile displayed both high and low chroma colors throughout the upper 13 inches of the soil surface and only low chroma colors below 13 inches. Redoximorphic features were observed beginning at 15 inches below the soil surface. The upper 18 inches of the soil surface exhibited variations in the soil matrix colors and textures, suggesting potential soil disturbance formerly occurred in this area. No hydric soil indicators were observed and the hydric soil parameter was not met.

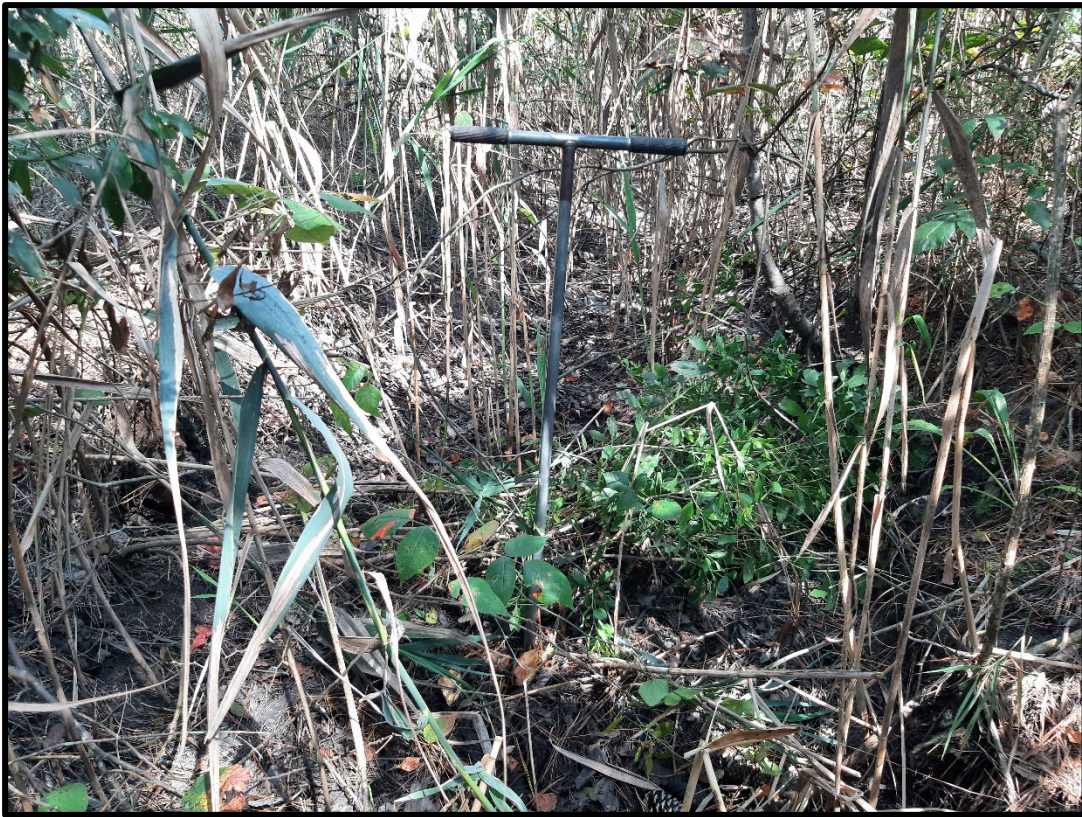
The wetland delineation field investigation resulted in identifying a remnant ditch within the western half of the study area that was approximately 237 linear feet. This ditch was approximately 2 to 3 feet wide and 3 to 4 feet deep. An ordinary high water mark was observed throughout the ditch. However, no surface water was observed within the ditch at the time of the site investigation. The remnant ditch was overgrown with vegetation but appeared to at least partially drain the immediate vicinity.

Photograph 11: Representative view of the remnant ditch within the study area

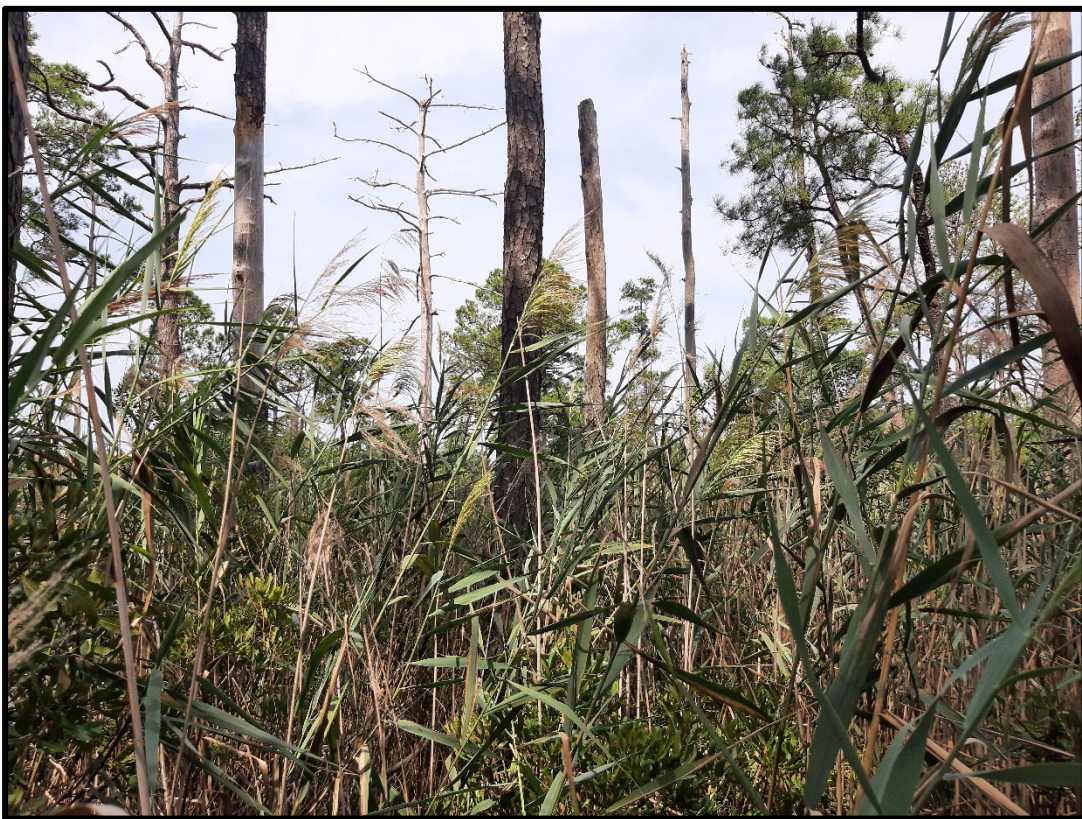
The wetland delineation field investigation resulted in identifying approximately 1.73 acres of forested wetlands located throughout the majority of the study area. The forested wetlands were dominated by needle-leaved evergreen vegetation within the tree stratum and the understory was densely vegetated within the herbaceous stratum with *Phragmites australis*. The forested wetlands were located upon a flat landscape that was situated upon a marine terrace landform. These forested wetlands were lower than the uplands located to the south, but higher than the estuarine wetlands located to the north. The forested wetland soil profile displayed low chroma colors throughout the upper 24 inches of the soil surface. Redoximorphic features were observed beginning at 6 inches below the soil surface. The dominant vegetation within the forested wetlands consisted of loblolly pine (*Pinus taeda*), wax myrtle (*Morella cerifera*), eastern baccharis (*Baccharis halimifolia*), and common reed (*Phragmites australis*). The dominance test hydrophytic vegetation indicator was met throughout the forested wetlands and therefore qualified for the hydrophytic vegetation parameter. The depleted below dark surface and depleted matrix hydric soil indicators were observed throughout the forested wetlands and the hydric soil parameter was met. No primary wetland hydrology indicators were observed throughout the forested wetlands. The geomorphic position and FAC-Neutral test secondary wetland hydrology indicators were observed throughout the forested wetlands. The wetland hydrology parameter was met throughout the forested wetlands.

Photograph 12: Representative view of the forested wetlands within the study area

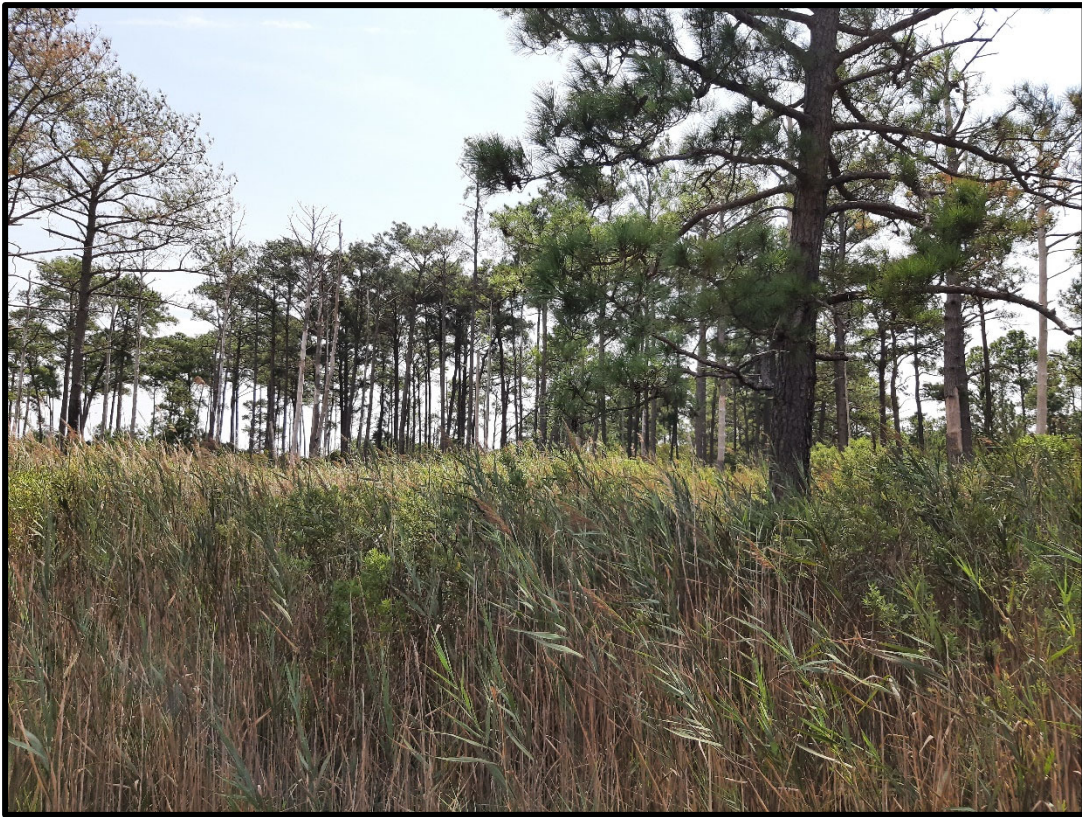
Photograph 13: Representative view of the forested wetlands near the boundary of the estuarine wetlands

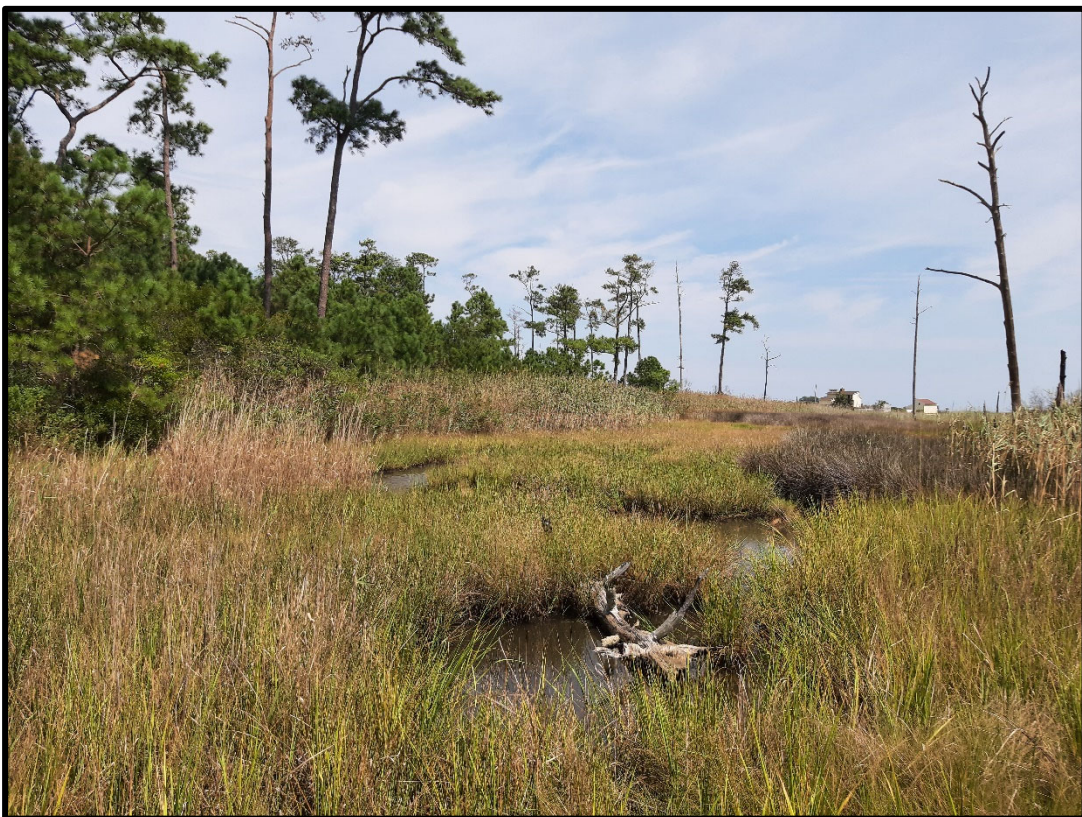
The wetland delineation field investigation resulted in identifying approximately 0.76 acres of estuarine wetlands located throughout the northern portion of the study area. The estuarine wetlands consisted of a tidal saltmarsh dominated by salt-tolerant species. The landscape was relatively flat and situated within a concave position relative to the southern portions of the study area. The hydrology was characteristic of a tidal saltmarsh system situated between the intertidal and high marsh zone. The soil profile displayed low chroma colors throughout the upper 24 inches of the soil surface. Redoximorphic features were observed beginning at 8 inches below the soil surface. A muck presence was observed within the uppermost soil layer and a hydrogen sulfide odor was observed throughout the soil profile. The dominant vegetation within the estuarine wetlands consisted of marsh elder (*Iva frutescens*), smooth cordgrass (*Spartina alterniflora*), and saltmeadow cordgrass (*Spartina patens*). The dominance test hydrophytic vegetation indicator was met throughout the estuarine wetlands and therefore qualified for the hydrophytic vegetation parameter. The hydrogen sulfide, muck presence, depleted below dark surface, and depleted matrix hydric soil indicators were observed throughout the estuarine wetlands and the hydric soil parameter was met. The surface water, high water table, saturation, drift deposits, aquatic fauna, hydrogen sulfide odor, and oxidized rhizospheres along living roots primary wetland hydrology indicators were observed. The geomorphic position and FAC-Neutral

test secondary wetland hydrology indicators were observed. The hydrology parameter was met throughout the estuarine wetlands.

Photograph 14: Representative view of the estuarine, tidal saltmarsh wetlands along the northern study area boundary

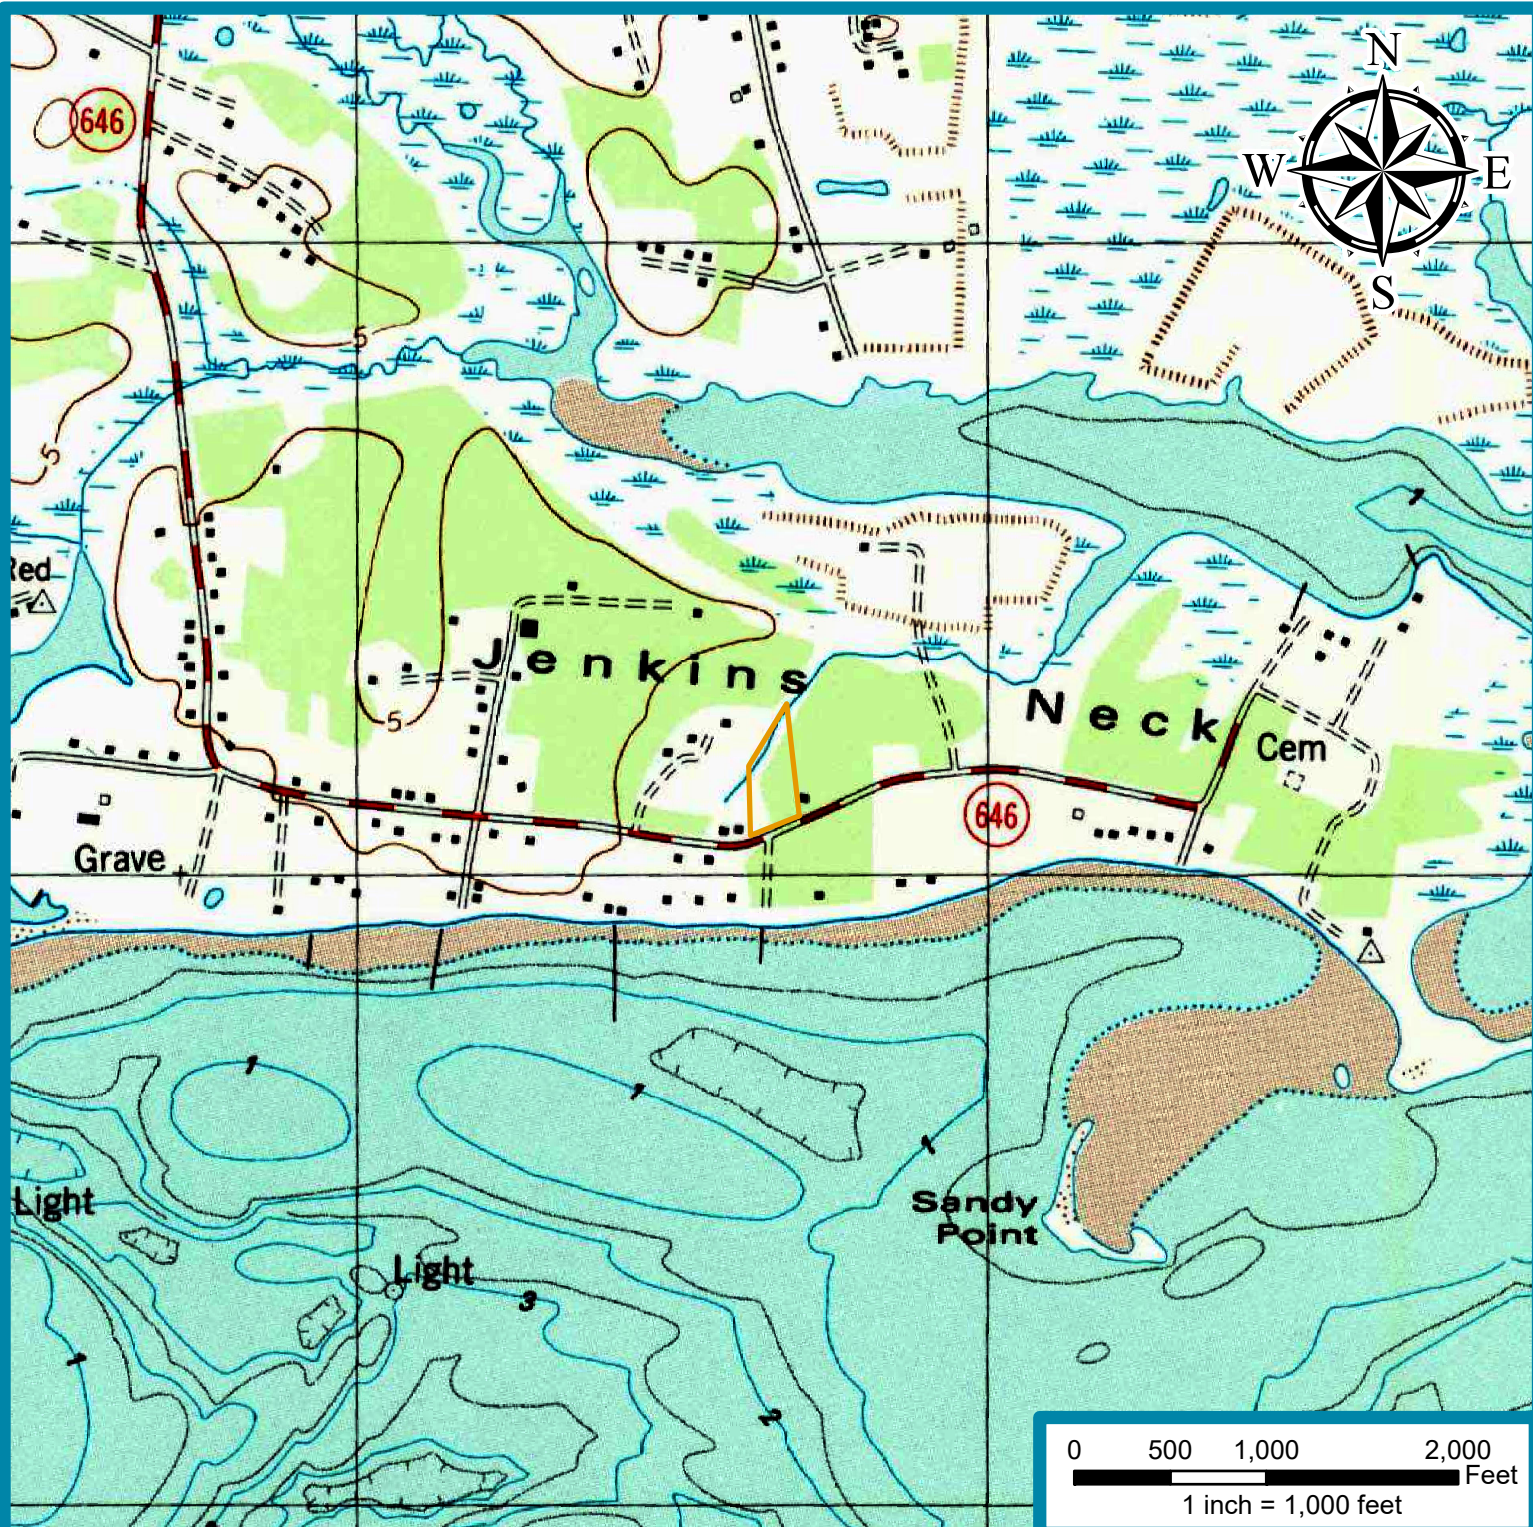
**Exhibit 1: USGS Topographical Map, Jenkins Neck Road Wetland Delineation, Hayes, VA**

The *USGS Achilles, VA Topographical Quadrangle* was used to produce the topographical map (Exhibit 1, Appendix 3) that illustrates many details of the study area and its vicinity. The study area is depicted at elevations situated between 0 and 5 feet above sea level. The study area is located upon the Jenkins Neck marine terrace landform that dominates much the immediate vicinity. A perennial drainage feature is depicted along the northern study area boundary that drains in a northeastern direction into Monday Creek. The study area is depicted as mostly vegetated with no structures within its limits. Jenkins Neck Road is illustrated along the southern study area boundary.
