# INSPECTION REPORT

For the Property at:  
**12 LAZY RIVER ROAD**  
GREEN SPRING, WV

Prepared for: DEBORAH MILLER  
Inspection Date: Tuesday, September 10, 2013  
Prepared by: David Wingenbach

RE: Report No. 1370  
12 Lazy River Road  
Green Spring, WV

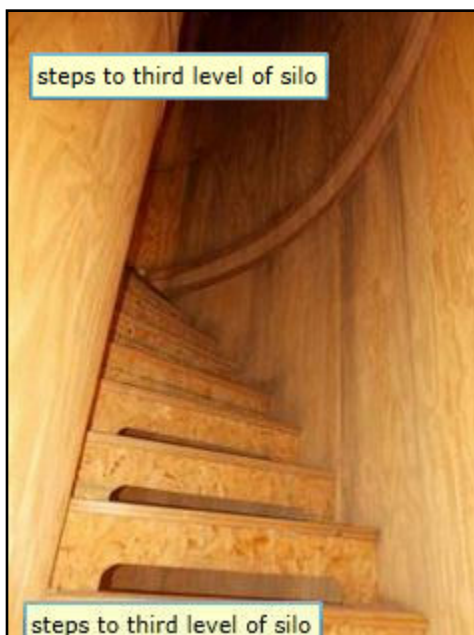
4.

**Garage:** • There is a silo associated with the property. The silo was in the process of being finished on the interior (construction is suspended). The wood walls and fixed windows are in place, the floors are plywood sub floor and the stairs are incomplete. The only utility in the silo is electricity. There is no apparent (or roughed in) water, bathroom, heat, or cooling.

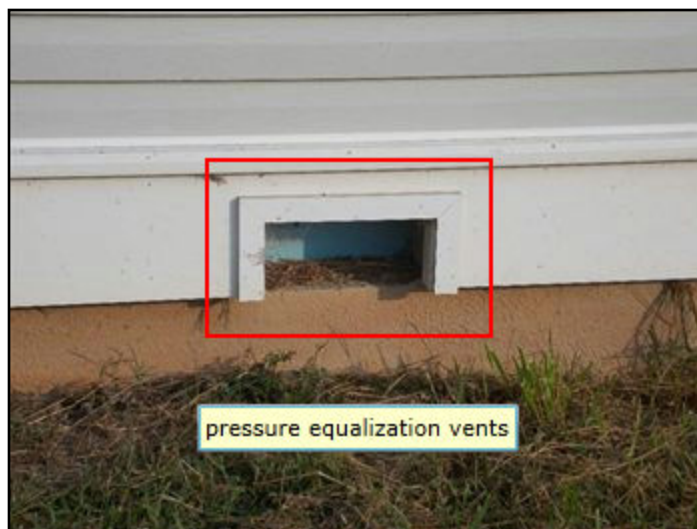
16.

**General:** • Note that there are vents in the foundation walls at the ground floor. The current owner's caretaker, Ron Gould, reported that since the property is in a flood plane that these vents provide pressure equalization in the event of a flood.
