## HOME INSPECTIONS INC.

**Prepared For:** Steven L. Rinehart

**Concerning:** 29442 Hegar Road Hockley, Texas 77447

**By:** Thomas Martin #7790

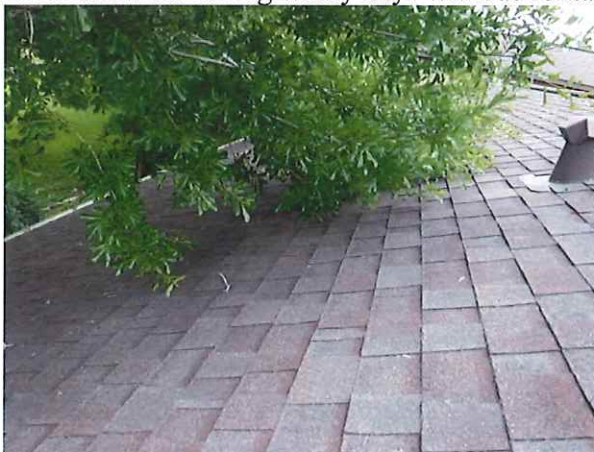
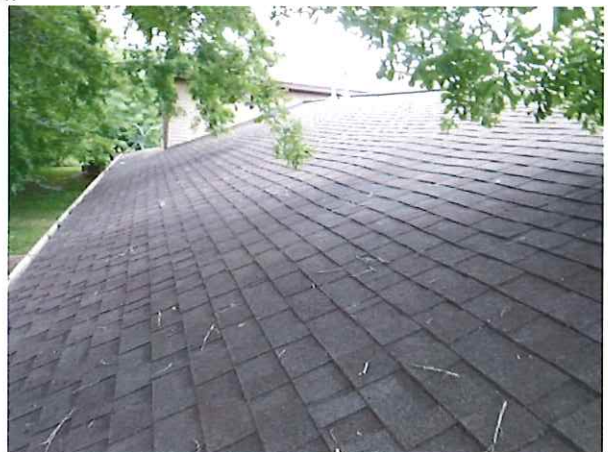
★ There are tree limbs on or very near the roof. Tree limbs should be a minimum of 4 feet from the roof to allow for strong windy days without contact.

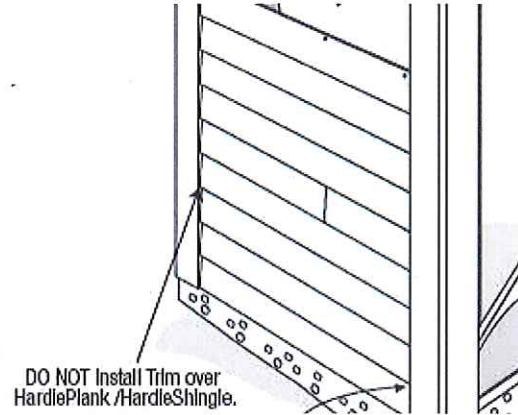
- ★ The hardy board trim is over the siding around the windows creating a gap for pests; incorrect according to hardy installation instructions. Hardy board installation instructions show the siding material to butt up to the trim board prevent any gaps in material. The image is from the hardy board installation instructions.

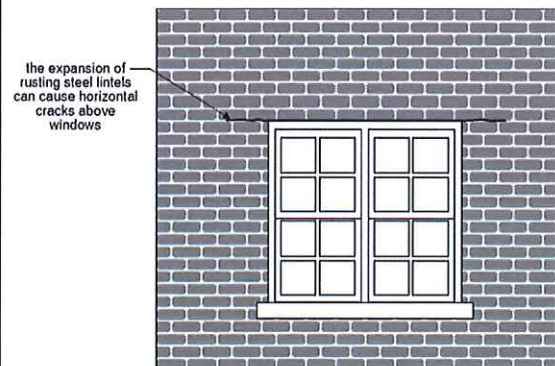
**Rusting lintels**

- ★ The lintels are rusting and above the windows / doors. When metal rusts' it expands and can cause brick cracks.

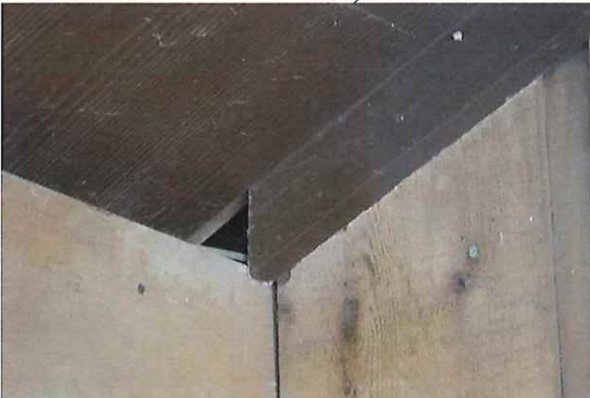
- ★ The sealant at most penetrations of the house is deteriorated or gaps in material. All penetrations and openings around the exterior should be properly sealed with caulk, screen mesh, expanding foam or mortar as needed to keep out moisture and unwanted pests (Do not seal up weep holes where the brick meets the slab).

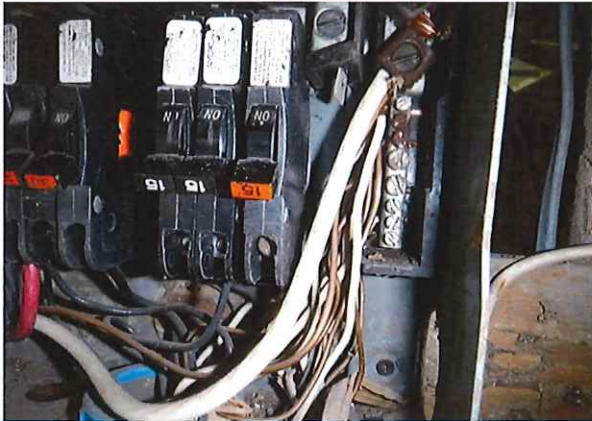
**Grounded (neutral) Conductor Terminals**  
 Section 408.21

- ★ The neutral wires are current carrying conductors and should not be double lugged. Grounded Conductor Terminations—Each grounded conductor shall terminate within the panelboard in an individual terminal that is not also used for another conductor. NEC408.21

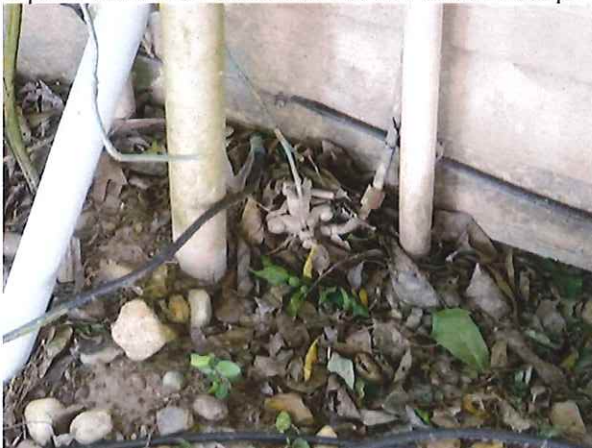
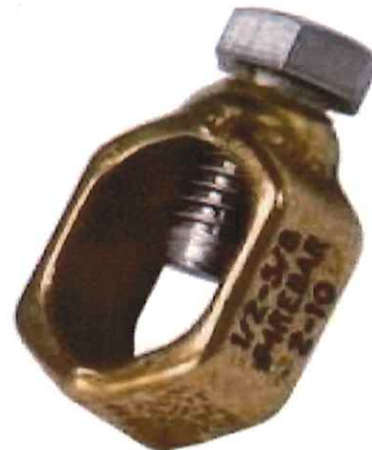
- ★ The ground rod clamp is not rated as a grounding clamp. A proper grounding clamp rated for the purpose should be used such as the acorn clamp.

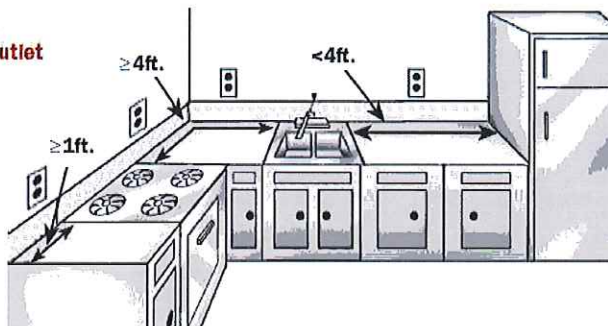
**Fig. e11**  
**Kitchen Outlet**  
**Spacing**

- ★ Kitchen counters missing required outlets. A receptacle outlet shall be installed at each wall counter space 12 inches or wider. Receptacle outlets shall be installed so that no point along the wall line is more than 24 inches, measured horizontally from a receptacle outlet in that space.  
REF IRC E3801.4.1

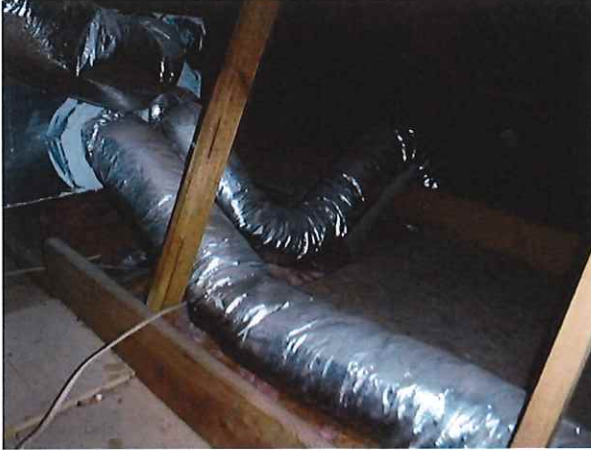
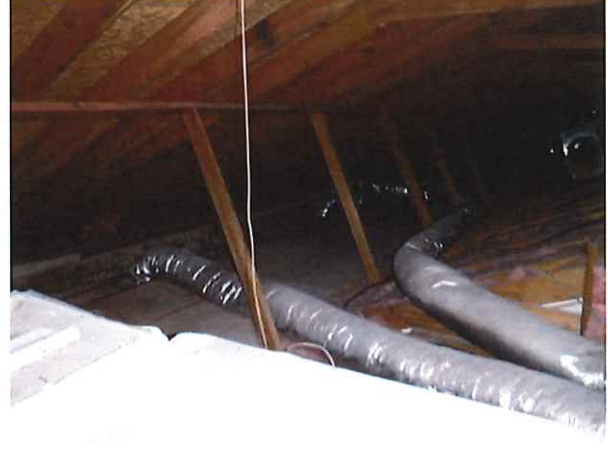
- ★ The air supply ducts are not properly supported and have excess bends at several locations.
