Edward W. Timmons Jr., P. E.  
Consulting Geotechnical Engineer  
P.O. Box 2836  
Santa Cruz, California 95063  
(408) 479 4731

Job No. 94-968

Re: Report of Soil Investigation  
Residential Construction - Existing Building Site  
362 Smith Road - APN 109-112-04  
Salsipuedes Rancho Area

Subject: GEOLOGIC HAZARDS ASSESSMENT, APN 109-112-04  
LOCATION: 362 Smith Road  
OWNER: Arriaga

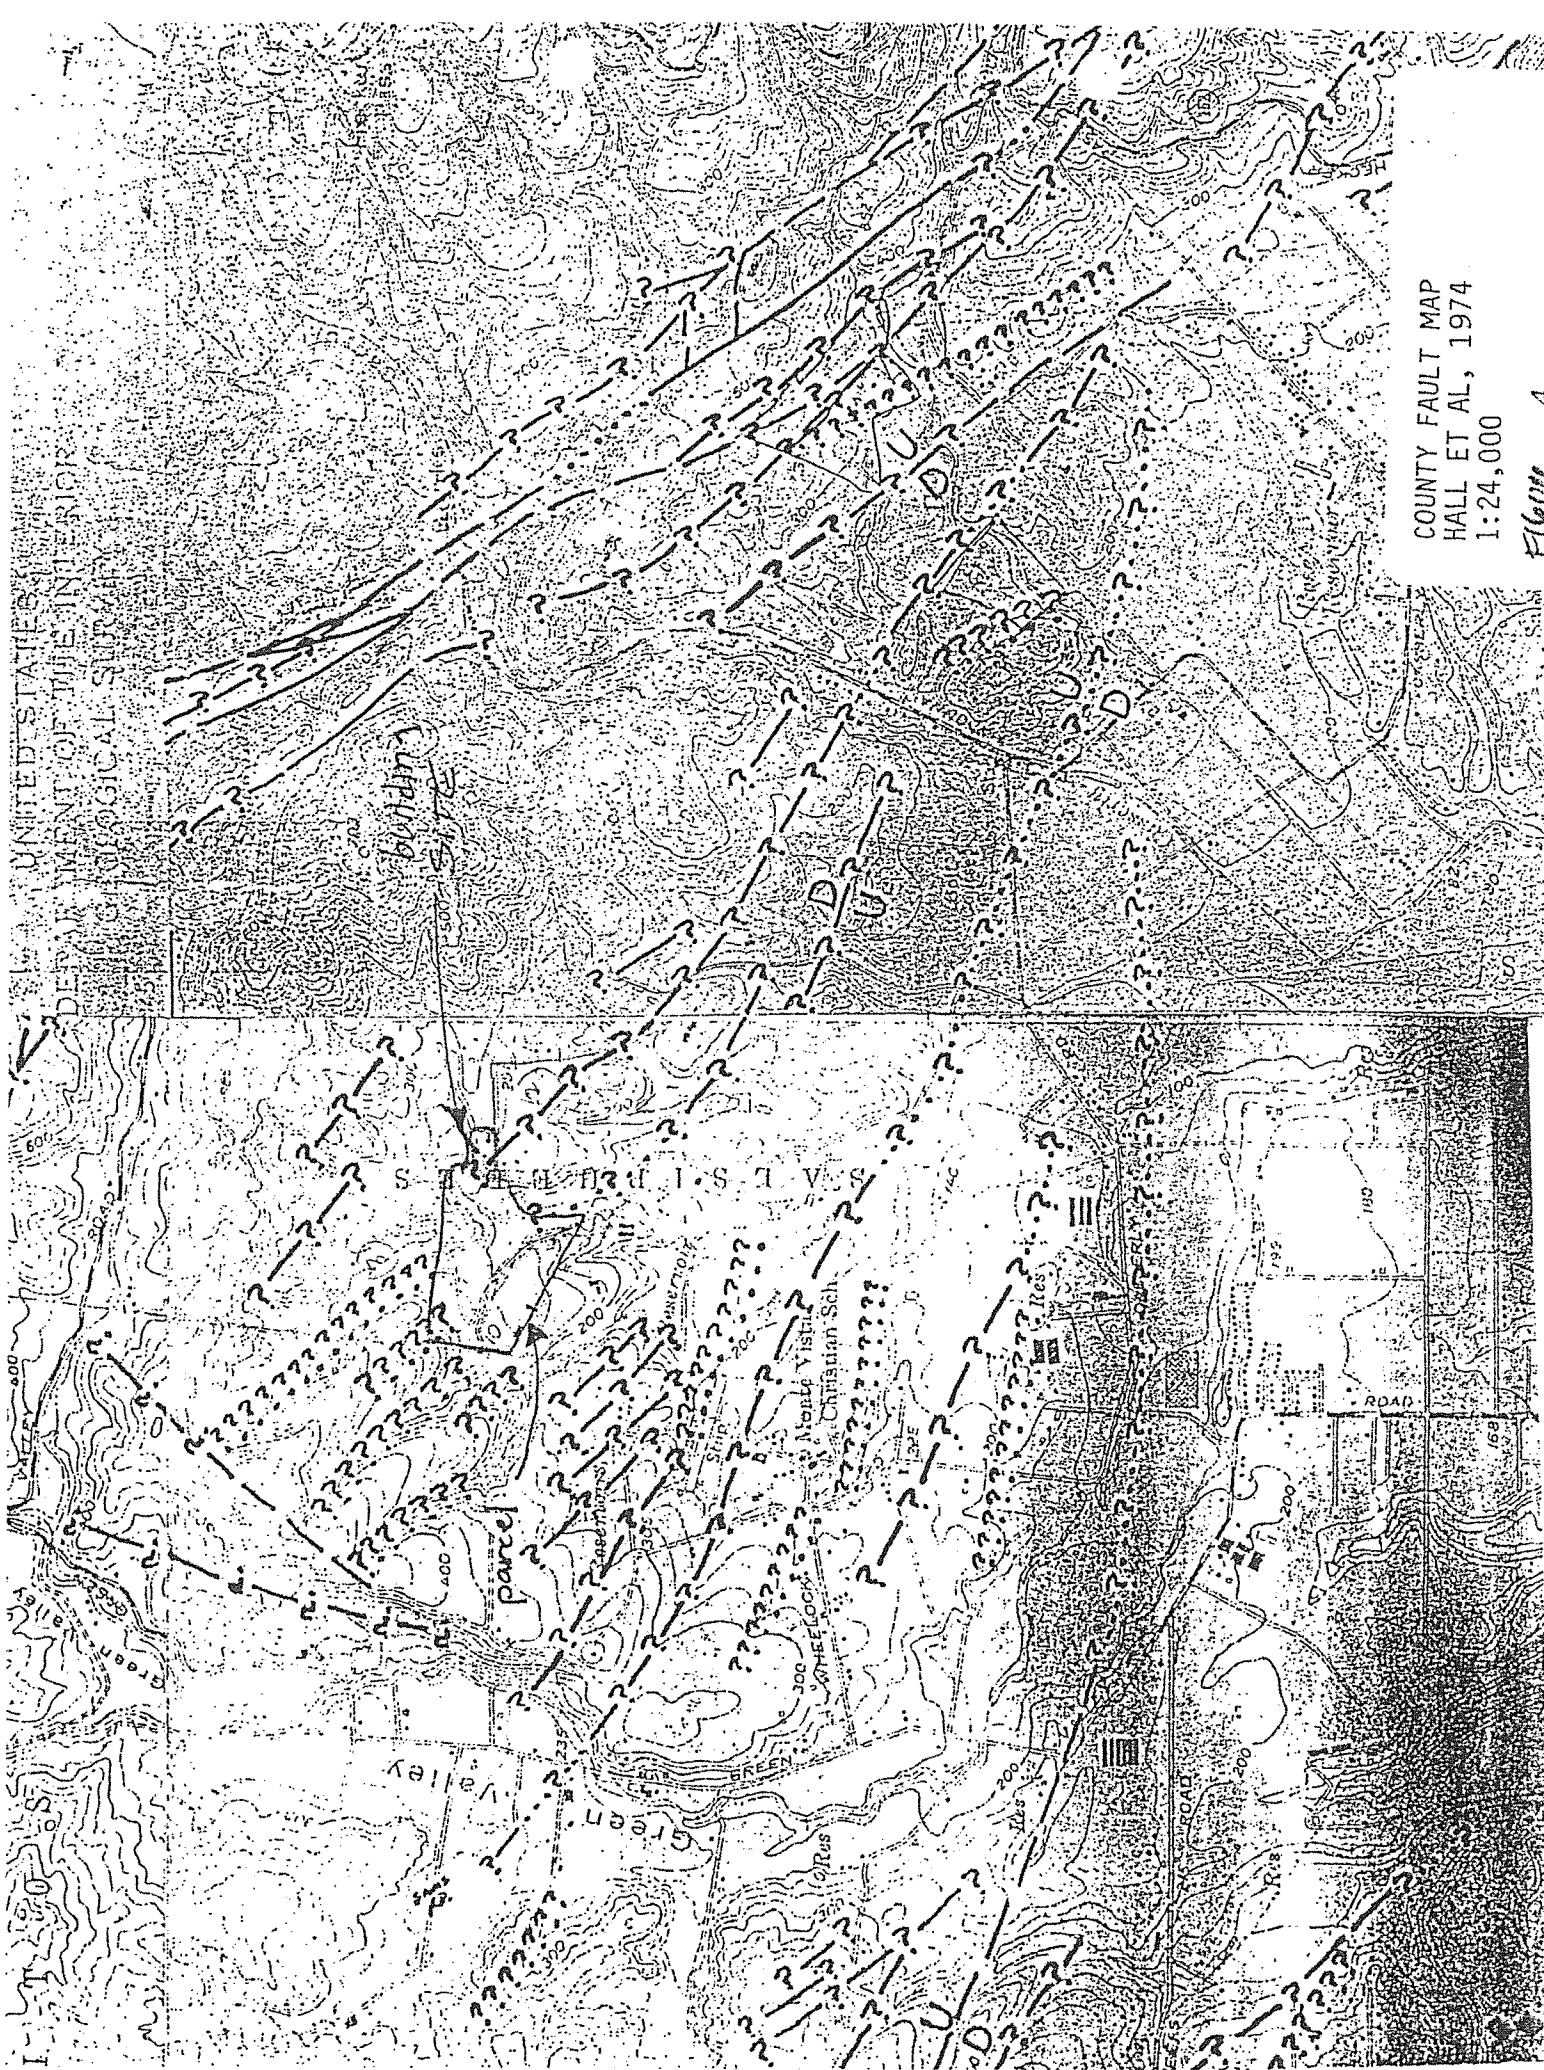
Figure 2

Further, potentially active fault traces can exist without any surface indications. Note that on the County fault map depicting potential for ground surface rupture (Figure 2), the parcel is in the area labeled "insufficient data." Not enough is known about the Corralitos Complex or the location of fault traces to determine where the hazard lies on the continuum from "low" to "high."
