HOME INSPECTION REPORT

414 Windmill Rd., Burnett, TX

Inspection Date:
July 2, 2019

Report Number:
190702-3456

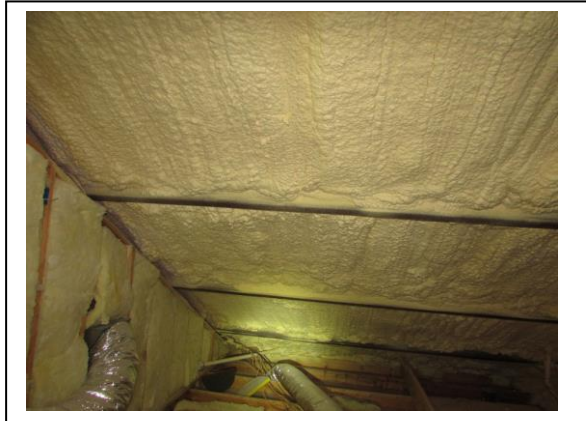
Overall, the roof structure and attic appeared to be in good condition.
The attic appeared to be adequately insulated.
Some portions of the attic were not easily or safely accessible. These areas were viewed from a distance. There were other sections of the attic that were not visible, and a visual inspection of these areas was not possible.
