## PROPERTY INSPECTION REPORT

**Concerning:** 1115 Oak Ridge, Blanco, TX  
(Address or Other Identification of Inspected Property)

**By:** Corey Hebert, Lic #20229 01/25/2017  
(Name and License Number of Inspector) (Date)

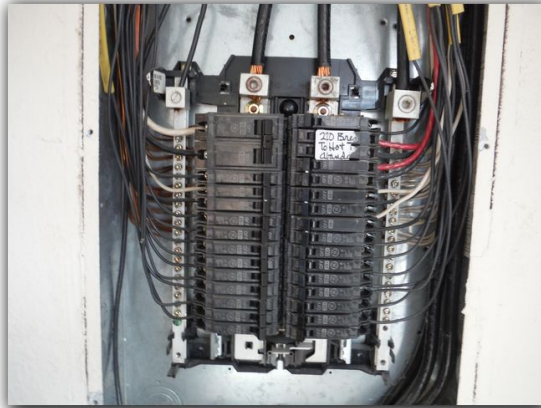
A/C condensing unit #1 specifies max amp breaker of 30 and a 30 amp breaker is in use(correct amp breaker in use) Minimum breaker size is 18.3 amp.

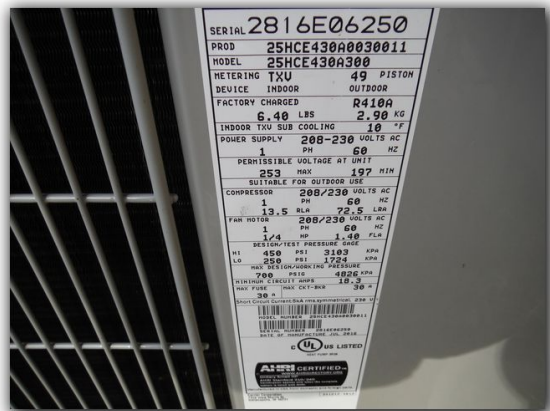
Temp. Differential: 18 Degrees F

The cooling equipment appears to be performing as intended at time of inspection.
