Barry Williams
1701 Cedar Crest Dr, Abilene , Texas

Inspection date
July 23, 2021

Level of inspection
Level I and parts of Level II

Prepared by
Brody Earles CSIA#10109
Shanes Chimney Care LP

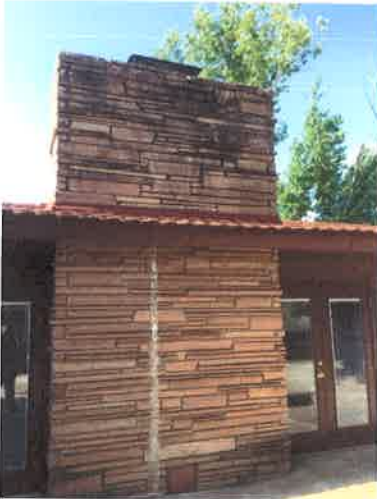
- **Brick / Stone / Chimney walls condition:** Meets industry standards
- **Crown / Wash cap:** Needs attention

- **Material:** Culture stone
- **Chimney location:** Exterior
- **Chimney height 3-2-10 rule:** Yes
- **Mortar Condition:** Meets industry standards

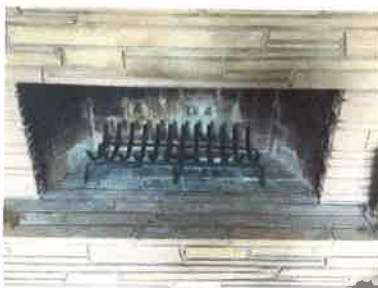
- **Fireplace configuration / Appliance manufacturer's clearance requirements:** Open wood burning

- **Flue tile sealed at smoke chamber:** Does not meet industry standards

The flue tile is not sealed at the top of the smoke chamber. This can allow the byproducts of combustion to go behind the flue tiles and may migrate to areas of the chimney and home not meant to contain them. The potential hazard exists that combustible residue could built up where it cannot be maintained and allow the possibility of a structure fire. This defect could also allow carbon monoxide the enter the home. 2016 NFPA 211 11.2.1.13

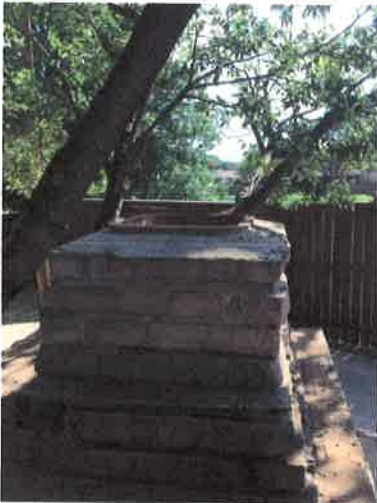
- **Material:** Culture stone
- **Chimney location:** Exterior
- **Mortar Condition:** Meets industry standards
- **Brick / Stone / Chimney walls condition:** Meets industry standards
