Hansen Home  
Inspections

# Home Inspection Report

407 High Crossing Road, Smithville, TX 78957

Thursday, May 6, 2021

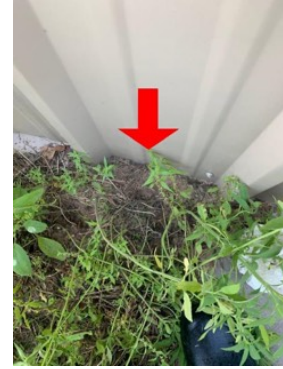
Grading up to wall by left garage door.

The grading should be improved to promote the flow of storm water away from the house. This can usually be accomplished by the addition or removal of top soil. The ground should slope away from the house at a rate of one inch per foot for at least the first ten feet. Ideally, at least eight (8) inches of clearance should be maintained between soil level and the top of the foundation walls. Grading all the way up to the wall increases the risk of water damage, and is conducive for pests.

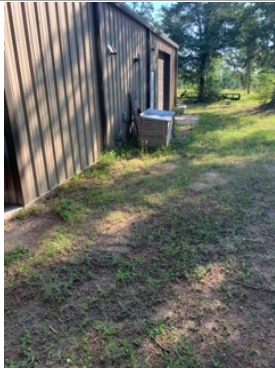
No slope away from building on the right side.

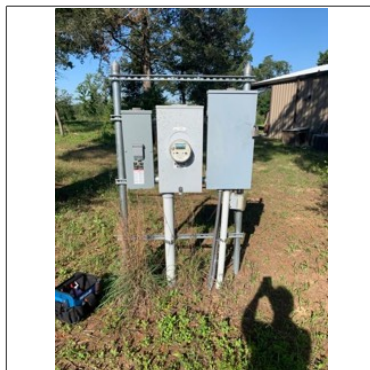
Service entrance is on the right side of building.

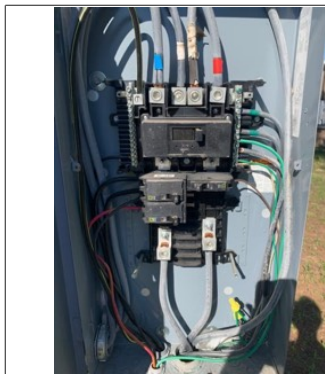
Inside view of the service panel.

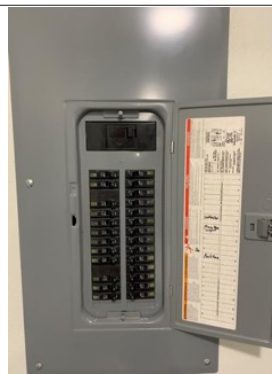
The sub-panel is in the laundry room. Not all breakers are labeled.

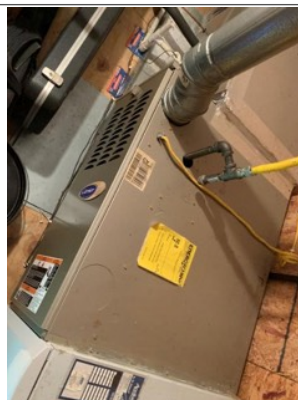
The furnace is in the attic above the laundry room.

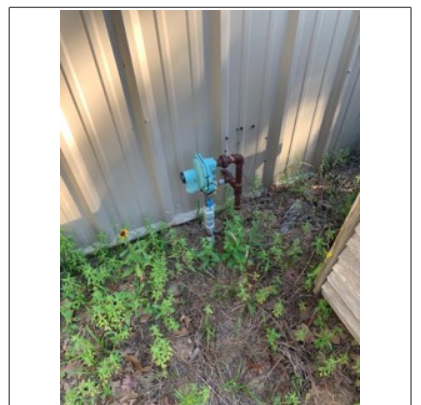
Gas entry is on the right side of the building.

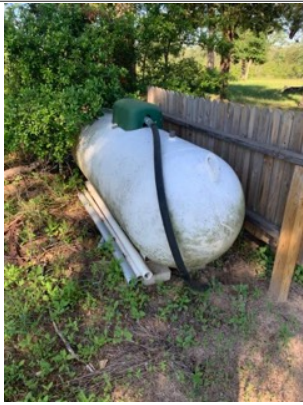
Propane tank to the right of the building.

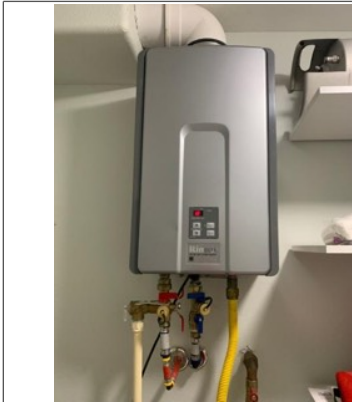
*Comments:* The water heating system was performing as intended on the day of the inspection.

The tankless water heater is in the laundry room.

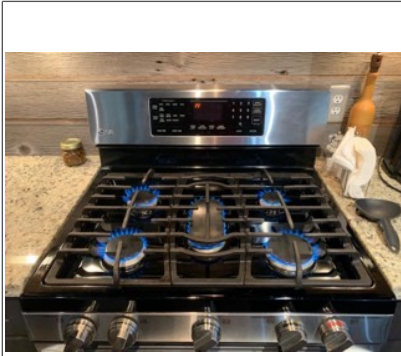
Burners were operational.

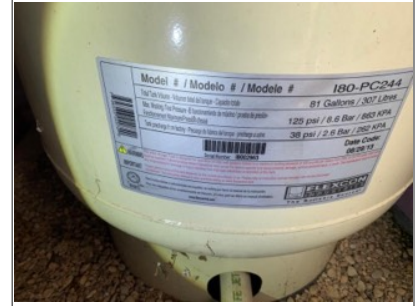
Label on pressurized tank. 81 gallons. Made in 2013.

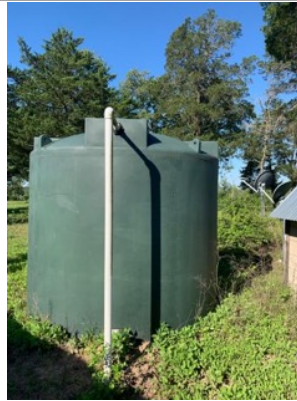
*Comments:* **Water was overflowing from the storage tank during operation. This condition should be investigated and repaired by a qualified service professional.**

2500 gallon storage tank.

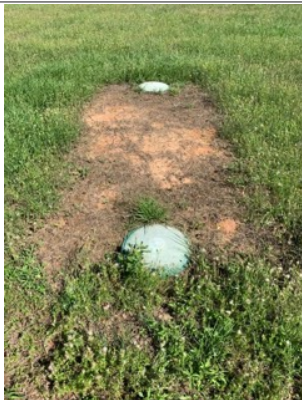
*Comments:* There was not much visible to inspect with the septic system. Check with the current owner for the location of the drain field, and records of service. Make sure the drain field is the proper distance from the well.

Septic is on the left side of the home. Unable to determine the location of the drain field, or locate any additional equipment to inspect.

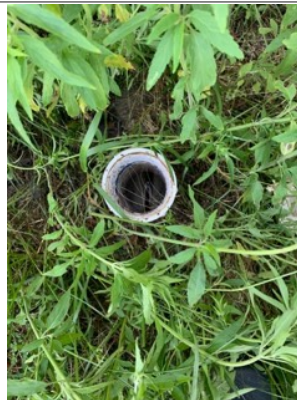
Septic cut-out was clear.
