Inspection Report

Property Address:
3033 McGregor Ln
Dripping Springs TX 78620

CODE 3 Property Inspections. PLLC

PROPERTY INSPECTION REPORT FORM

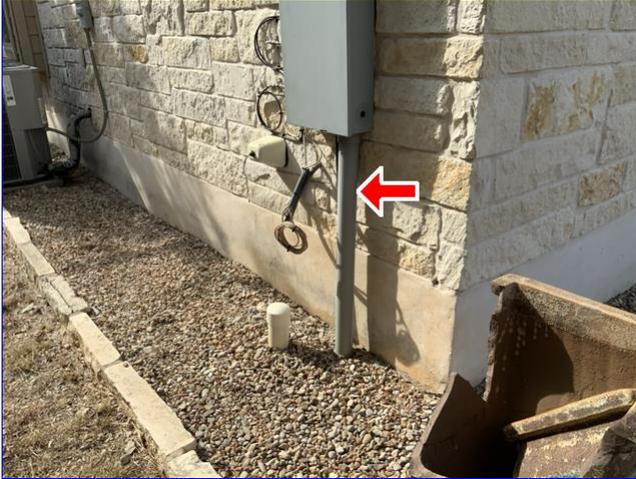
A. Item 1(Picture)

(2) Missing the dead front cover plate to the right electrical panel. This panel is located next to the main service meter.
