# INSPECTION REPORTS

Job Site Address: 15771 SW OBERST LN

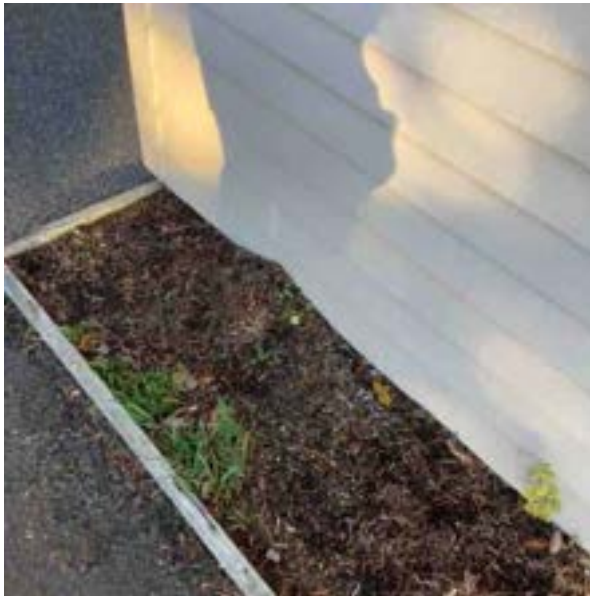
2.3.3 Elimination of all earth to siding contact is advised to reduce the chance of rot and/or infestation by wood destroying insects. If damage is found when this is done correction is advised.

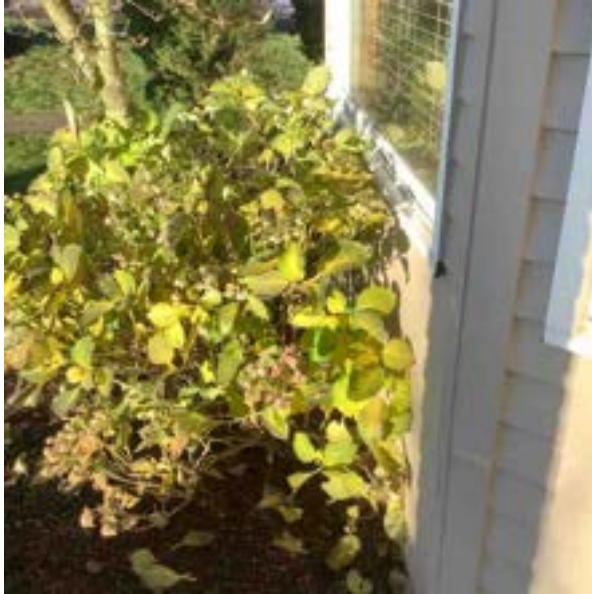
2.3.4 All plants should be kept trimmed back 12" (Minimum) from home to reduce the chance of premature deterioration of siding moisture by allowing better ventilation as well as to help reduce the chance of infestation by wood destroying insects. **(Exterior Front)**

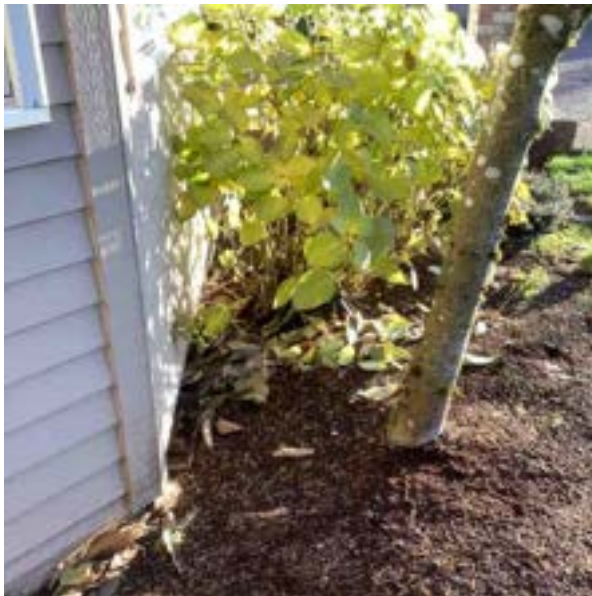
2.3.5 Landscaping slopes to the house in some areas. Grades should always be sloped away from the house 1" per foot, out 6 feet from the foundation for proper drainage & to reduce the chance of moisture intrusion and damage.

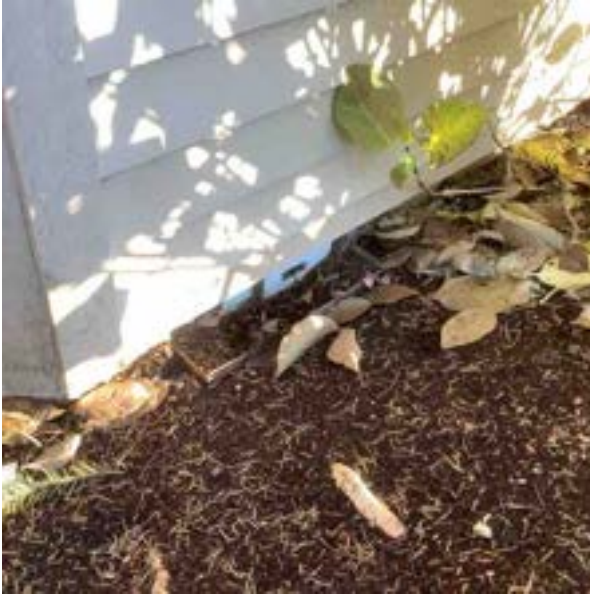
2.3.6 Some foundation vents are at or below ground level. This can allow water to enter the crawlspace. Grades should be lowered approx. 6" under these foundation vents & vent wells installed where necessary to hold back the dirt and allow water to flow away from foundation and not into the crawlspace. **(Exterior Front)**

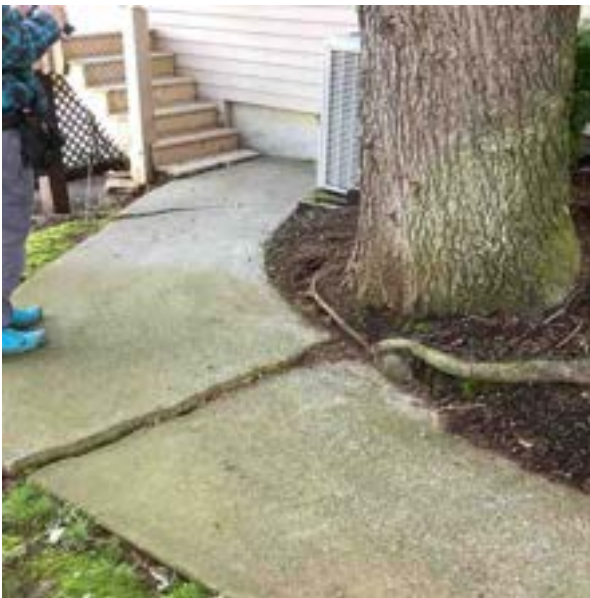
2.4.1 The condition of the walkway poses a potential trip hazard. Further evaluation and correction of all issues found is advised.

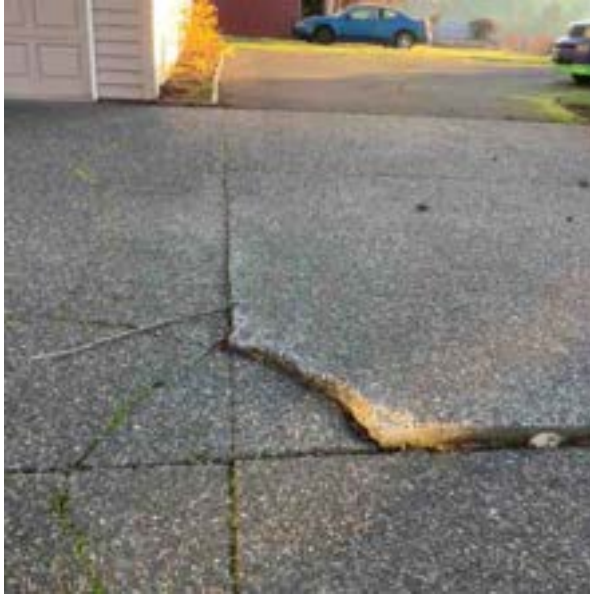
2.5.2 Driveway has settled to the point that it poses a trip hazard. Further evaluation and correction of all issues found is advised.

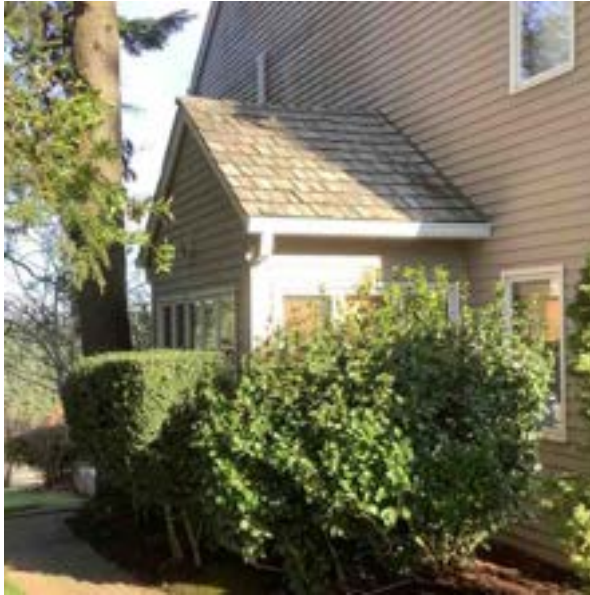
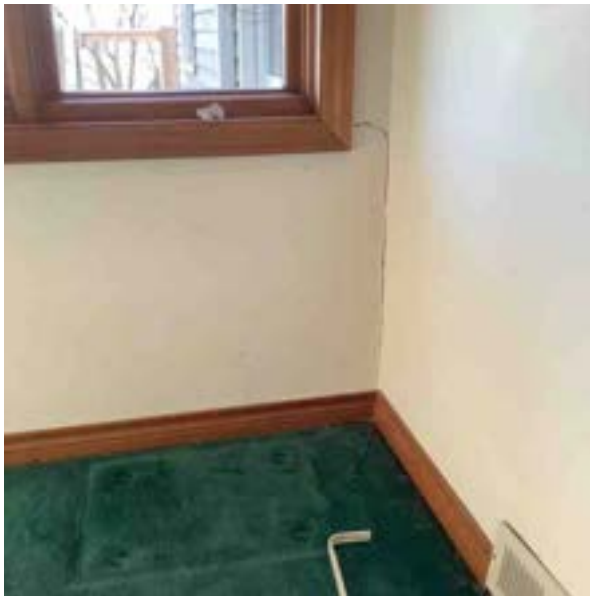
- Exterior Left
- den

3.2.1 Separation noted at a joint in exterior wall and crack noted at interior wall in the west room off of the den indicates settling has occurred. Evaluation and correction of all issues. Found advised.

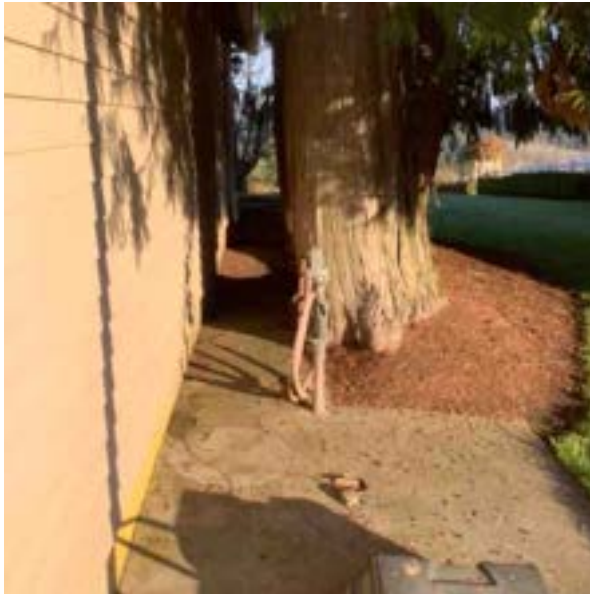
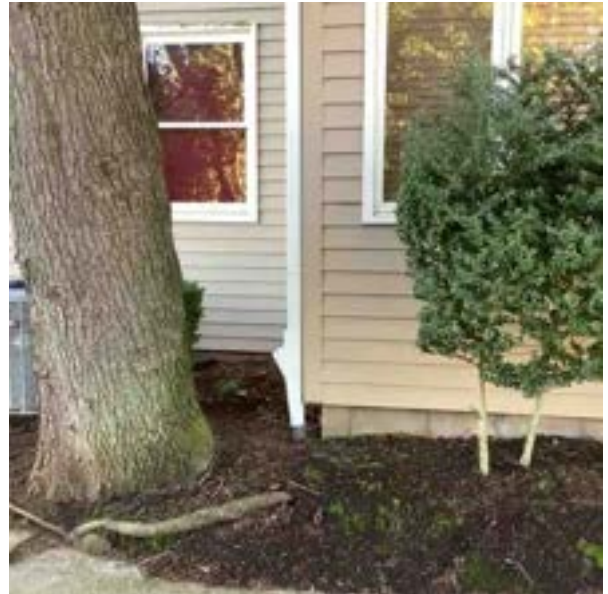
- Exterior Back
- Exterior Left

3.3.2 Trees were planted in close proximity to the house. Tree roots may cause damage to the foundation over time and cause damage to the siding, windows, etc. Further evaluation is advised.

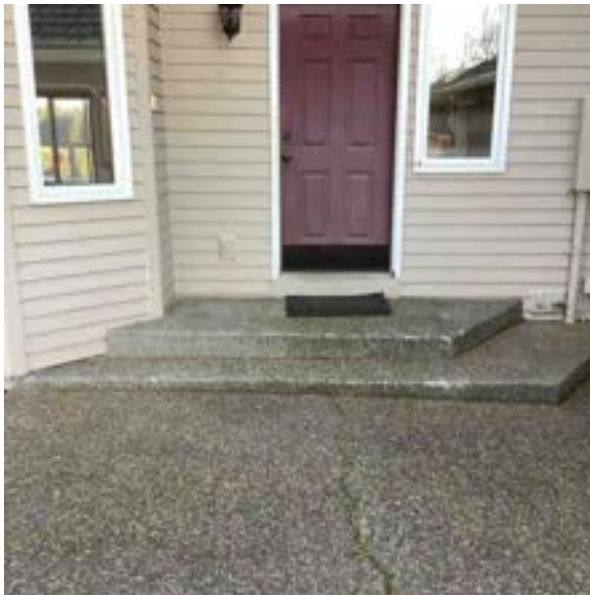
3.4.3 Concrete is touching the wooden siding. This can lead to moisture intrusion issues. Unsure if hidden damage exists. Further evaluation and correction of all issues found advised. **(Exterior Front)**

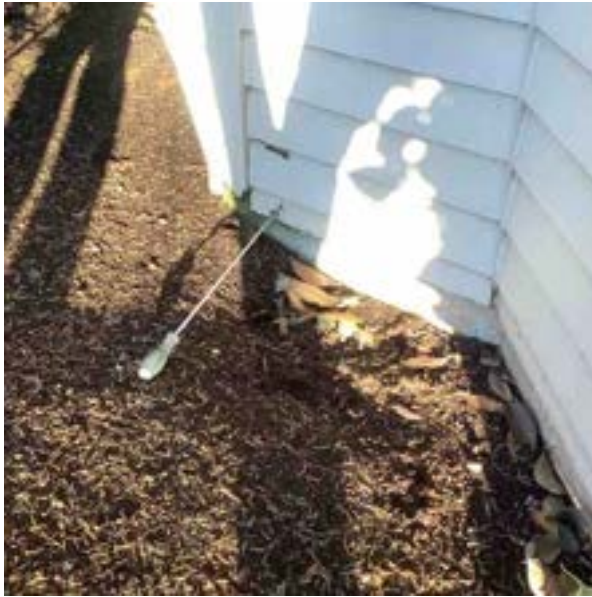
3.4.4 Rot in siding. Unable to determine extent of damage. Further evaluation and correction of all issues found is advised. **(Exterior Front)**

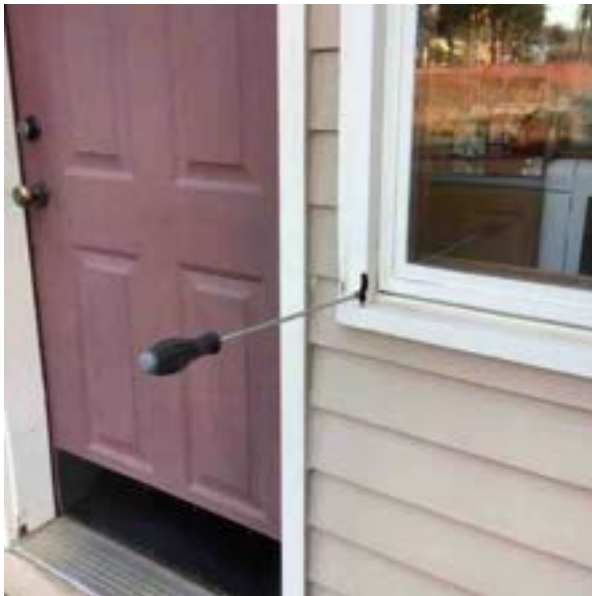
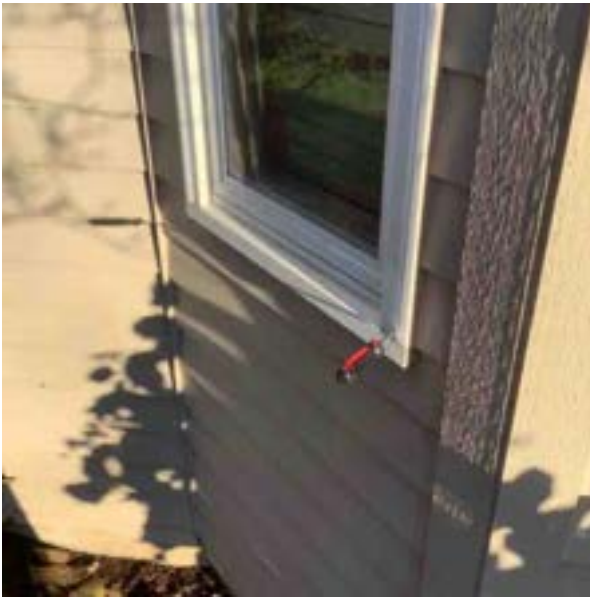
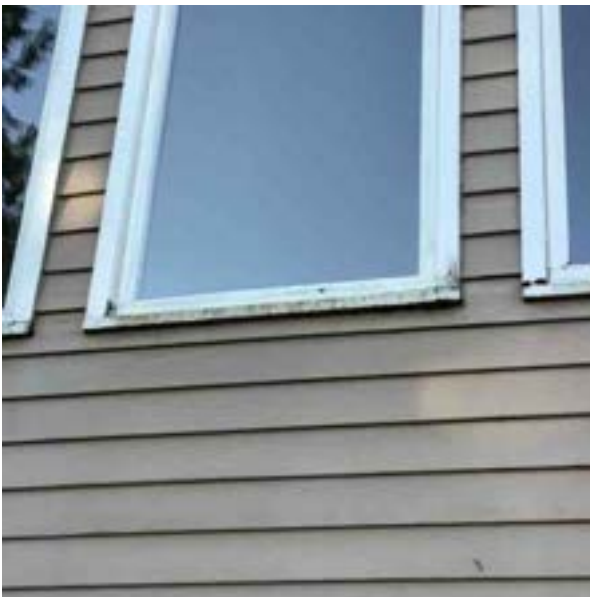
3.6.1 Rot in trim around the house. Mostly at the front. Unable to determine extent of damage. Further evaluation and correction of all issues found is advised.

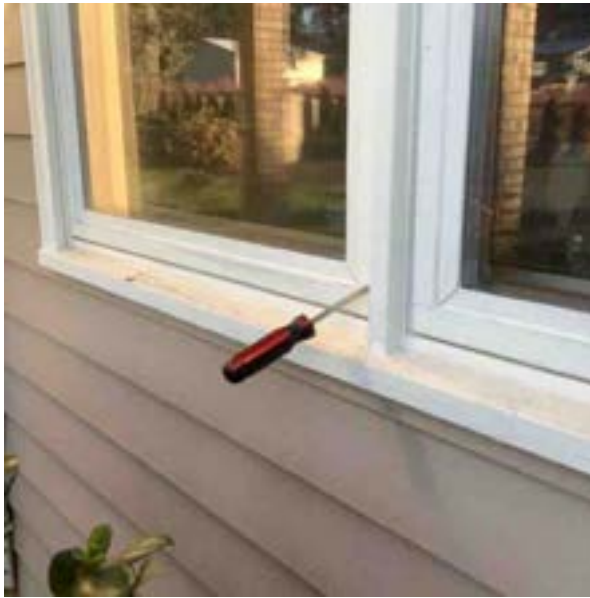
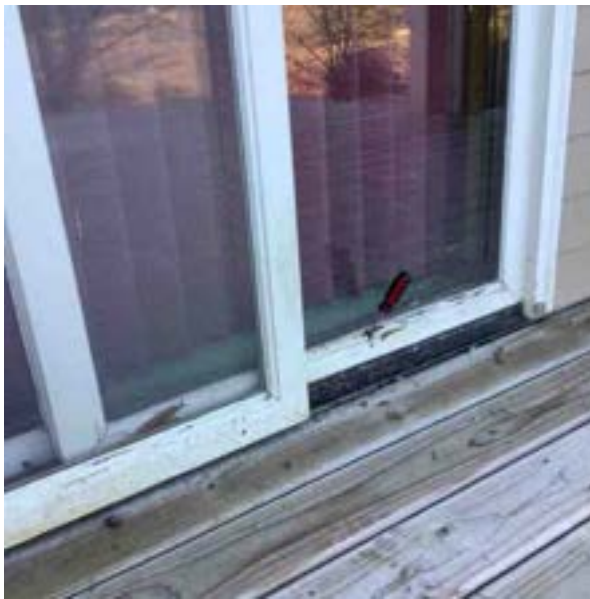
3.7.4 These types of wood windows and sliding doors from this time period are known to have issues with rot, wear and separation of joints. Some windows have issues and rot was found. Further evaluation of ALL windows and correction of all issues found is advised.

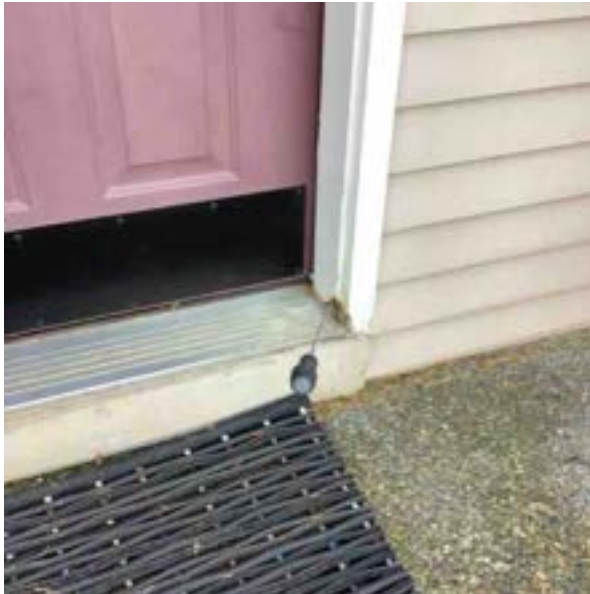
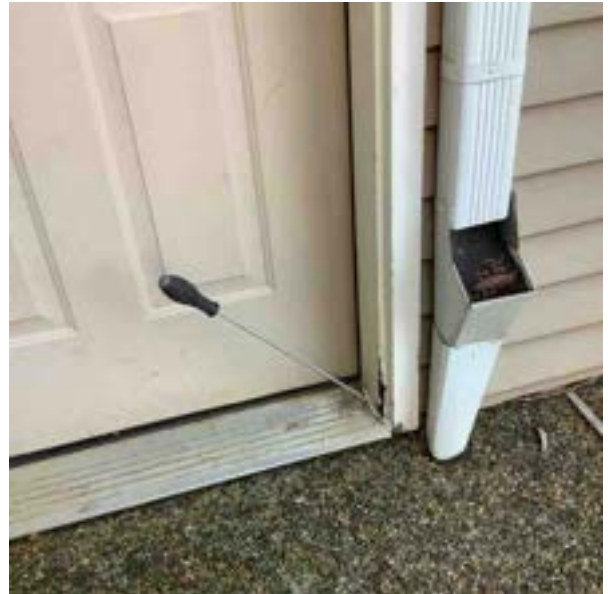
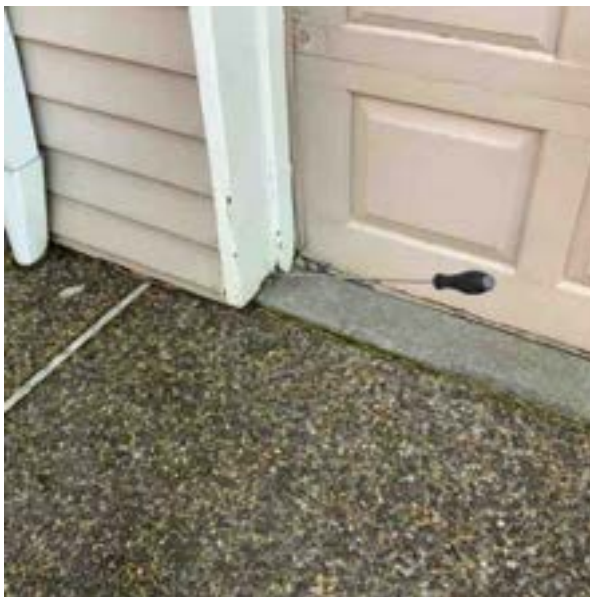
- Garage
- Laundry

3.8.3 Rot in the frame of the exterior doors. Unable to determine extent of damage. Further evaluation and correction of all issues found is advised.

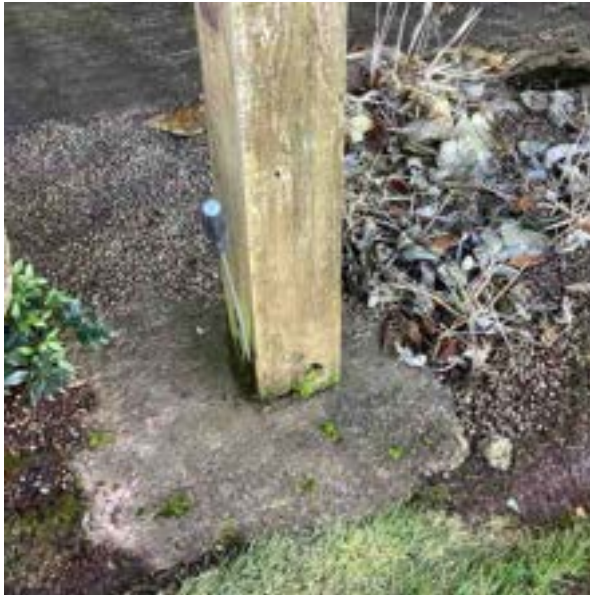
3.10.6 Rot was found in posts. Unable to determine extent of damage. Further evaluation and correction of all issues found is advised. **(Exterior Back)**

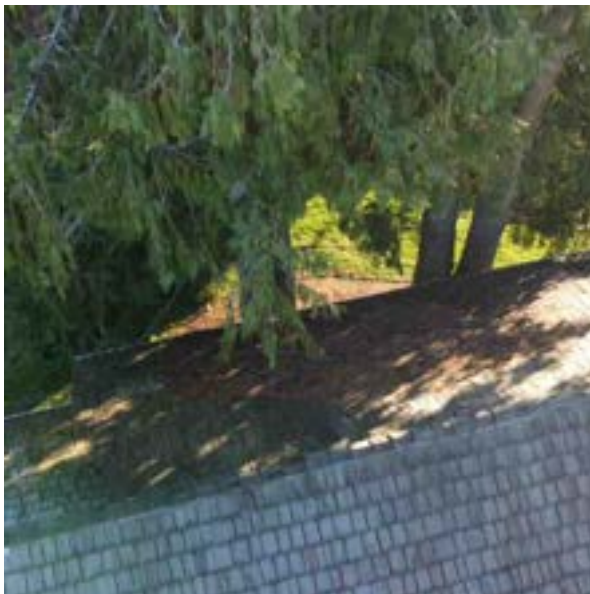
4.2.3 All tree branches should be kept trimmed back at least 6 to 8 feet from the house, roof & gutters to extend their life, reduce debris & the chance of damage.

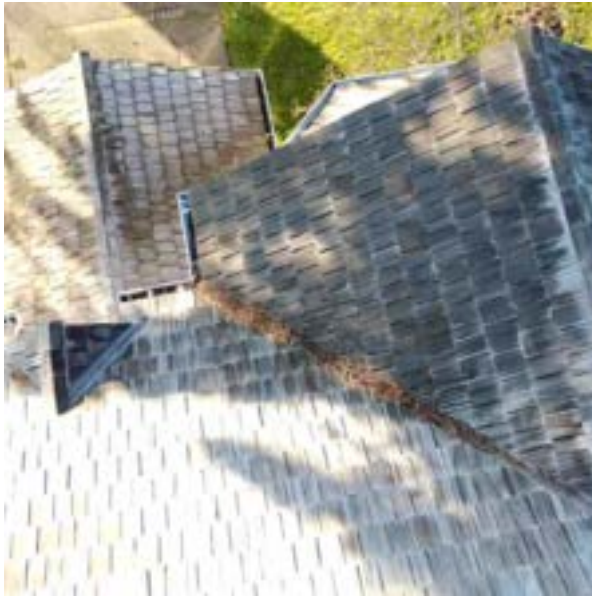
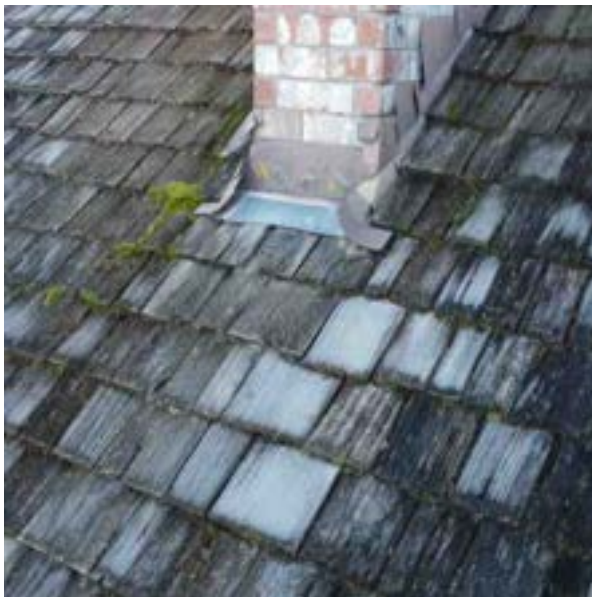
4.2.4 Keep roof cleaned of moss and tree debris to allow water to more easily flow off and into the gutters and to extend the life of the roof. Evaluation and correction of all issues found advised.

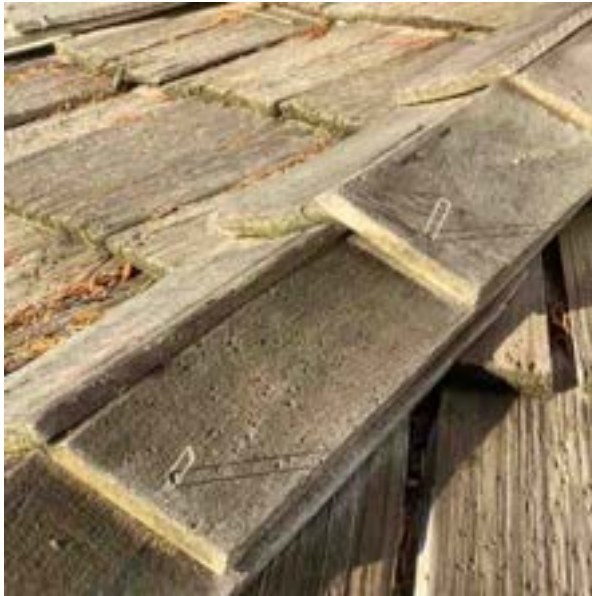
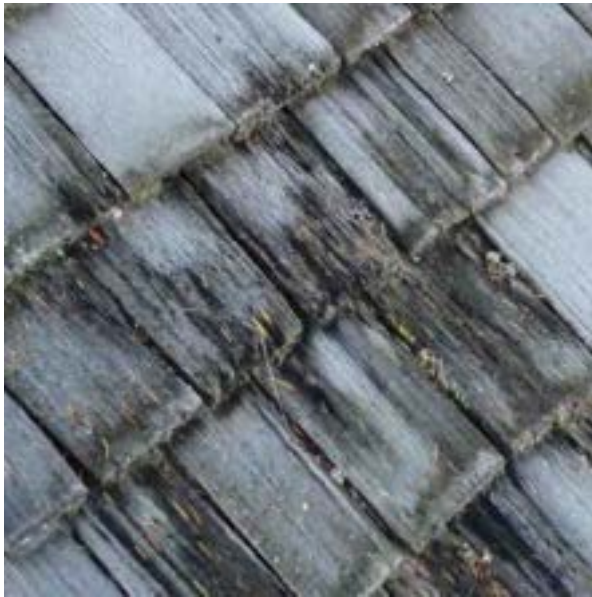
4.4.2 There are lifting staples, moss, and some rotted shakes noted. Further evaluation of the entire roofing system and correction of all issues found is advised.

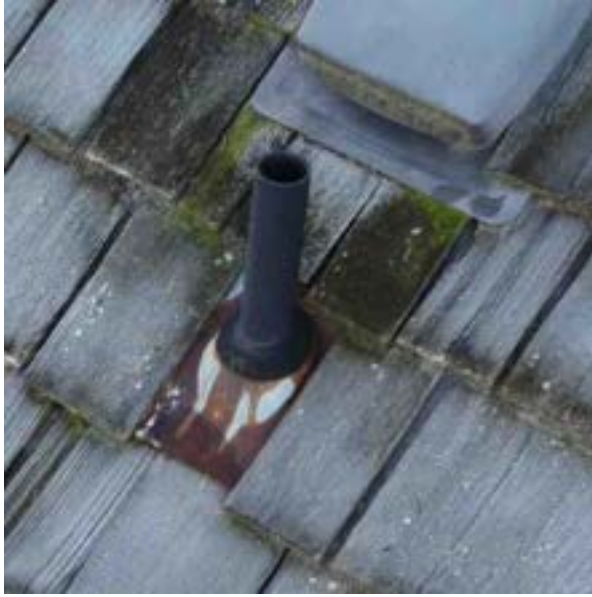
4.5.2 Flashings are beginning to rust which can lead to premature failure. Further evaluation and correction of all issues found is advised.

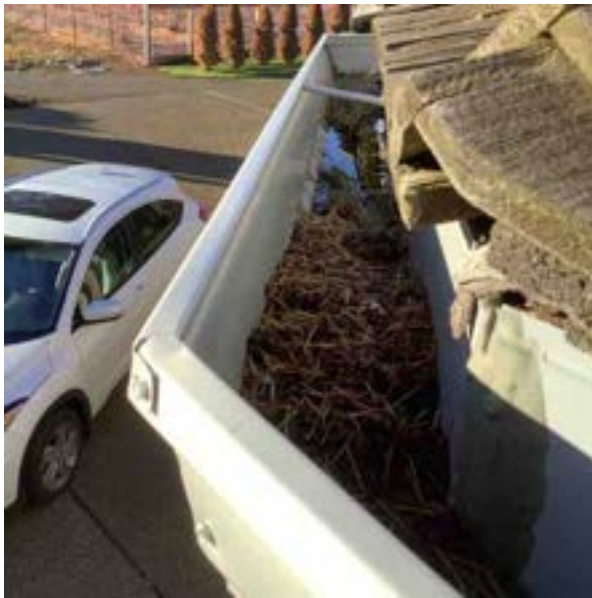
4.6.3 Gutters could use cleaning to facilitate water drainage towards downspouts. Further evaluation and correction of all issues found is advised.

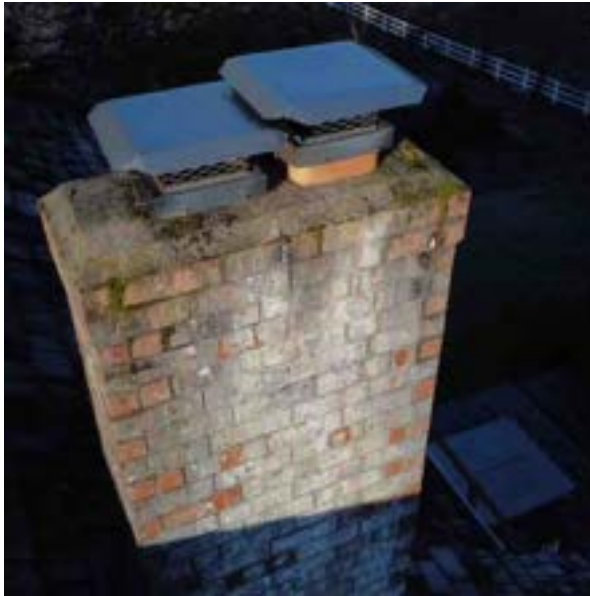
4.7.2 Typical chimney cap cracks and moss noted. Further evaluation and correction of all issues found is advised.

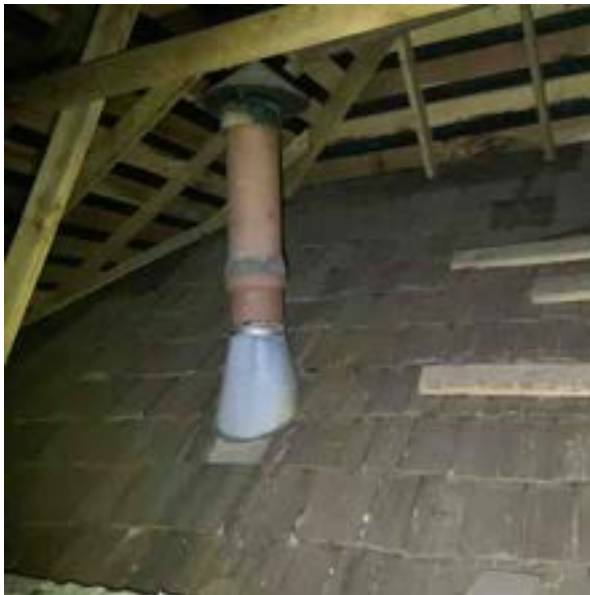
5.1.3 Old wood burning stove is venting into the attic. Stove does not appear to meet state standards and has not been used in quite some time. Further evaluation and correction is advised. (**Attic Garage**)

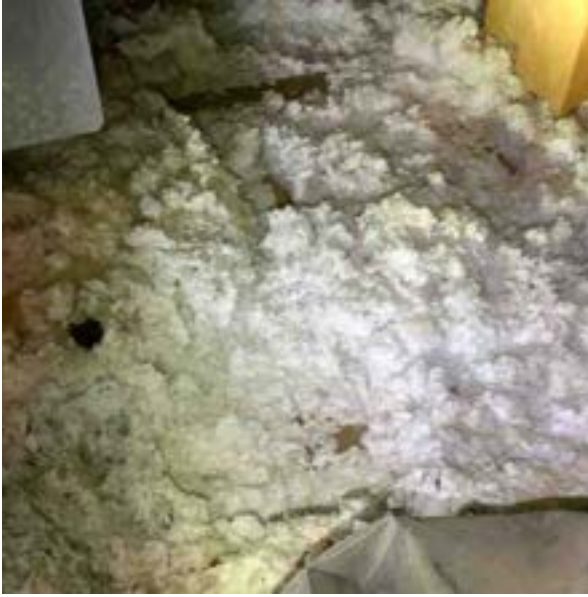
5.3.3 Insulation level has been compacted in several places; this can reduce its effectiveness. Further evaluation and correction of all issues found is advised. **(Attic: Upper)**

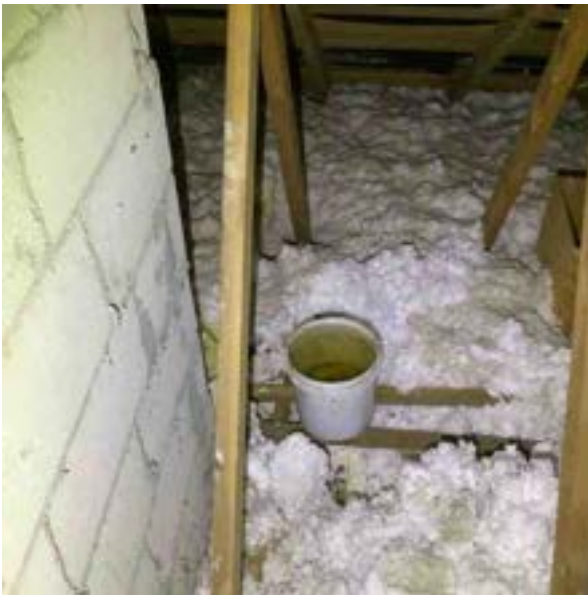
5.6.3 Light was visible around the chimney, which is not unusual, but there is also light visible in other areas where it shouldn't be visible. A bucket with water in it, evidently from a roof leak was noted. Further evaluation and correction of all issues found advised.

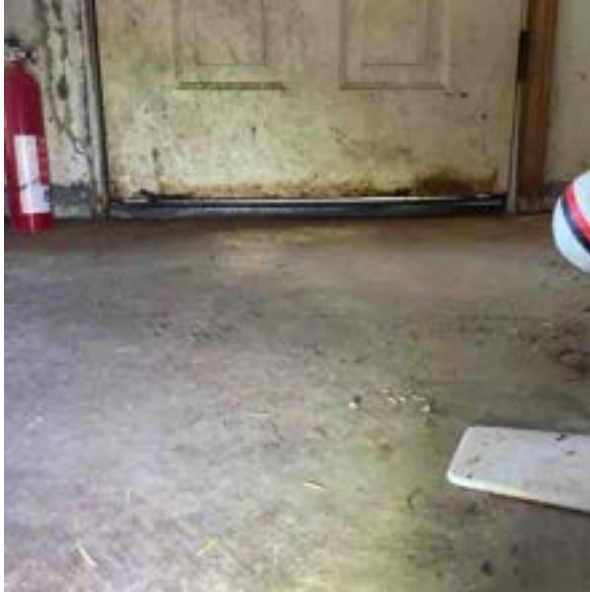
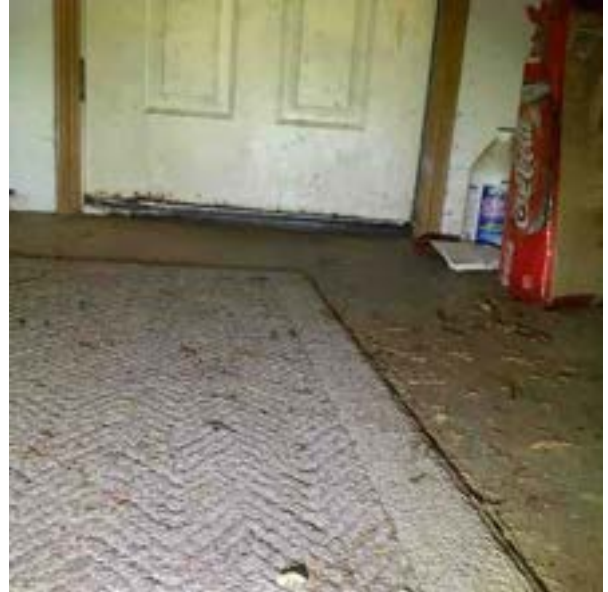
6.3.2 Weather strip is damaged or missing around door to the outside. Further evaluation and correction of all issues found is advised. **(Garage)**

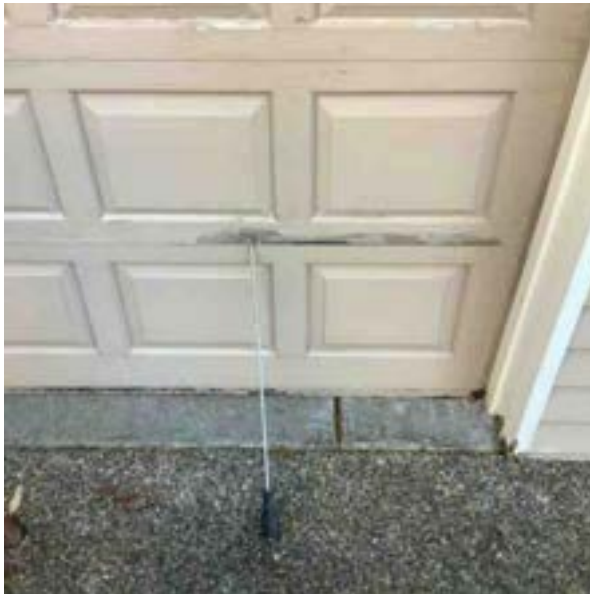
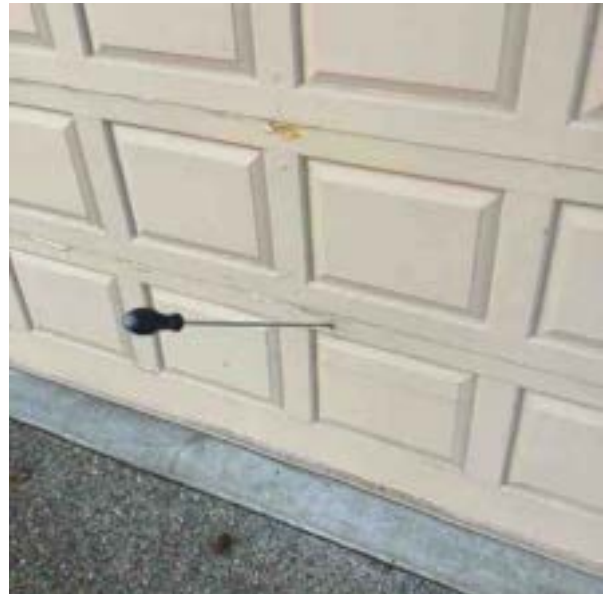
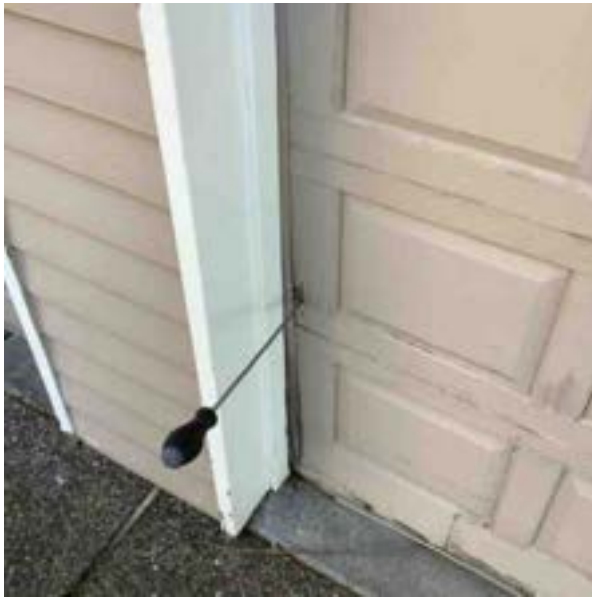
6.4.5 The garage doors have rot. Further evaluation and correction of all issues found is advised.

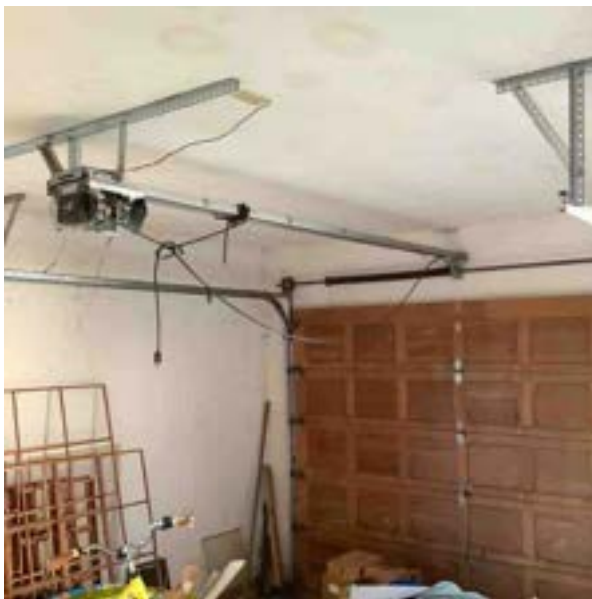
6.5.4 The garage door opener is not plugged in and appears to be damaged. There may be a very good reason this was done so the opener was not tested. Further evaluation and correction of any issues found is advised. **(Garage)**

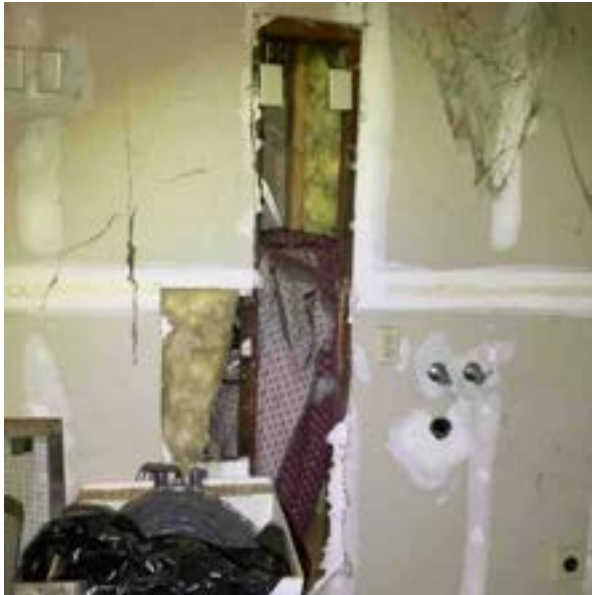
6.7.5 Holes noted in the firewall between garage and living space. Further evaluation and correction of all issues found is advised to keep the integrity of the firewall intact. **(Garage)**

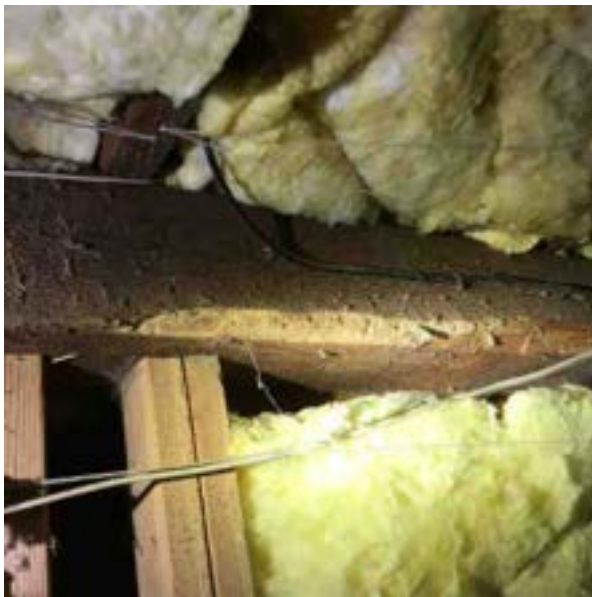
7.3.2 Evidence of old wood destroying insect activity and surface damage noted along a few beams. Find out from seller if the house has been exterminated/evaluated. If not, further evaluation and correction of all issues found is advised. **(Original CrawlSpace)**

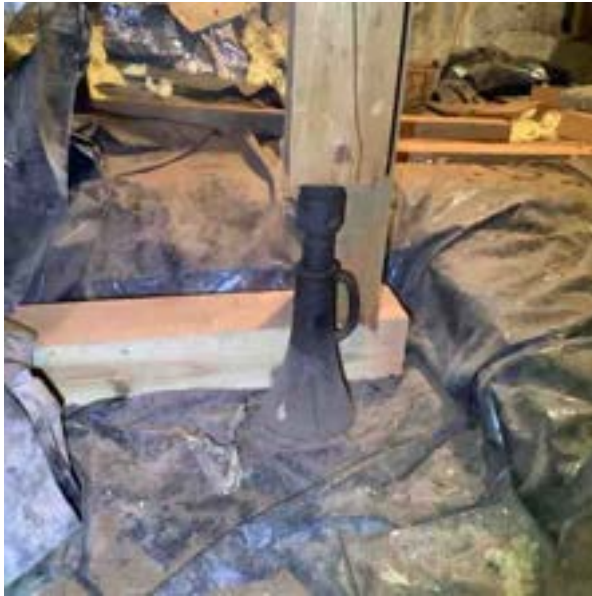
7.3.3 Extensive sub-structure repairs noted in the crawlspace and possible incorrect pillar supports. Obtain all documentation from the seller regarding all work done in the crawlspace for warranty purposes. If concerned further evaluation and correction is advised. **(Original Crawlspace)**

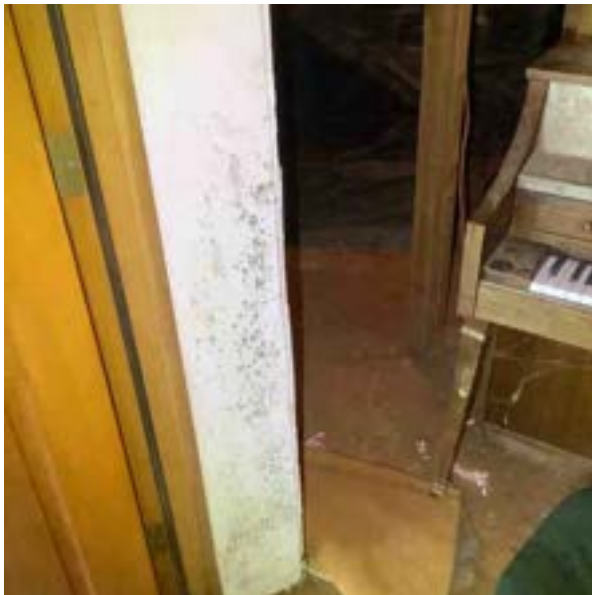
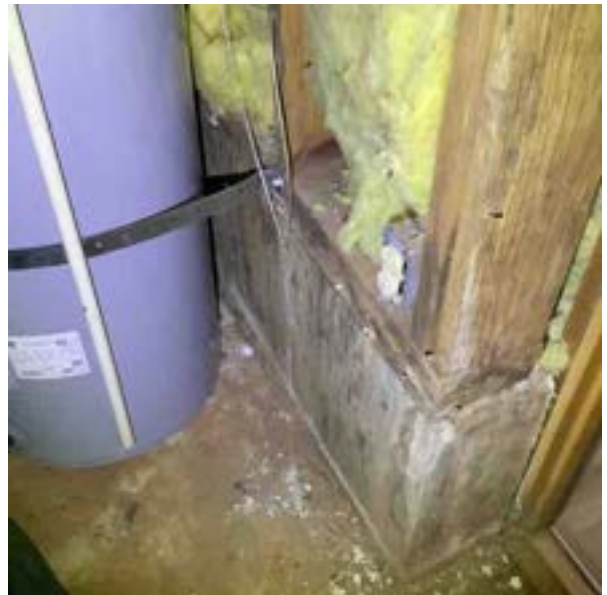
8.2.2 Fungal growth noted and could possibly be from a previous water heater leak. Furth evaluation and correction is advised. **(Crawlspace)**

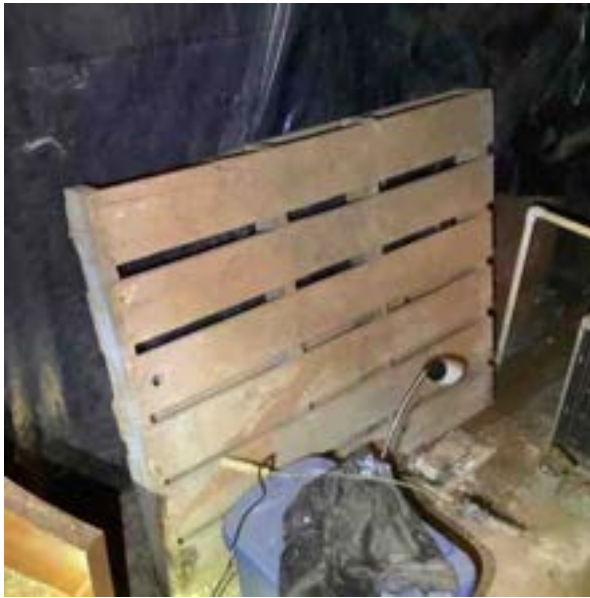
8.3.1 Cellulose debris was noted in the crawlspace. Removal of all cellulose (loose wood, wood or cardboard forms, plants, or any other debris) large enough to be picked up by a standard garden rake is advised to reduce the chance of infestation by wood destroying insects.

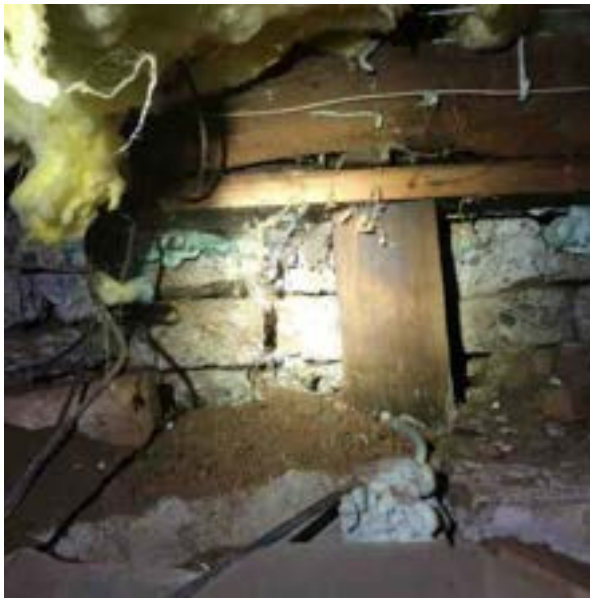
8.3.2 Earth to wood contact noted at the west crawlspace. Further evaluation and correction of all issues found is advised. **(Original Crawlspace)**

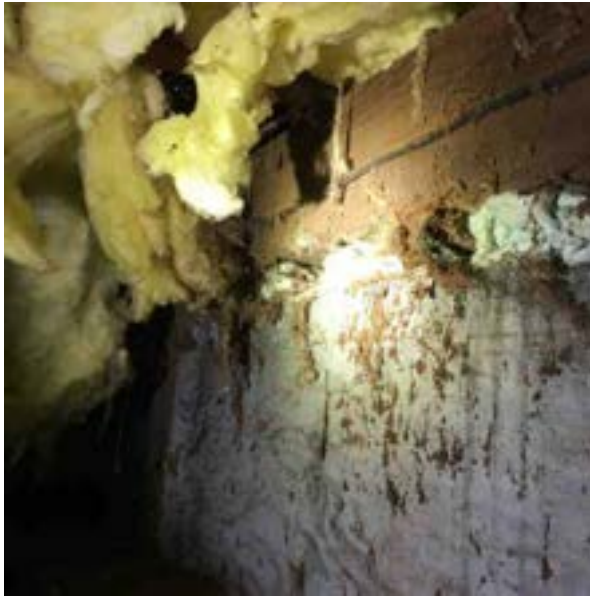
8.3.3 Possible Frass from wood destroying insects noted. Unable to determine if activity is current or damage has occurred. Further evaluation and correction of all issues found is advised.

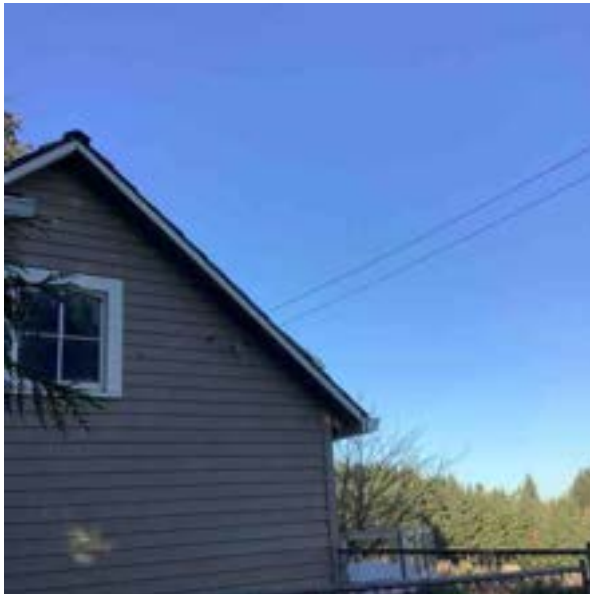
9.2.1 Low hanging unprotected electrical line to barn noted. Further evaluation and correction of all issues found is advised.

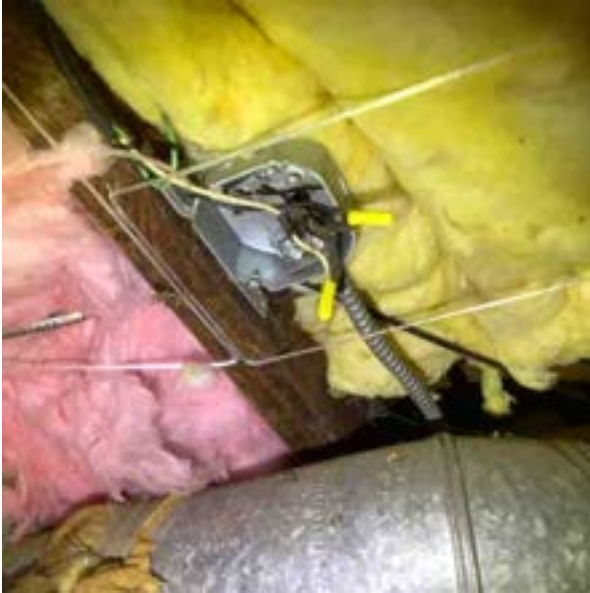
9.6.2 A missing junction box cover was noted. Correction advised. **(Original CrawlSpace)**

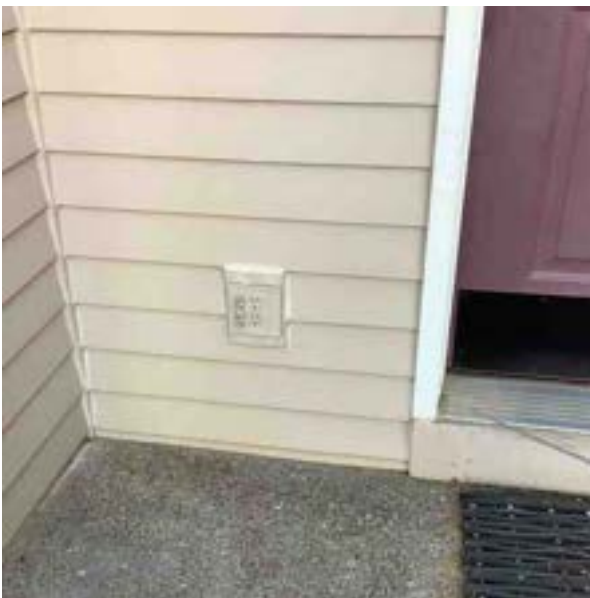
9.7.4 All outdoor receptacles should have approved covers for safety. Correction advised. **(Exterior Front)**

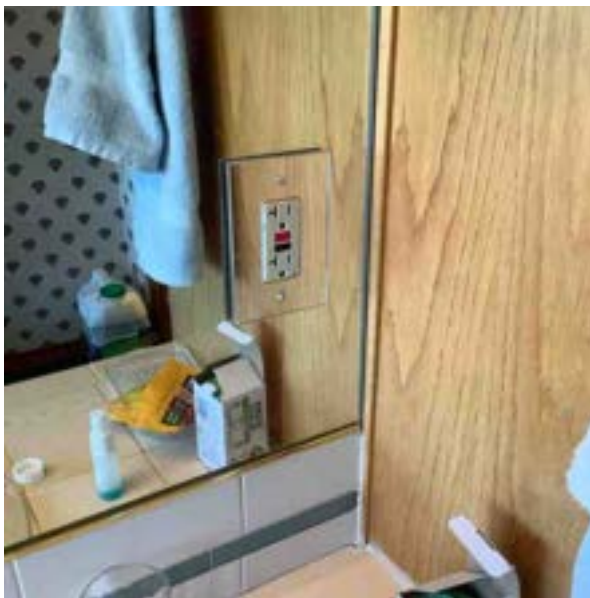
9.10.4 When the GFCI receptacle is tripped it turns off everything else, including the lights, in the bathroom. This can be a safety hazard if it is dark when this happens. Further evaluation and correction is advised. **(1st Floor SW Bathroom)**

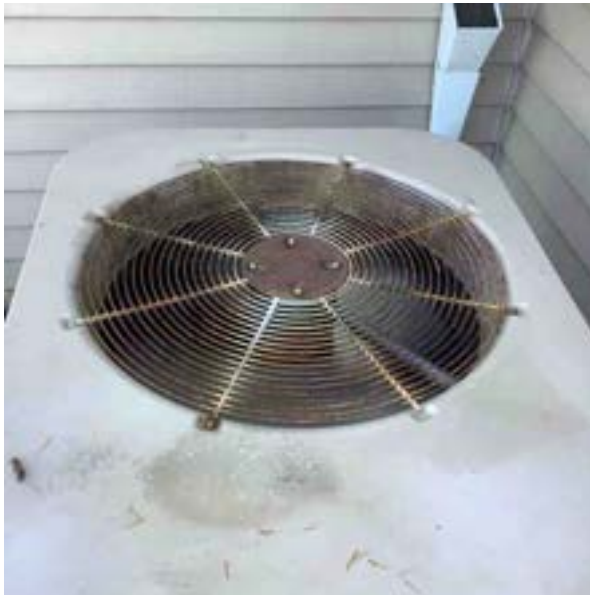
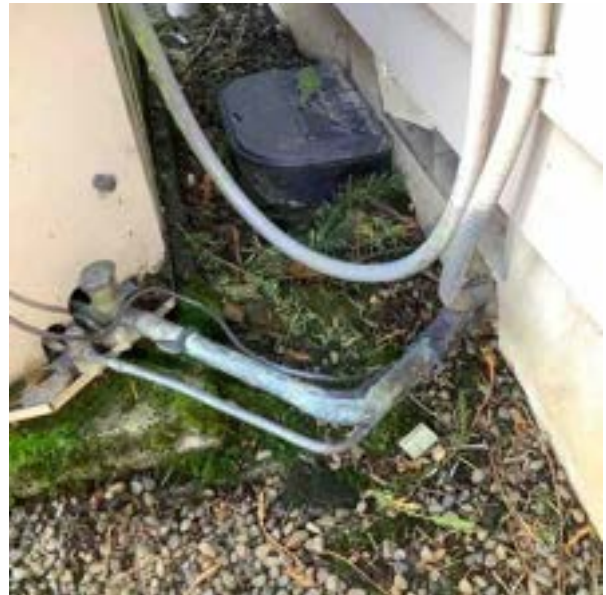
10.5.5 The outside of the heat pump is rusting. Further evaluation and correction of all issues found is advised.

Refrigerant line has damaged insulation, this will lower the efficiency. Further evaluation and correction of all issues found is advised.

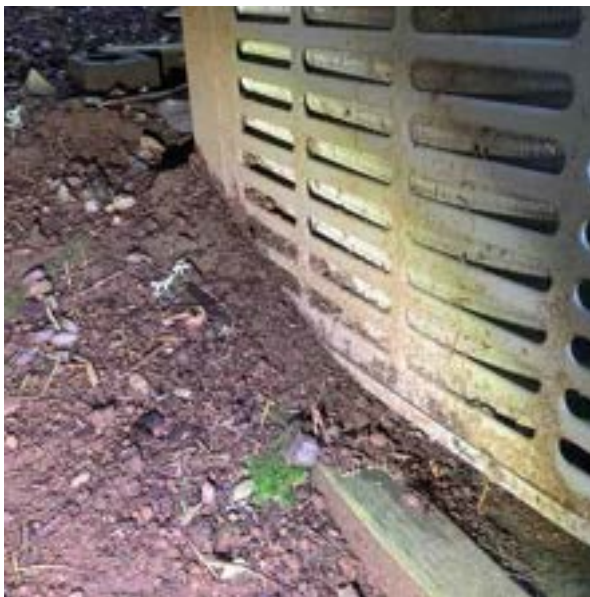
10.5.6 System is dirt and there is earth up against the unit. Further evaluation and correction of all issues found is advised. **(Exterior Left)**

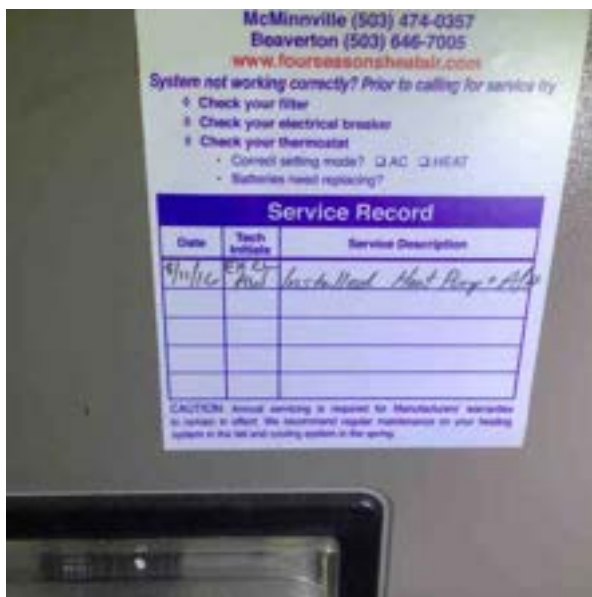
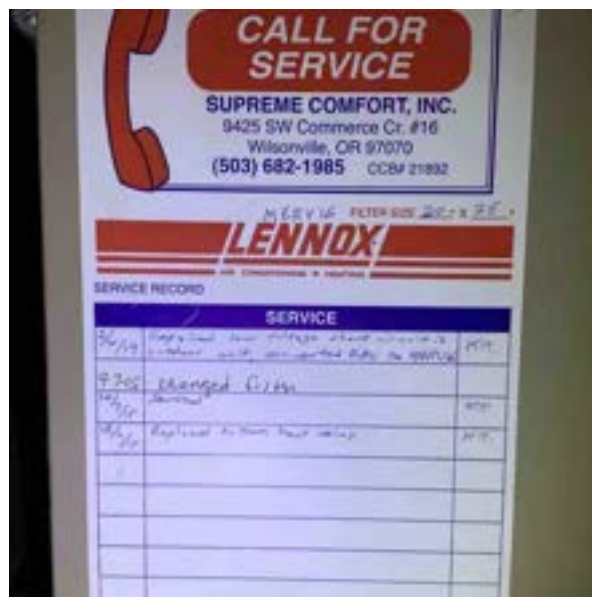
- Attic: Upper
- Crawlspace

10.6.2 The HVAC system is in need of a service call; it does not appear this has been done in some time. Have the entire HVAC system inspected, tuned-up, any issues found corrected and the system cleaned by a licensed heating contractor prior to closing to extend the life of the system. Sometimes this has been done recently but the contractor only checked and serviced things ( did not clean them and put a service sticker on it and all I can go off is what I see) so if the above has been done recently, get a copy of the paperwork and talk to the service tech if you have any questions or concerns.

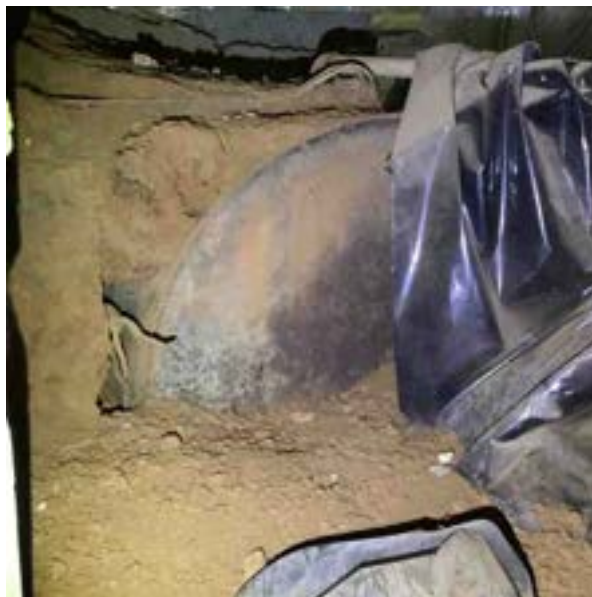
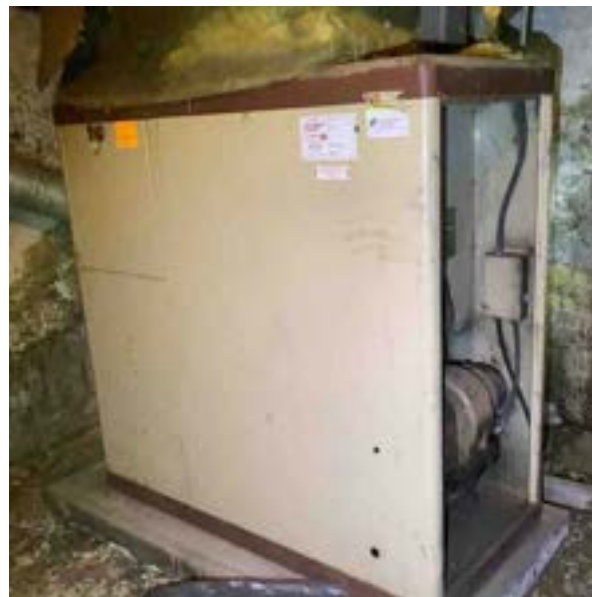
10.10.1 Original crawlspace:

There is an underground oil storage tank for the defunct oil furnace. Further evaluation and correction of all issues found is advised.
