# INSPECTION REPORTS

Job Site Address: 15771 SW OBERST LN

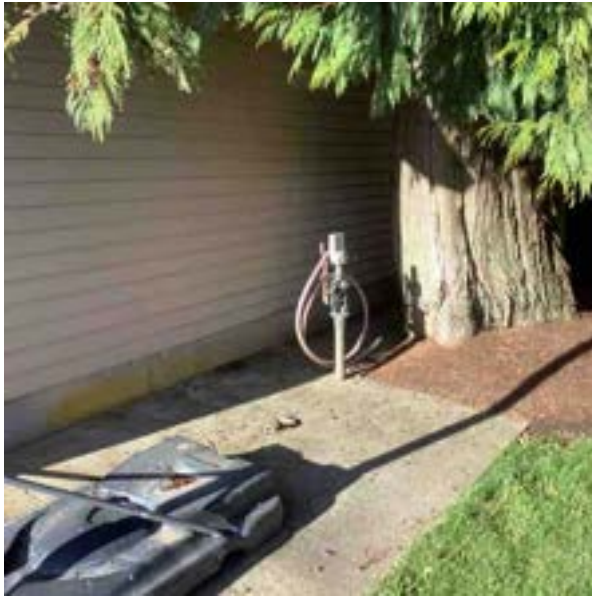
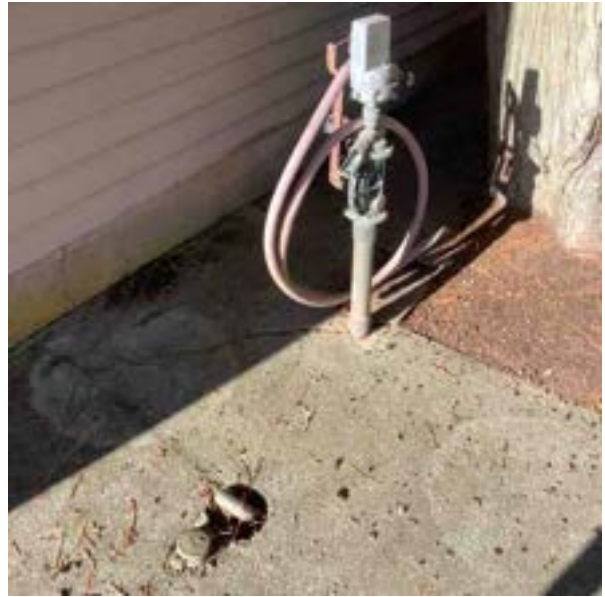
10.10.2 Behind the garage, there is what appears to be a fuel pump and underground storage tank. Ask the sellers about this. Further evaluation and correction of all issues found advised.

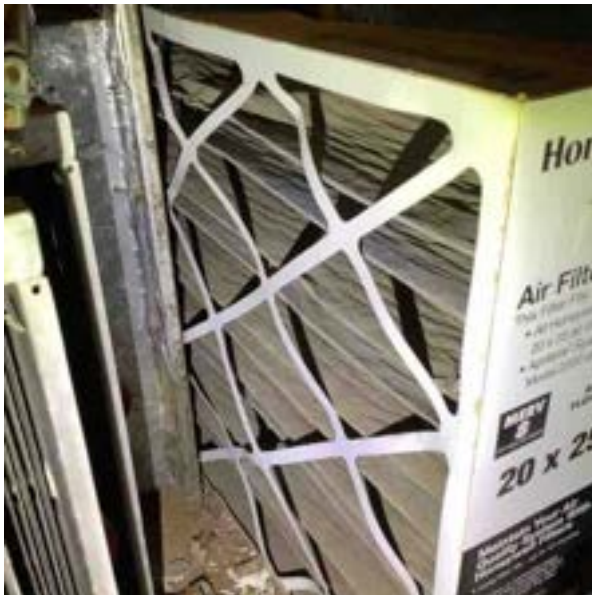
10.11.6 The air filter is dirty. Correction advised. **(Crawlspace)**

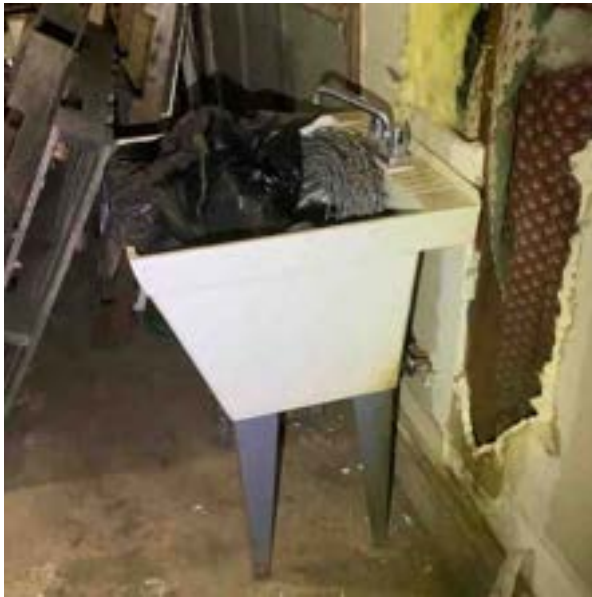
11.7.11 Sink is loose. Correction is advised. **(Garage)**

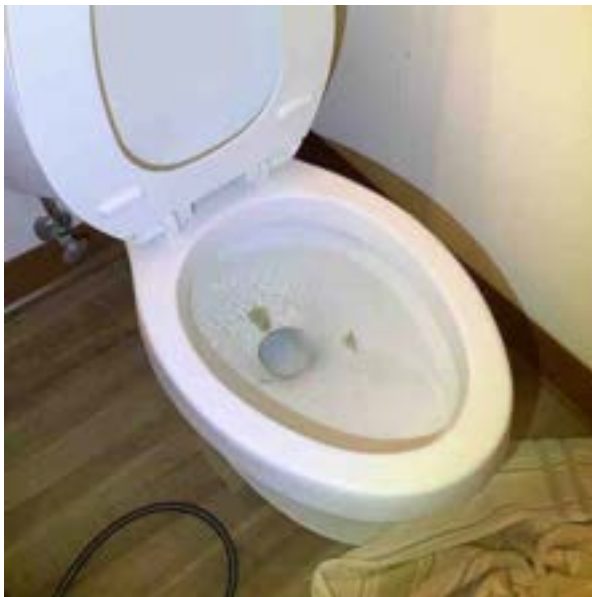
11.8.2 Toilet appears to be clogged. There is Drano and toilet snake near fixture too. Further evaluation and correction of all issues found is advised. **(Basement bathroom)**

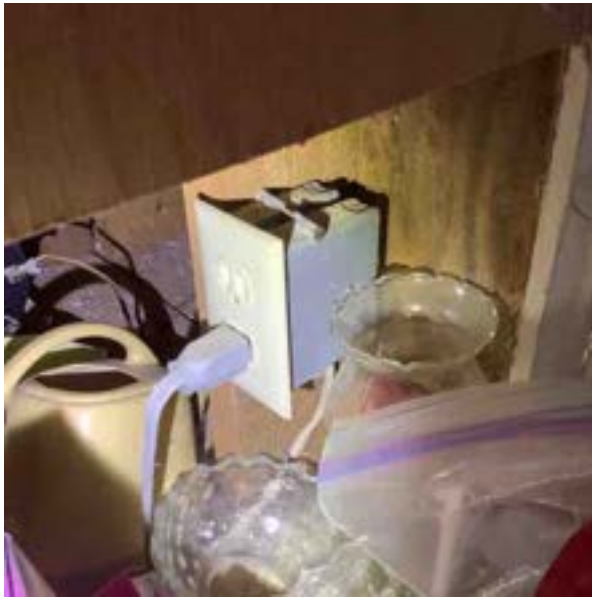
11.9.3 Jetted tub should be on a GFCI outlet. Correction is advised. **(1st Floor SW Bathroom)**

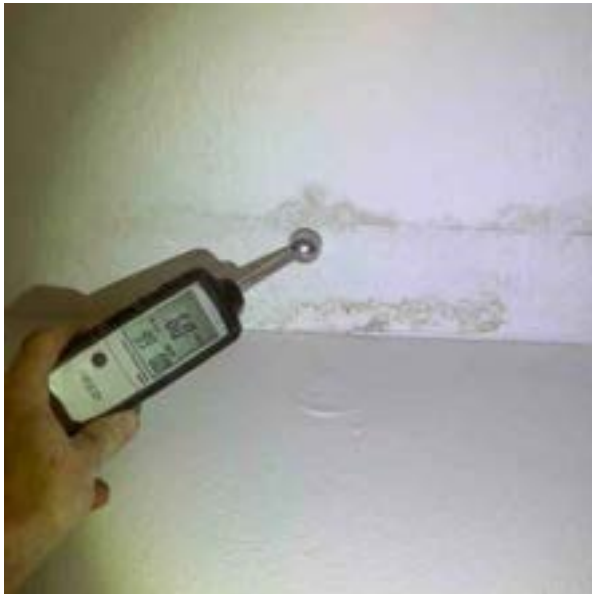
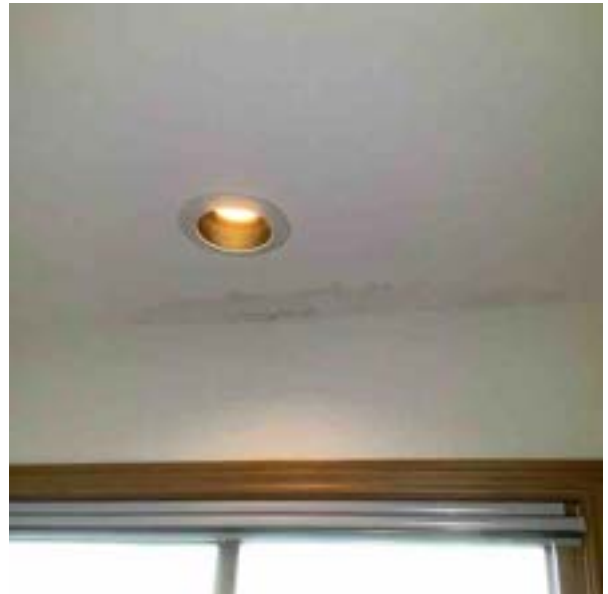
12.4.4 Stains noted but no moisture or damage detected. Ask the seller about this and if still concerned, evaluation and correction of any issues found is advised. **(2nd Floor Hall Bathroom)**

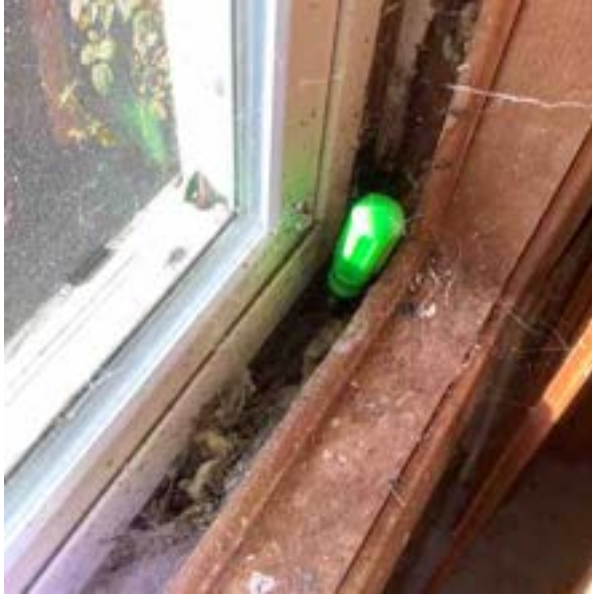
12.5.5 Rot found in sill. Unable to determine extent of damage. Further evaluation and correction of all issues is advised. **(Garage)**

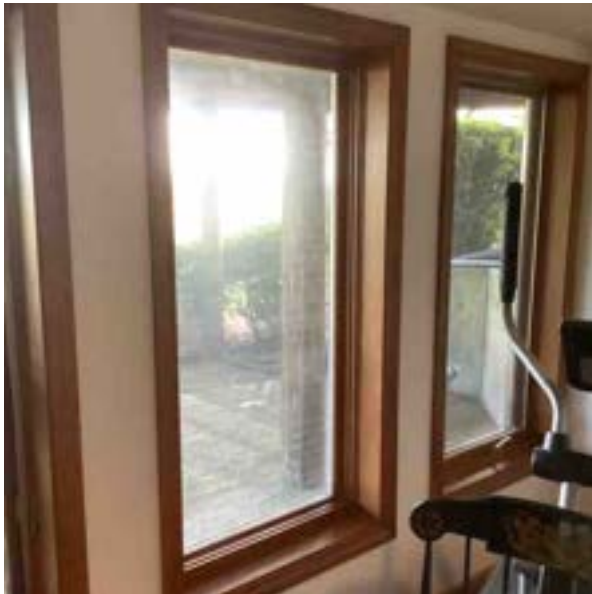
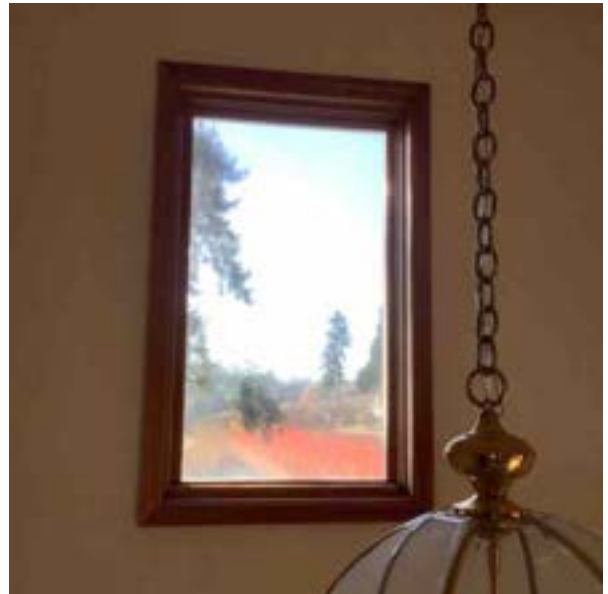
- Basement Family Room
- Entry

12.5.8 Thermopane seals are broken causing moisture staining/discoloration between the panes of glass. Replacement/repair may be desirable but this is a cosmetic issue and will not cause damage.

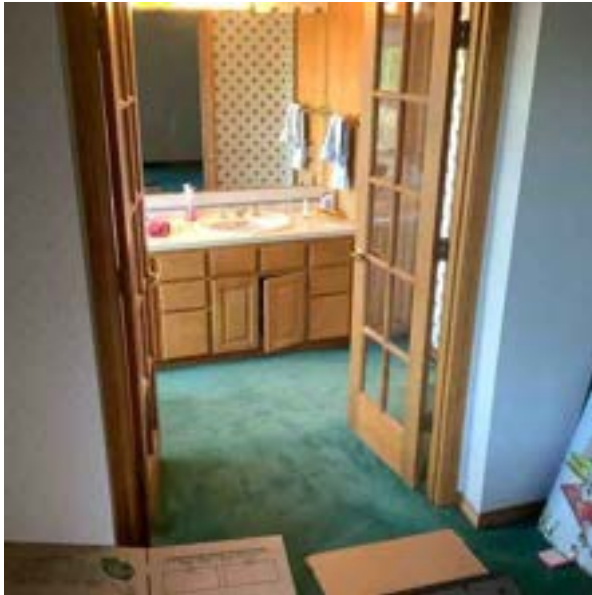
12.6.3 Doors rub on carpet so they are unable to function properly. Further evaluation and correction is advised. **(1st Floor SW Bathroom)**

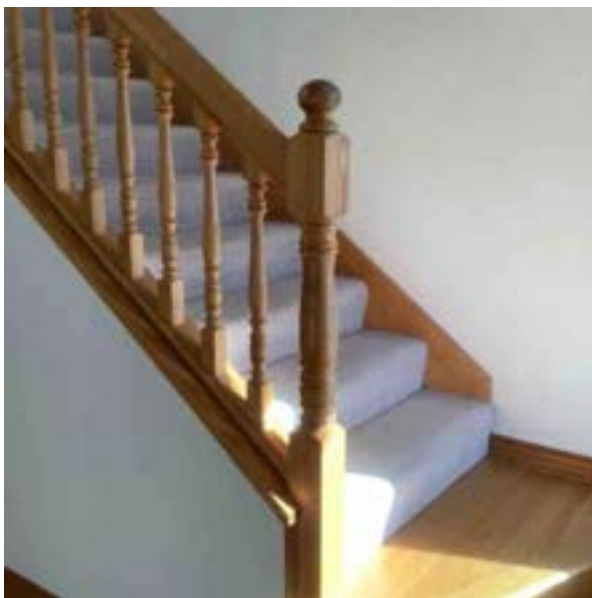
12.8.4 Handrail is loose. Further evaluation and correction of all issues found is advised.

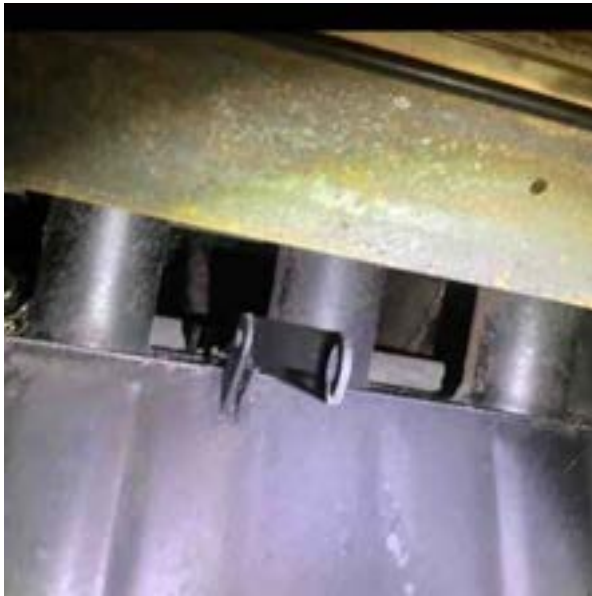
13.3.2 Damper will not move. Further evaluation and correction is advised. **(Basement Family Room)**

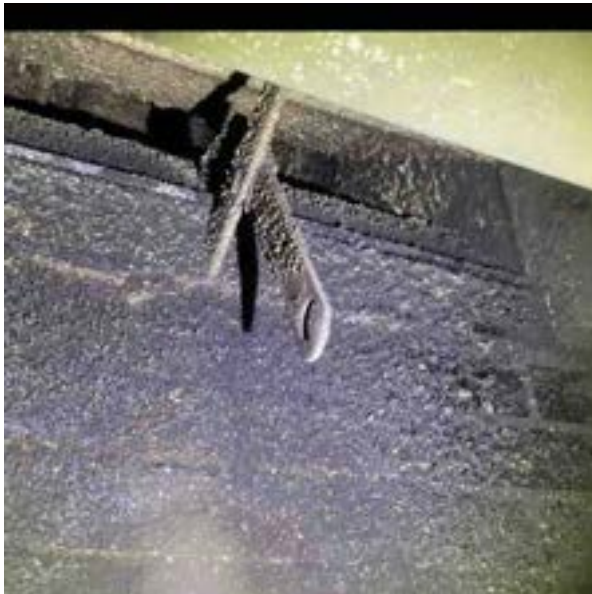
13.4.1 Creosote/soot buildup noted in the firebox and flue. Further evaluation and correction of all issues found is advised. **(Living Room)**

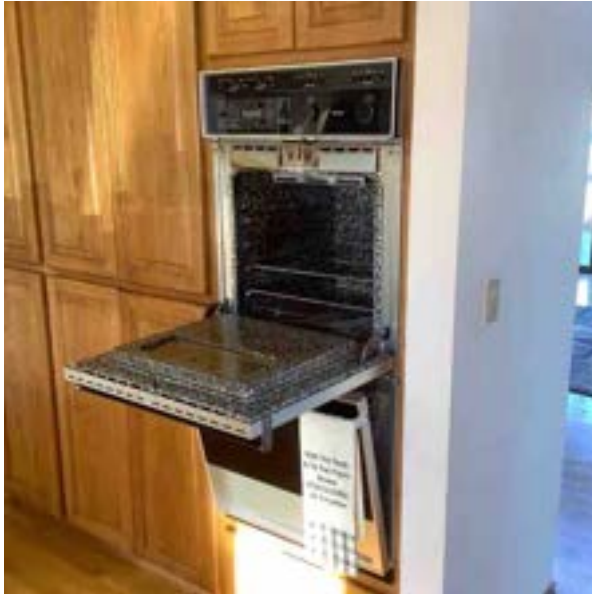
14.4.2 Oven door falls open. Correction advised.  
Oven light is not working. Correction is advised.

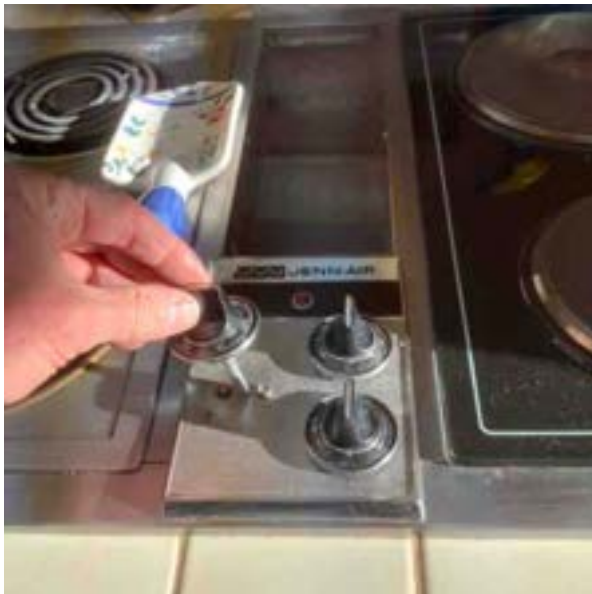
14.4.3 Knob is damaged, unable to test the feature it controls. Further evaluation and correction of all issues found is advised.

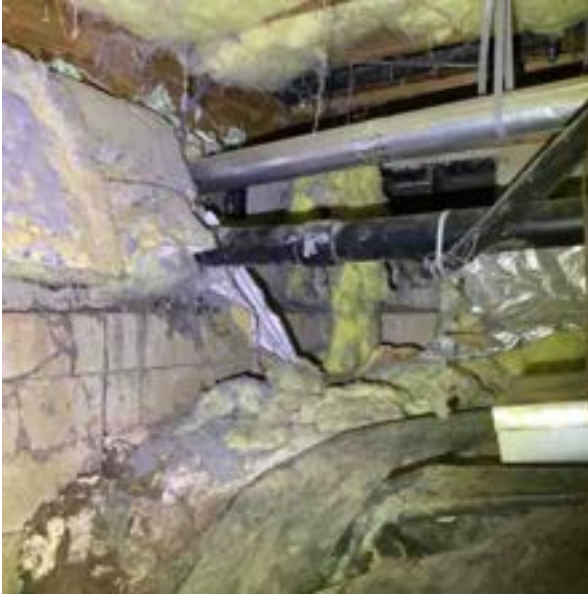
14.10.2 The dryer vent cover has quite a bit of lint caught in it and is blowing into the crawlspace. Further evaluation and correction of all issues found is advised. **(Crawlspace)**

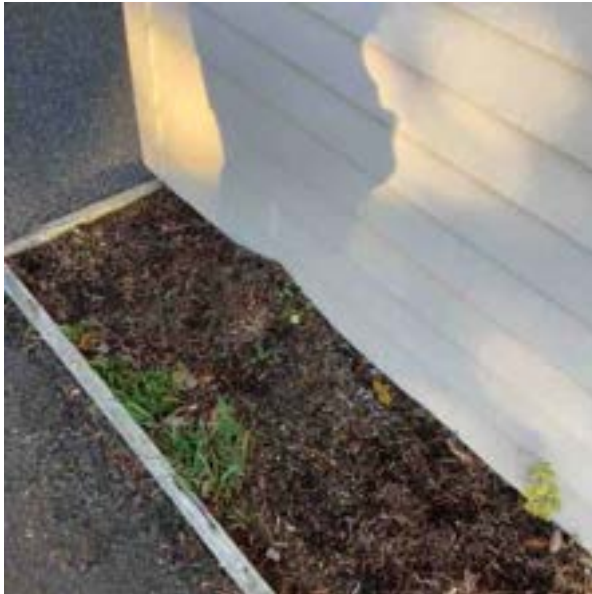
2.3.3 **Elimination of all earth to siding contact is advised to reduce the chance of rot and/or infestation by wood destroying insects. If damage is found when this is done correction is advised.**

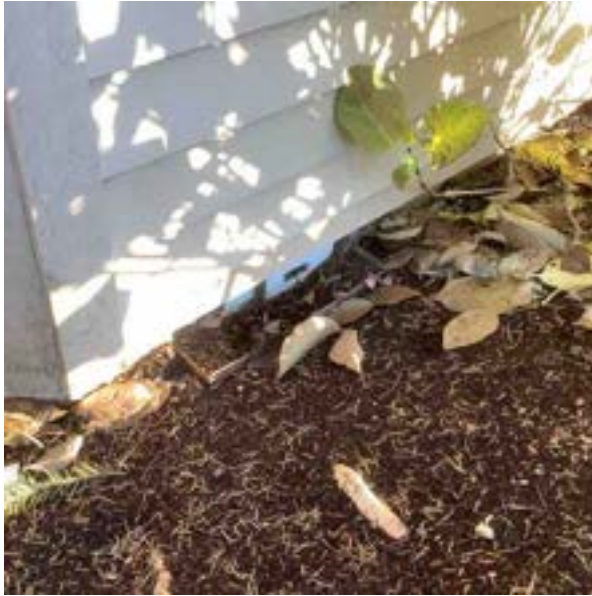
**2.3.6** Some foundation vents are at or below ground level. This can allow water to enter the crawlspace. Grades should be lowered approx. 6" under these foundation vents & vent wells installed where necessary to hold back the dirt and allow water to flow away from foundation and not into the crawlspace. (Exterior Front)

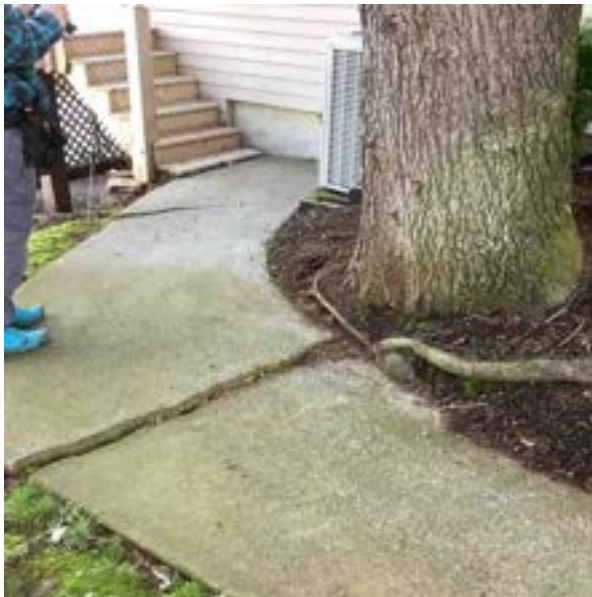
**2.4.1** The condition of the walkway poses a potential trip hazard. Further evaluation and correction of all issues found is advised.

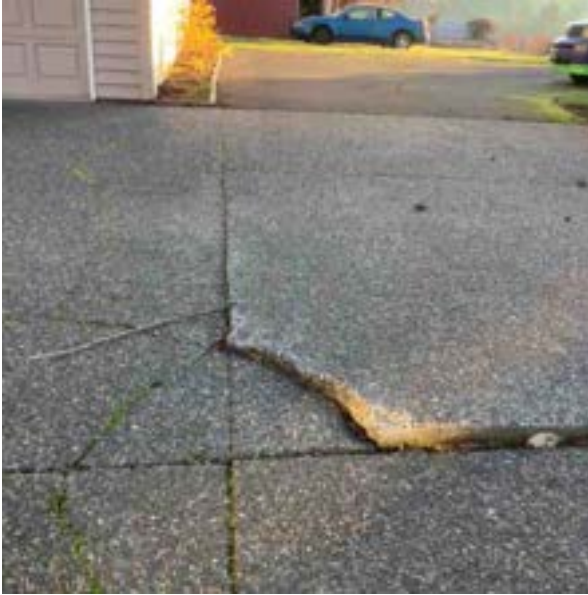
**2.5.2 Driveway has settled to the point that it poses a trip hazard. Further evaluation and correction of all issues found is advised.**

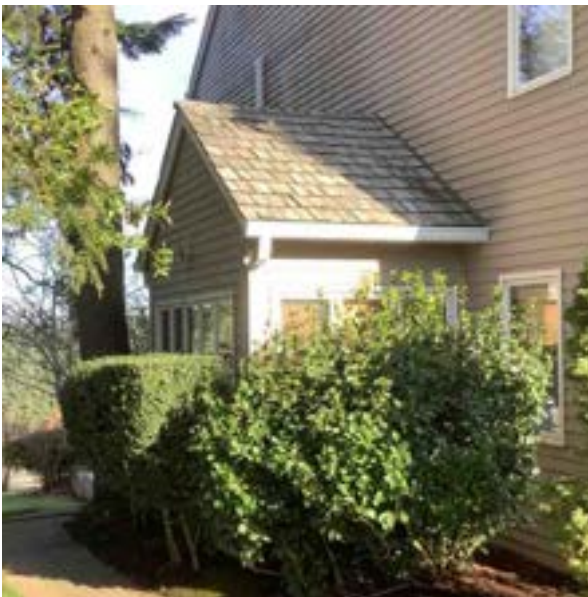
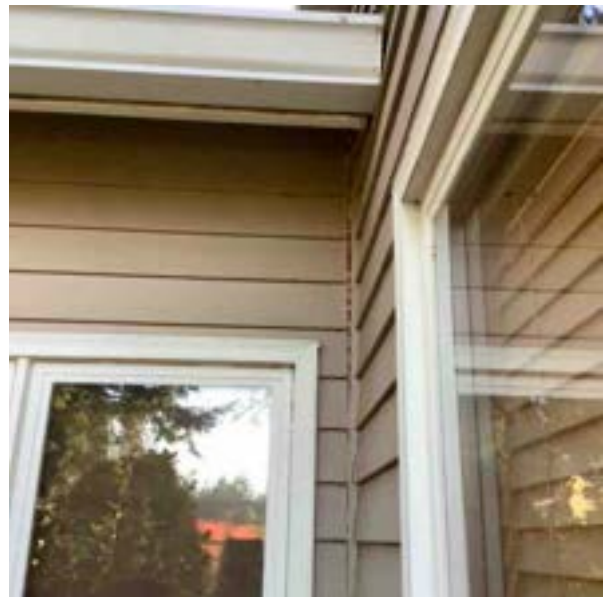
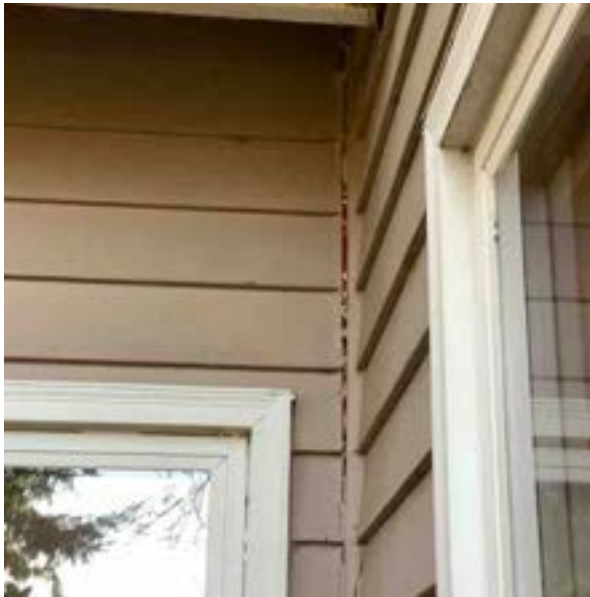
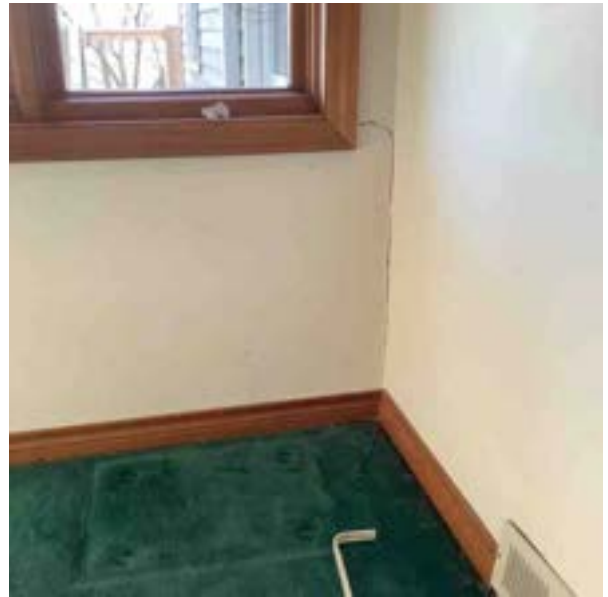
- Exterior Left
- den

**3.2.1 Separation noted at a joint in exterior wall and crack noted at interior wall in the west room off of the den indicates settling has occurred. Evaluation and correction of all issues. Found advised.**

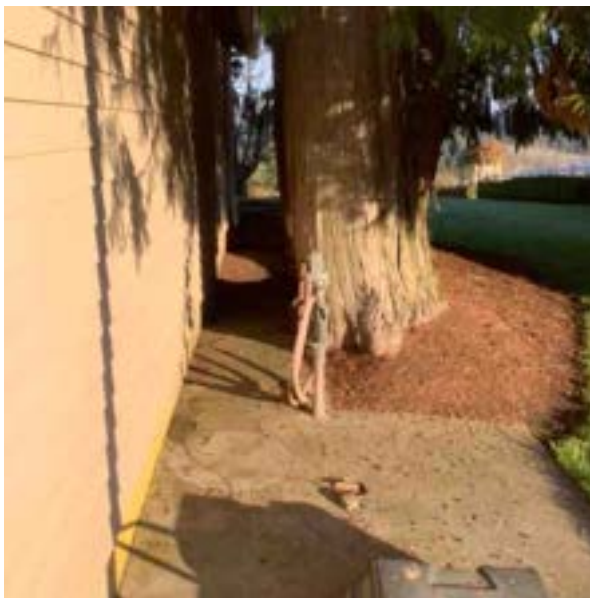
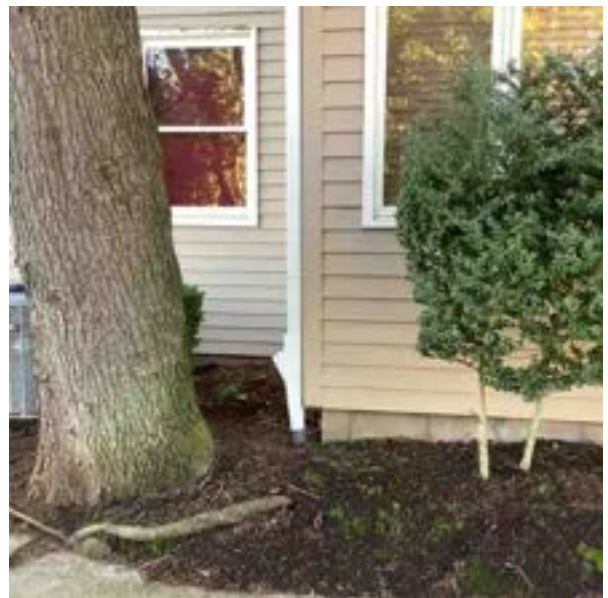
- Exterior Back
- Exterior Left

**3.3.2 Trees were planted in close proximity to the house. Tree roots may cause damage to the foundation over time and cause damage to the siding, windows, etc. Further evaluation is advised.**

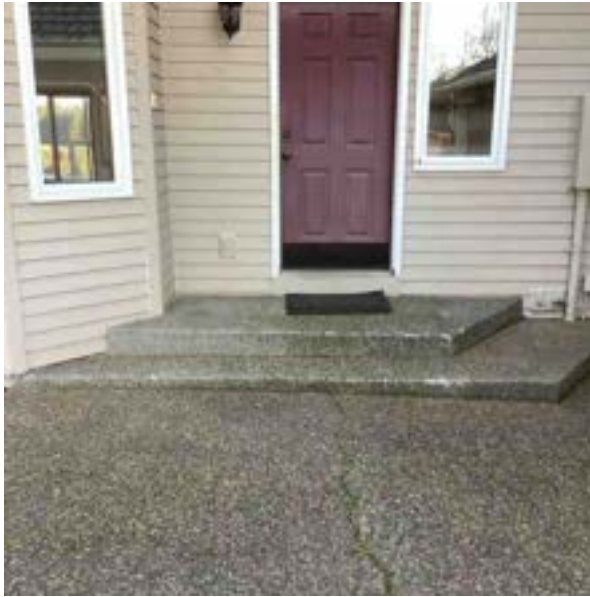
**3.4.3 Concrete is touching the wooden siding. This can lead to moisture intrusion issues. Unsure if hidden damage exists. Further evaluation and correction of all issues found advised. (Exterior Front)**

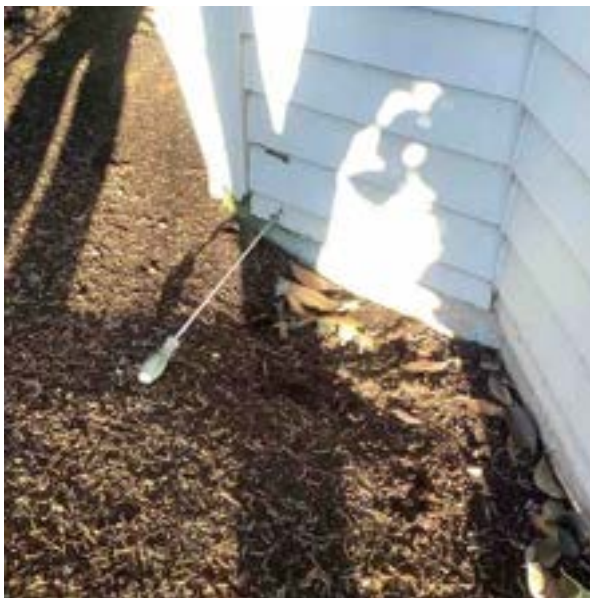
**3.4.4 Rot in siding. Unable to determine extent of damage. Further evaluation and correction of all issues found is advised. (Exterior Front)**

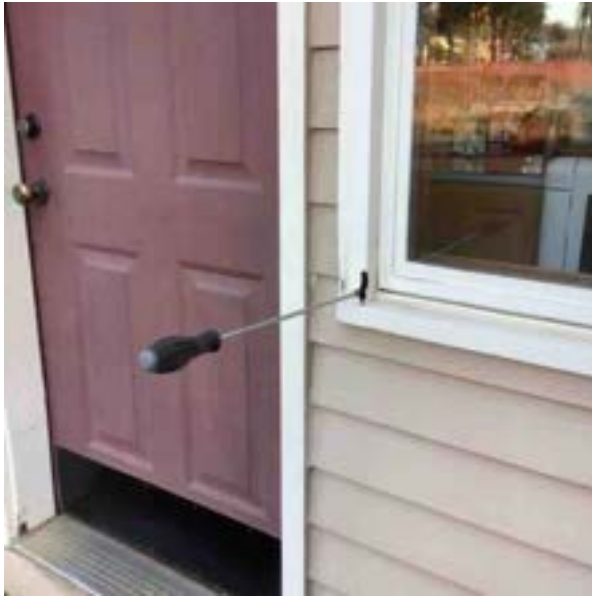
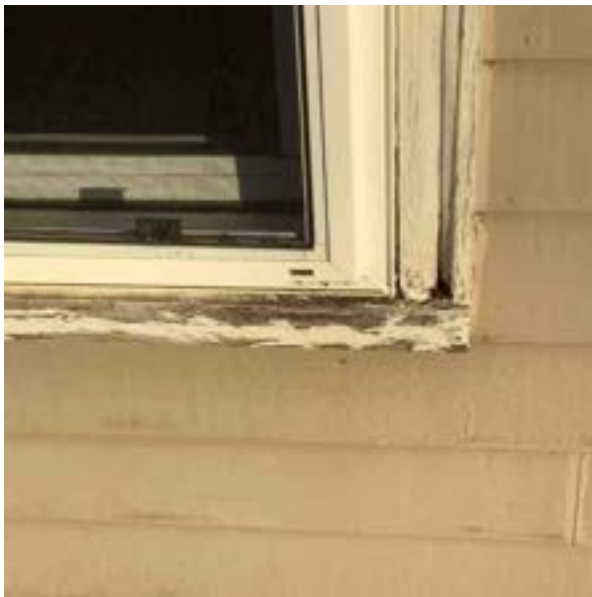
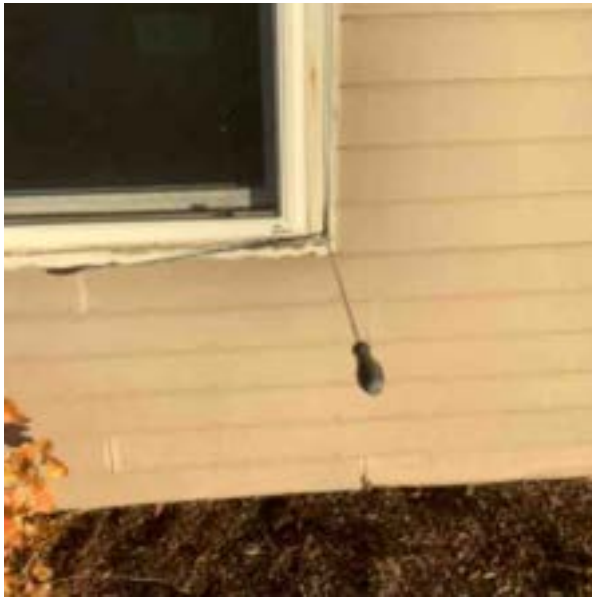
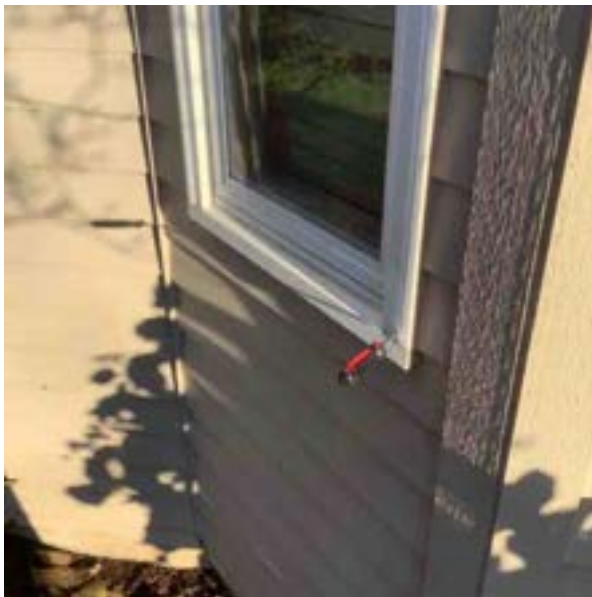
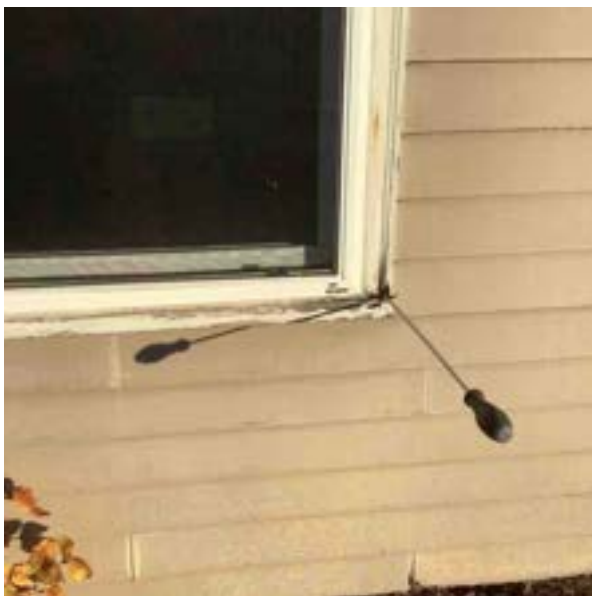
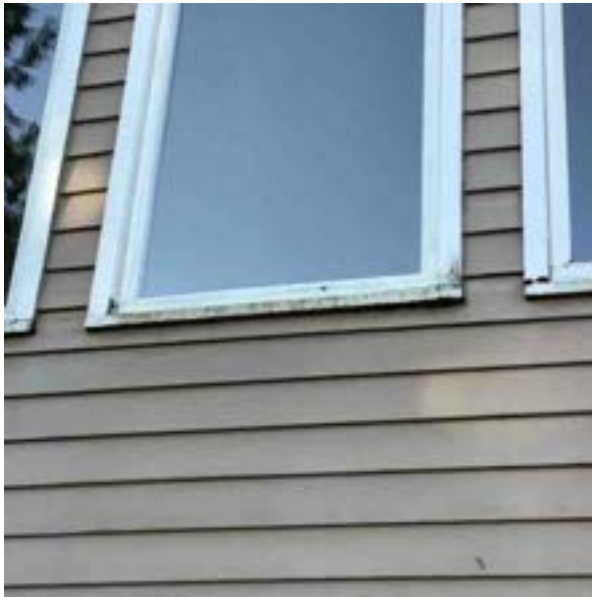
**3.6.1 Rot in trim around the house. Mostly at the front. Unable to determine extent of damage. Further evaluation and correction of all issues found is advised.**

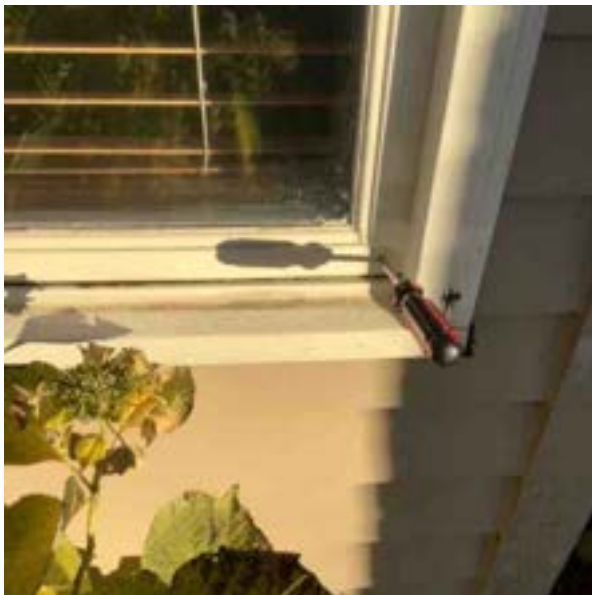
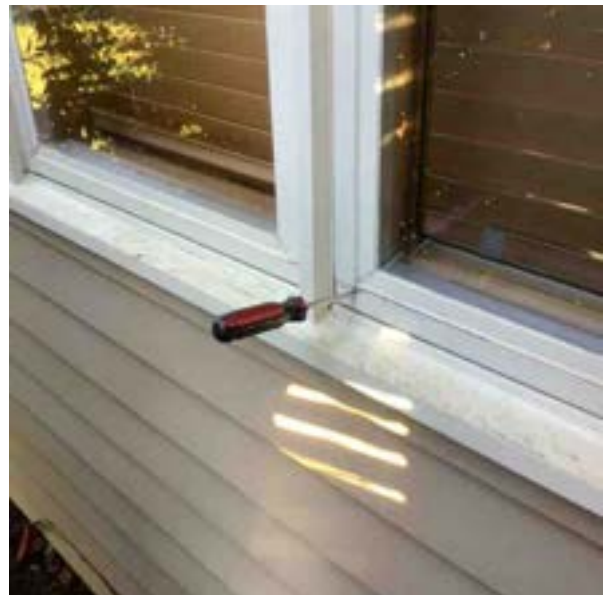
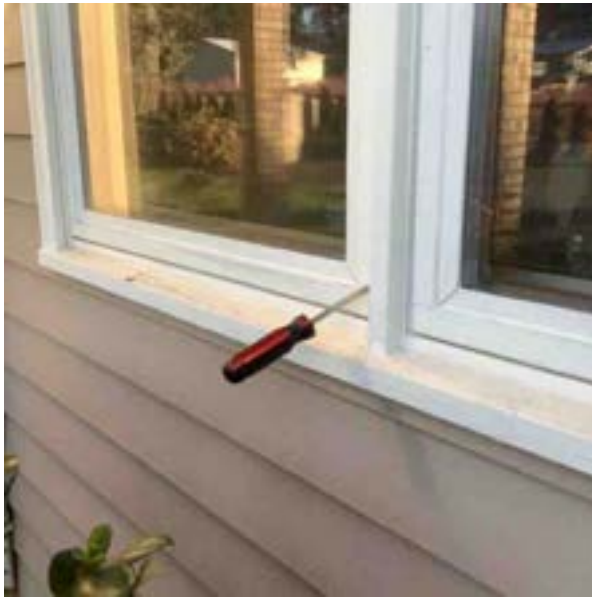
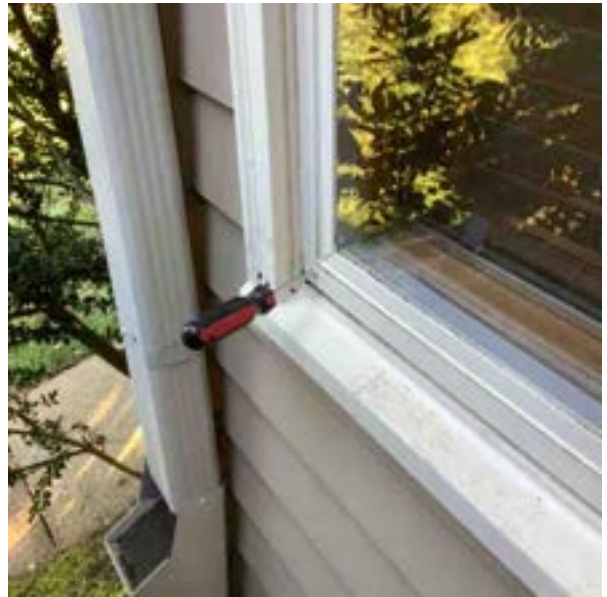
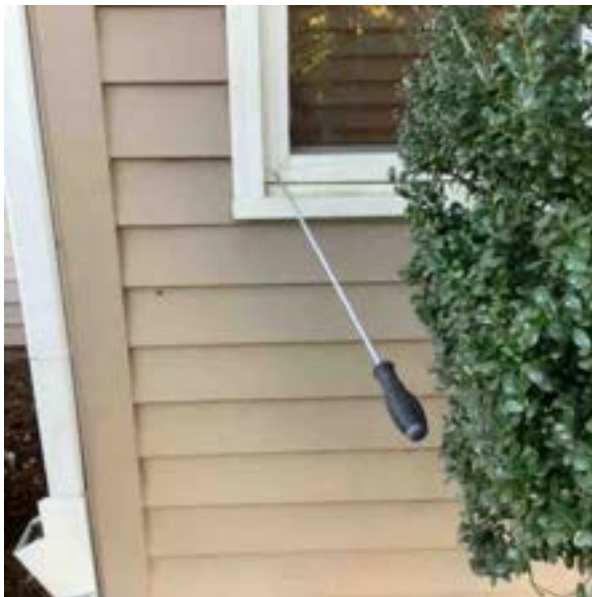
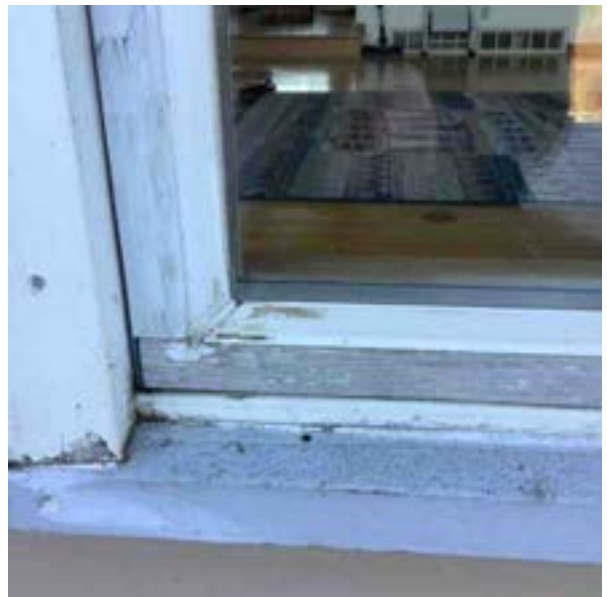
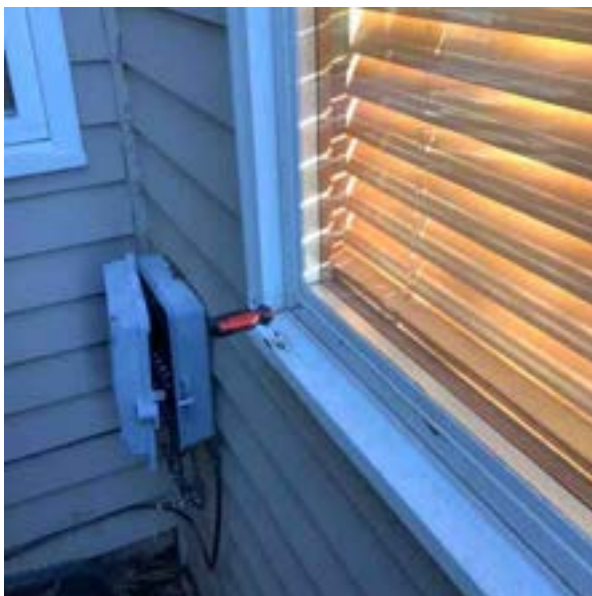
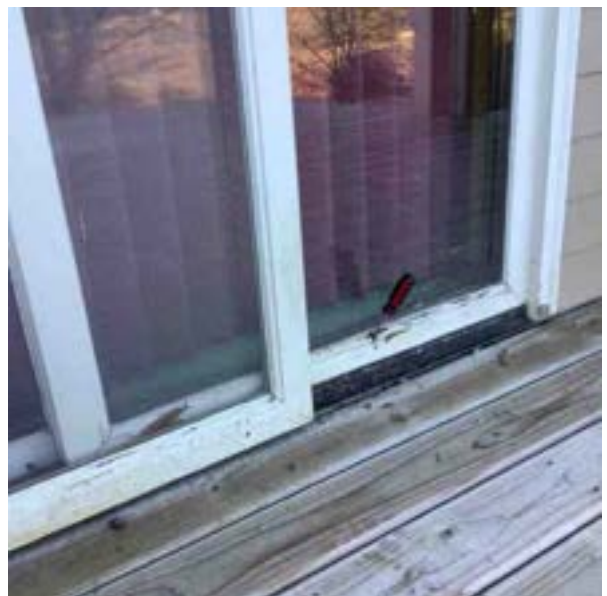
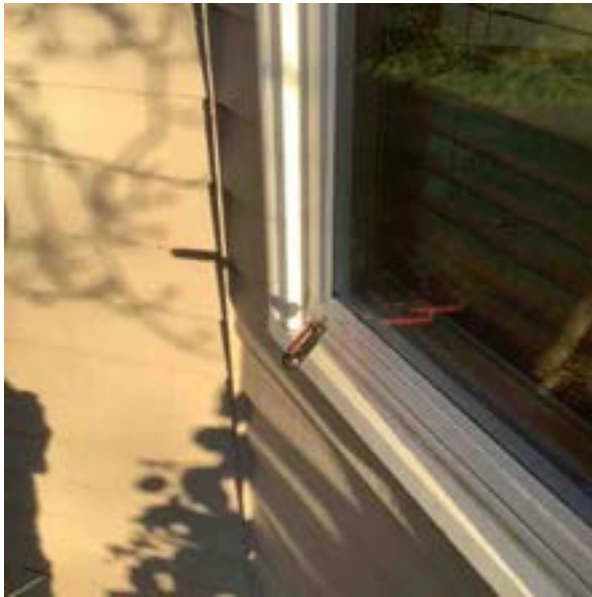
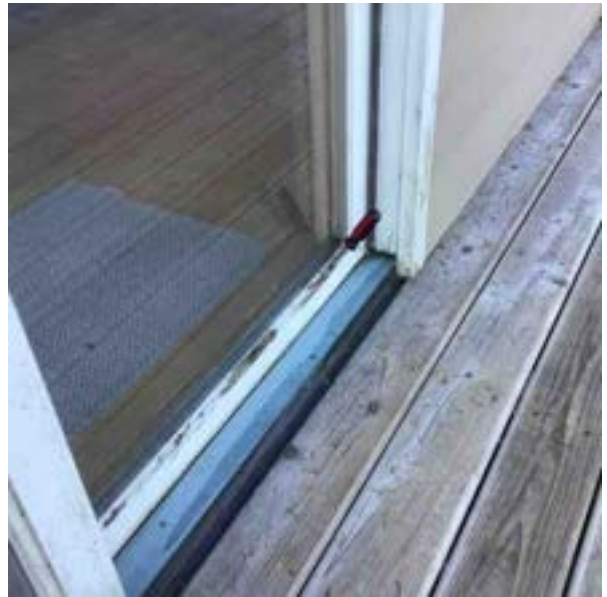
3.7.4 **These types of wood windows and sliding doors from this time period are known to have issues with rot, wear and separation of joints. Some windows have issues and rot was found. Further evaluation of ALL windows and correction of all issues found is advised.**

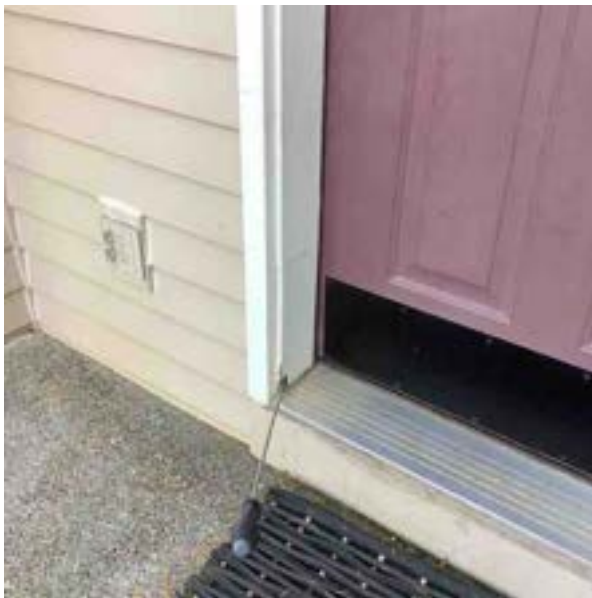
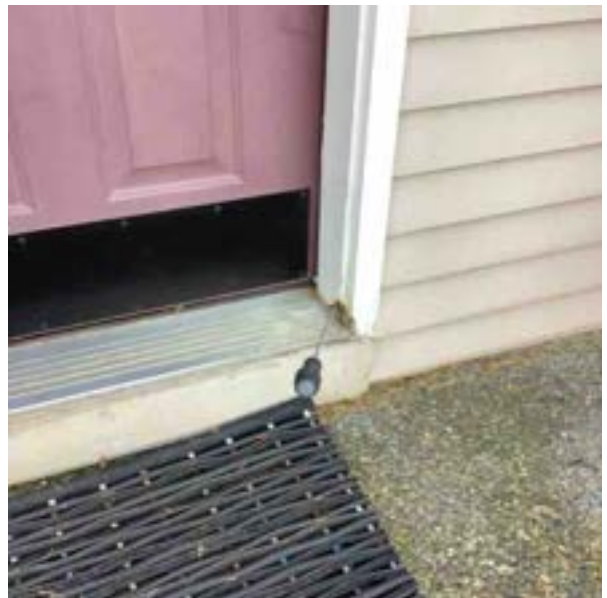
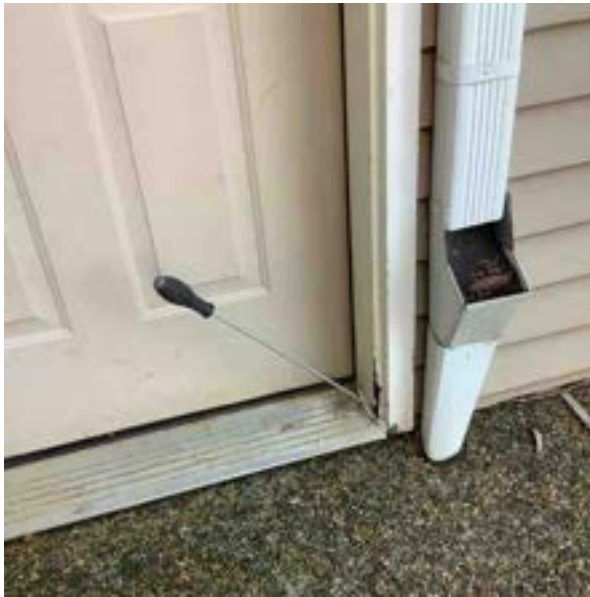
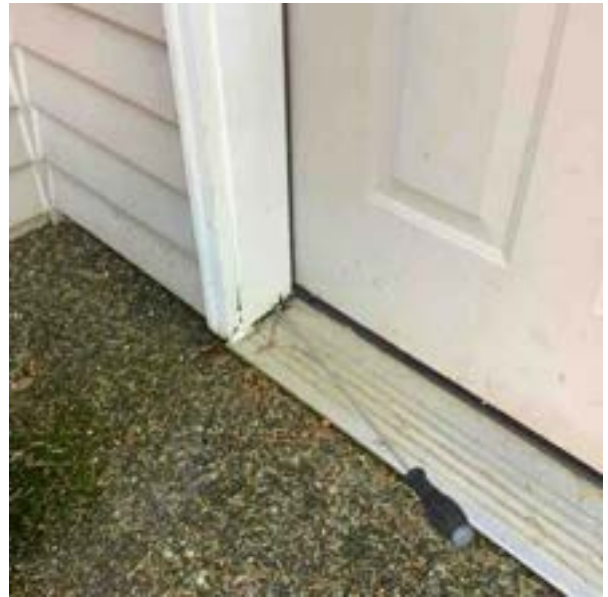
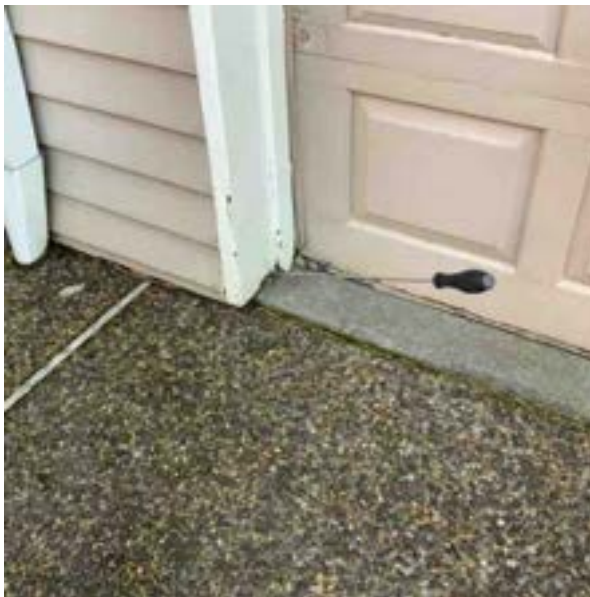
- Garage
- Laundry

3.8.3 **Rot in the frame of the exterior doors. Unable to determine extent of damage. Further evaluation and correction of all issues found is advised.**

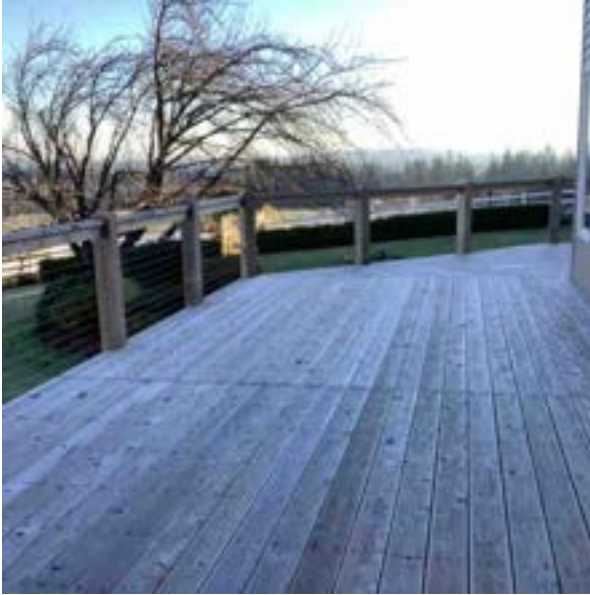
3.10.5 The railing has different levels all running horizontally which can allow children to climb over it, which poses a safety risk. Correction advised.

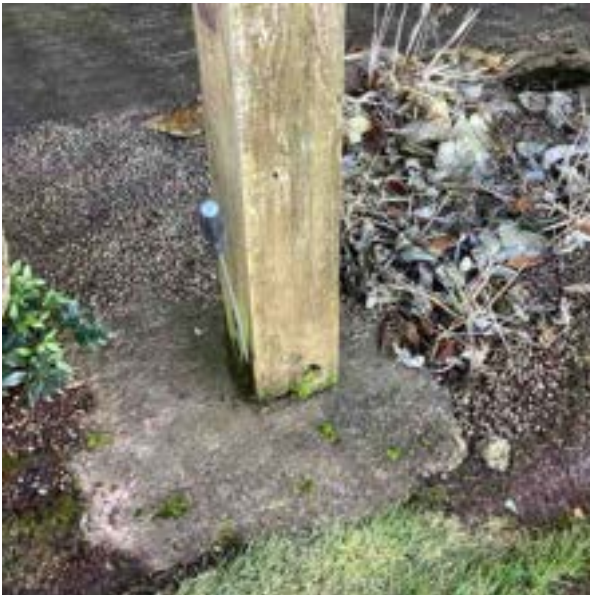
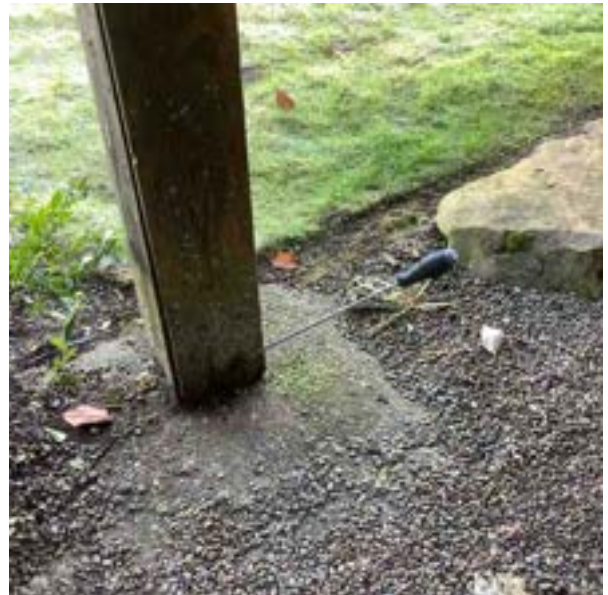
3.10.6 Rot was found in posts. Unable to determine extent of damage. Further evaluation and correction of all issues found is advised. (Exterior Back)

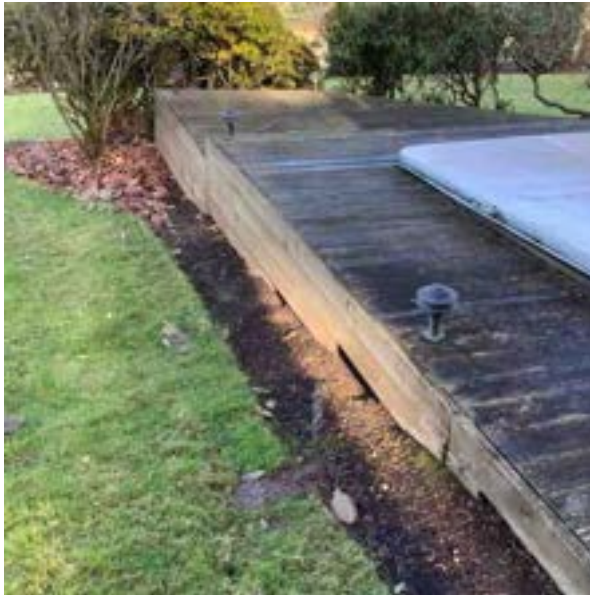
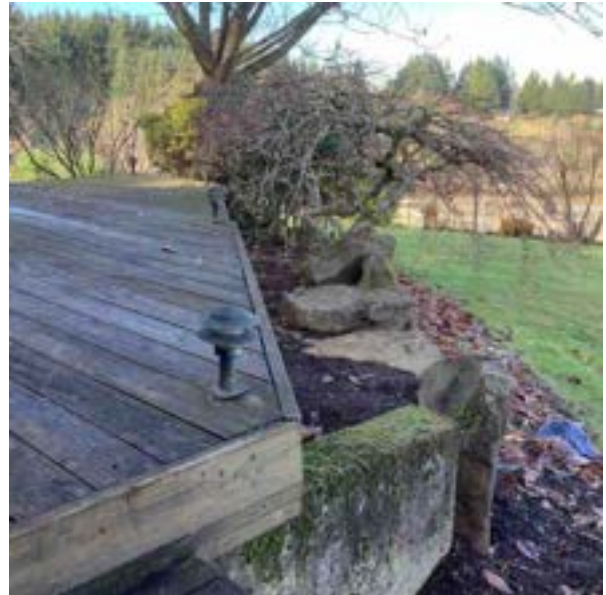
3.10.7 Even though detached decks are typically outside the scope of an inspection. Recommend adding a railing for safety. **(Exterior Back)**

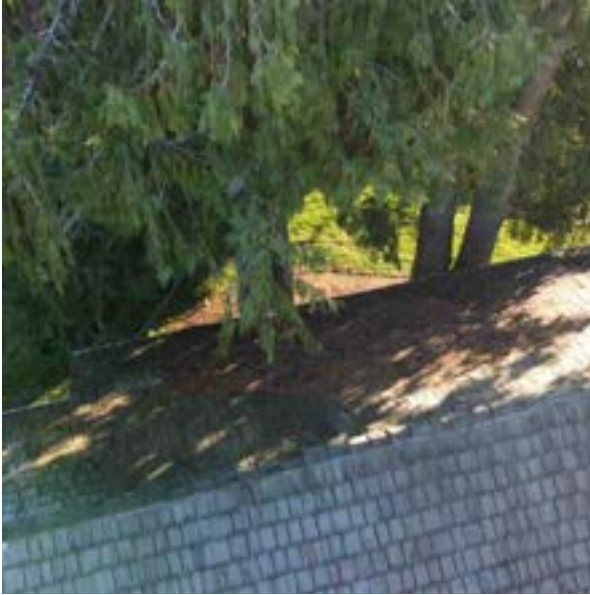
**4.2.3 All tree branches should be kept trimmed back at least 6 to 8 feet from the house, roof & gutters to extend their life, reduce debris & the chance of damage.**

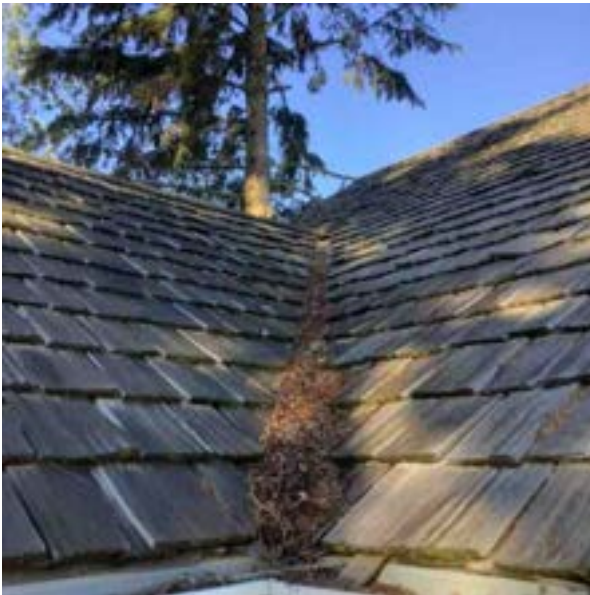
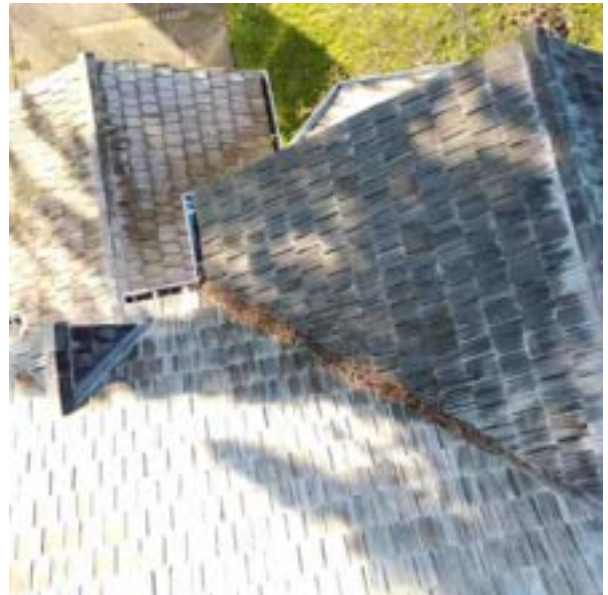
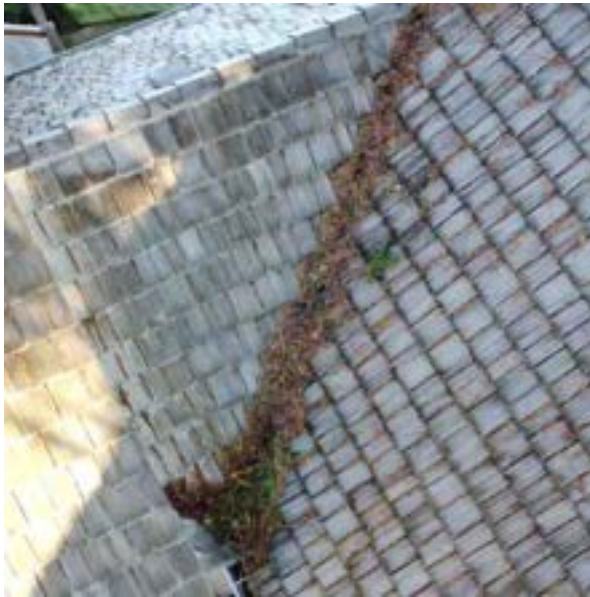
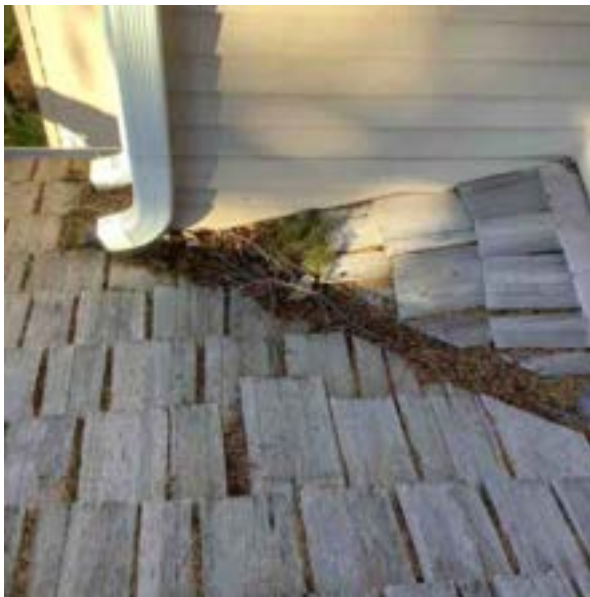
**4.2.4 Keep roof cleaned of moss and tree debris to allow water to more easily flow off and into the gutters and to extend the life of the roof. Evaluation and correction of all issues found advised.**
