# INSPECTION REPORTS

Job Site Address: 15771 SW OBERST LN

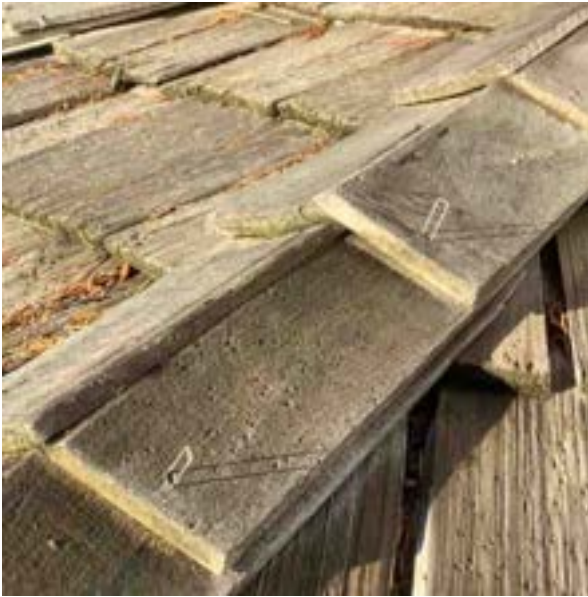
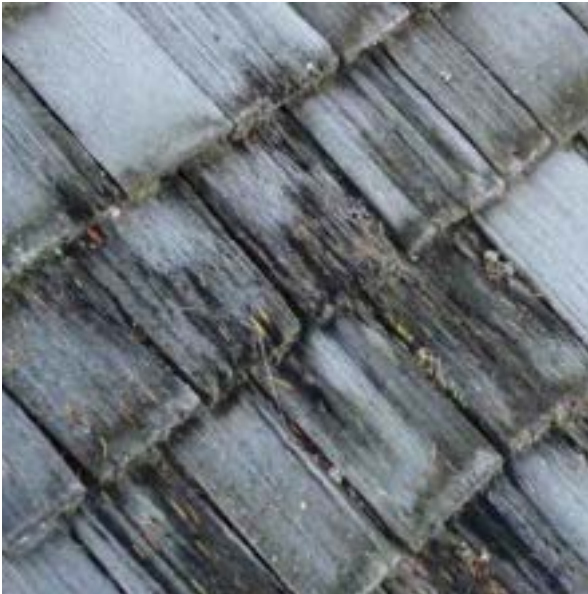
4.4.2 There are lifting staples, moss, and some rotted shakes noted. Further evaluation of the entire roofing system and correction of all issues found is advised.

4.4.1 I highly recommend having the entire roofing system evaluated and cleaned (not power washed, this wears out the shakes and can cause leaking), selective shake replacement (if absolutely necessary since felt paper under the shakes can be torn if new shakes are improperly installed), securing loose shakes, fix or replace anything else needing it & treating be done by a licensed roofing contractor to extend life of roof.

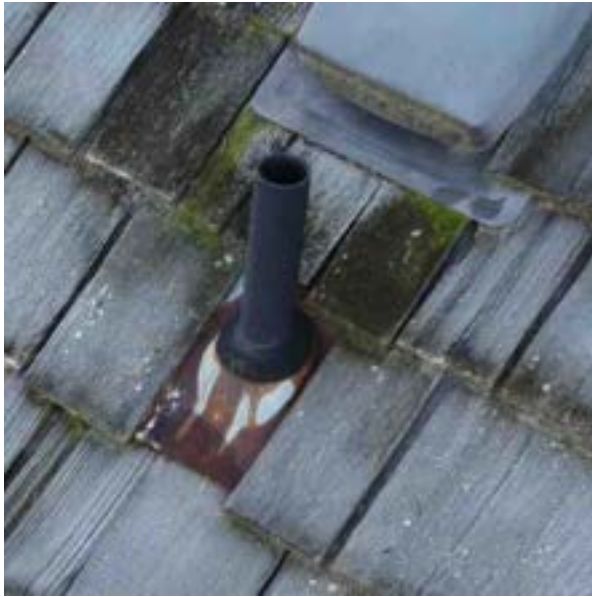
4.5.2 **Flashings are beginning to rust which can lead to premature failure. Further evaluation and correction of all issues found is advised.**

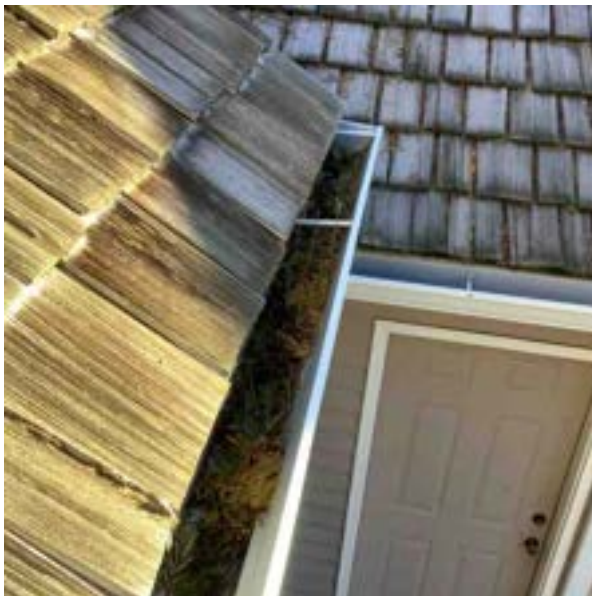
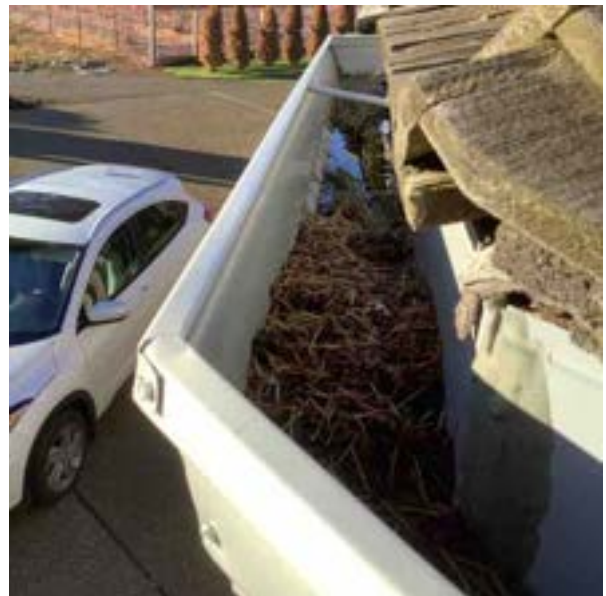
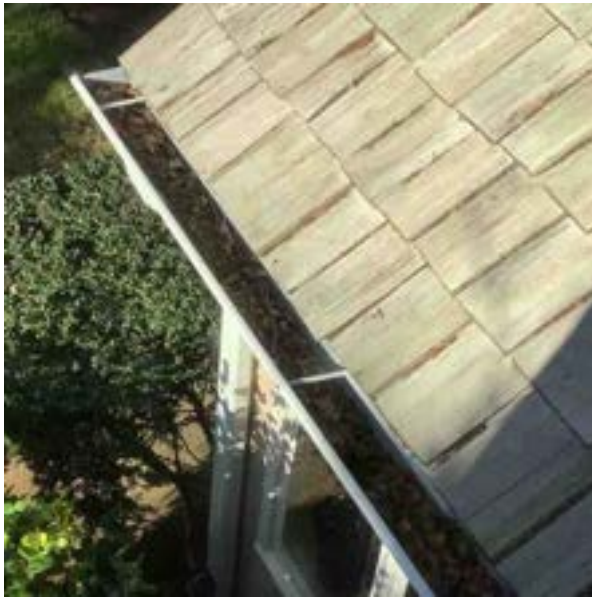
4.6.3 **Gutters could use cleaning to facilitate water drainage towards downspouts. Further evaluation and correction of all issues found is advised.**

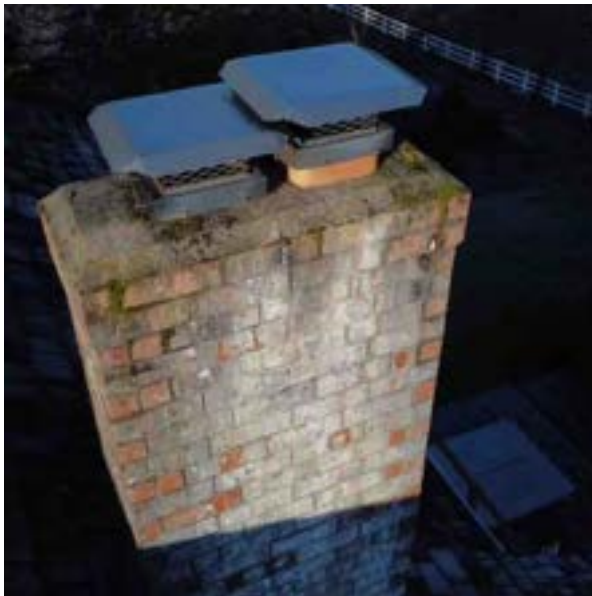
4.7.2 **Typical chimney cap cracks and moss noted. Further evaluation and correction of all issues found is advised.**

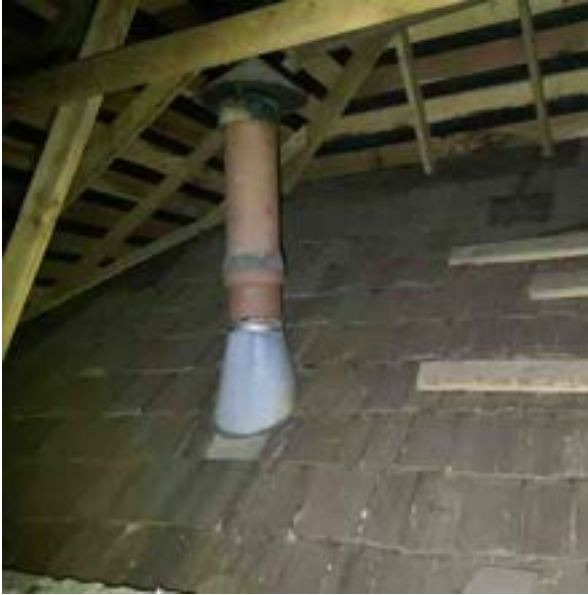
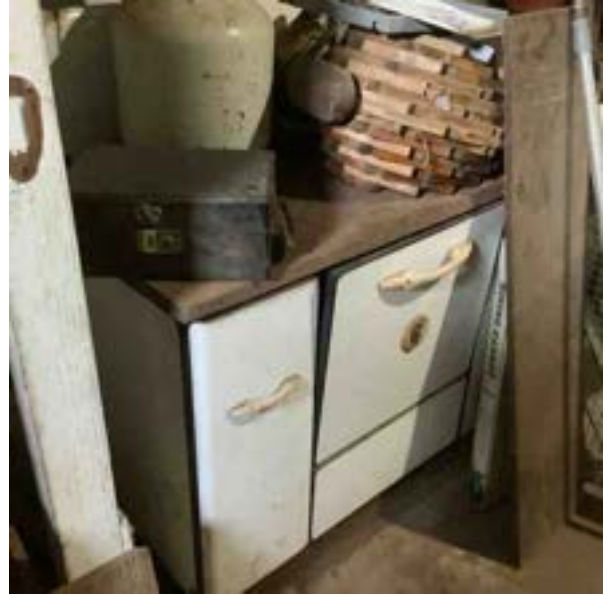
5.1.3 Old wood burning stove is venting into the attic. Stove does not appear to meet state standards and has not been used in quite some time. Further evaluation and correction is advised. (Attic Garage)

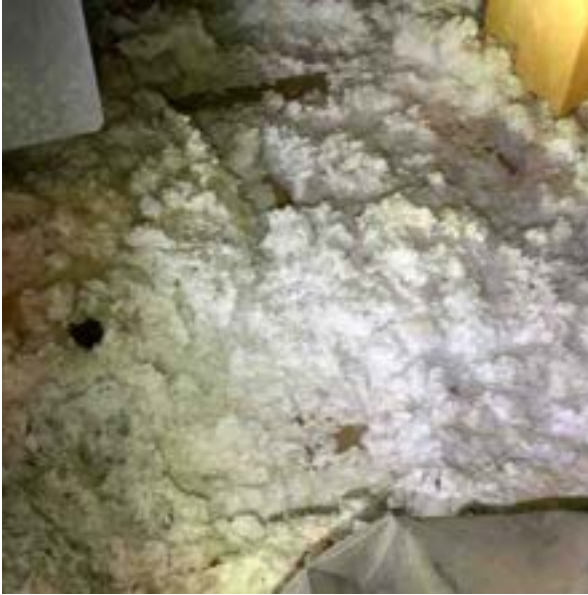
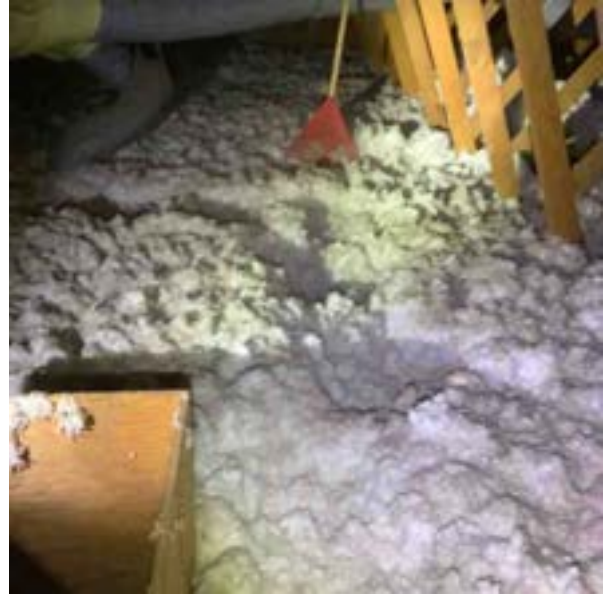
5.3.3 **Insulation level has been compacted in several places; this can reduce its effectiveness. Further evaluation and correction of all issues found is advised. (Attic: Upper)**

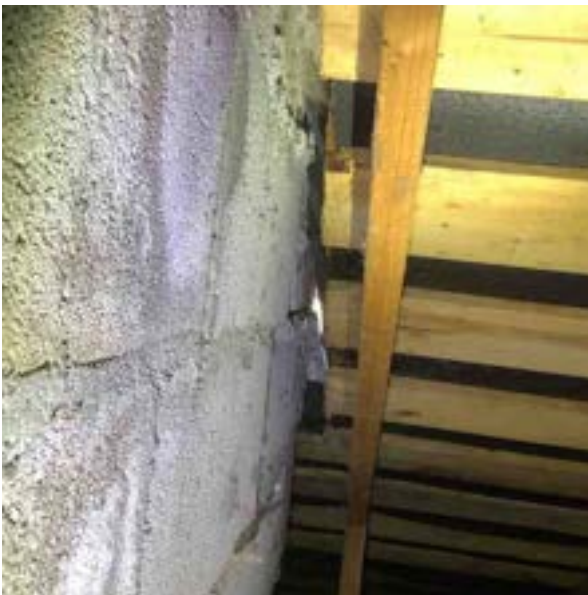
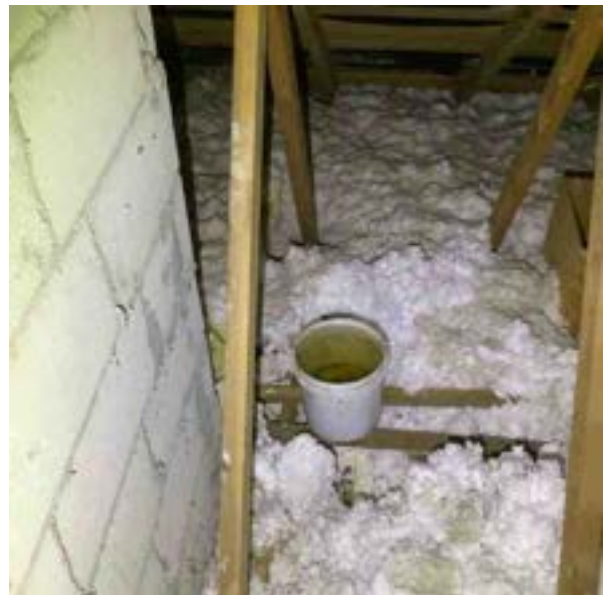
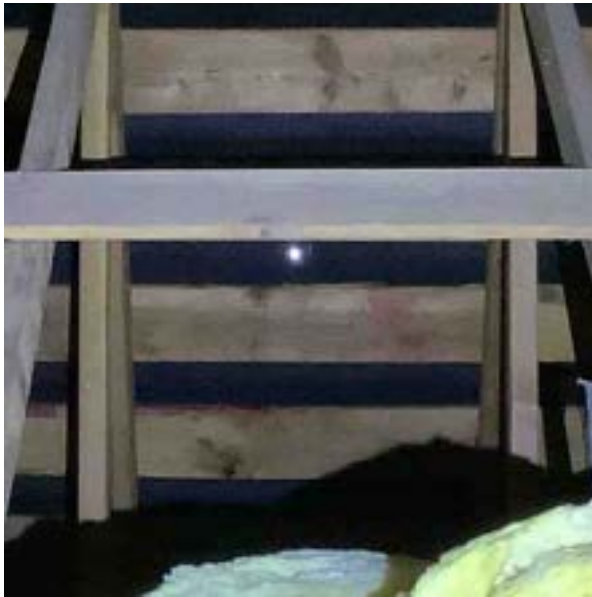
5.6.3 **Light was visible around the chimney, which is not unusual, but there is also light visible in other areas where it shouldn't be visible. A bucket with water in it, evidently from a roof leak was noted. Further evaluation and correction of all issues found advised.**

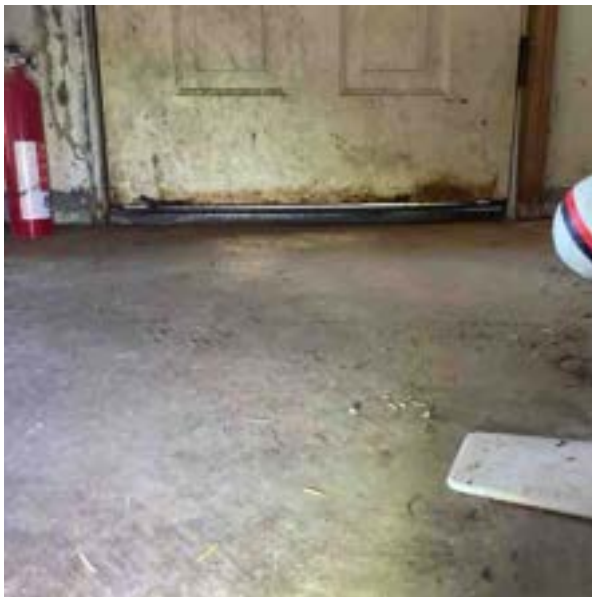
6.3.2 **Weather strip is damaged or missing around door to the outside. Further evaluation and correction of all issues found is advised. (Garage)**

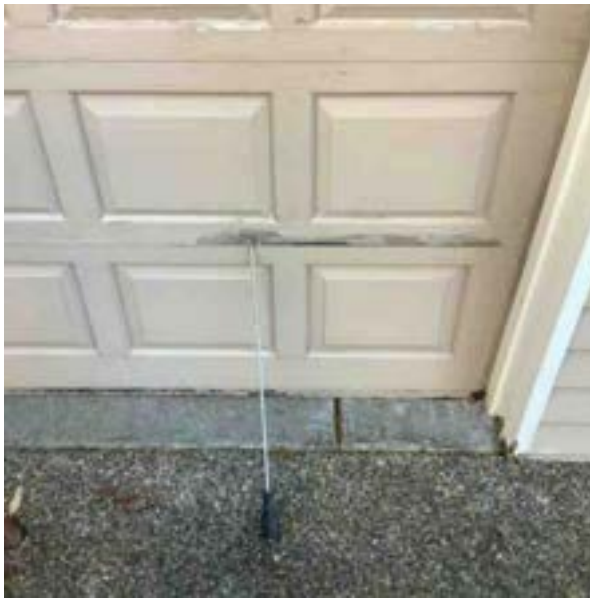
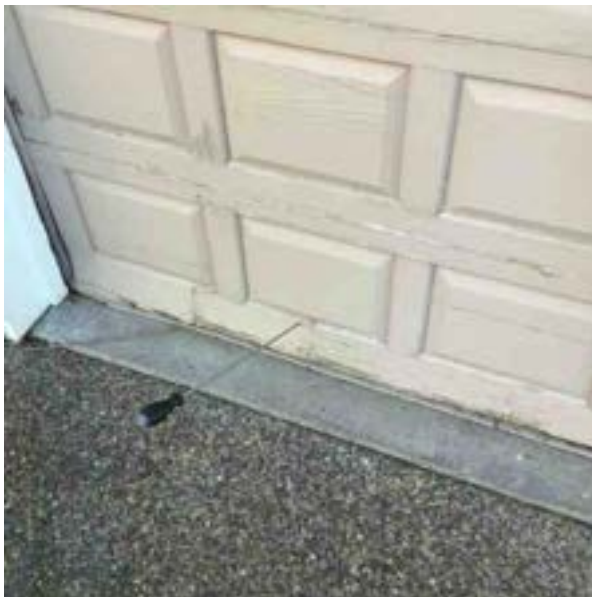
6.4.5 **The garage doors have rot. Further evaluation and correction of all issues found is advised.**

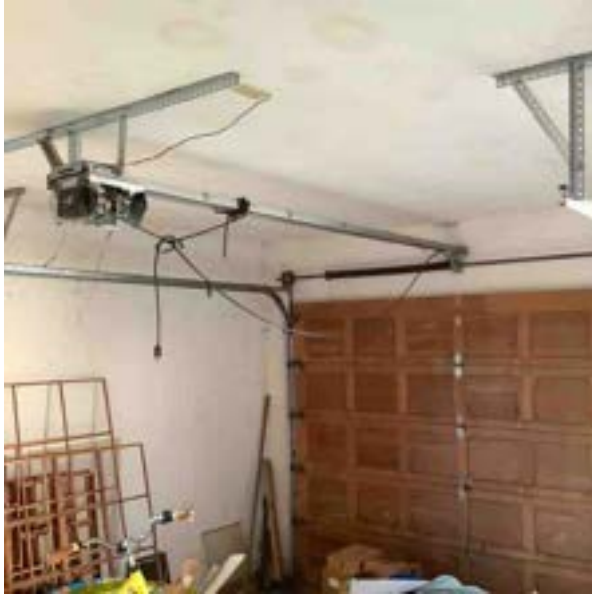
6.5.4 The garage door opener is not plugged in and appears to be damaged. There may be a very good reason this was done so the opener was not tested. Further evaluation and correction of any issues found is advised. (Garage)

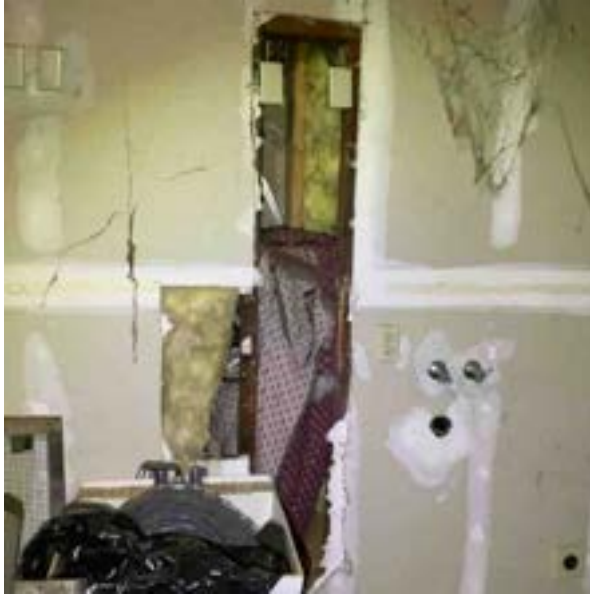
**6.7.5 Holes noted in the firewall between garage and living space. Further evaluation and correction of all issues found is advised to keep the integrity of the firewall intact. (Garage)**

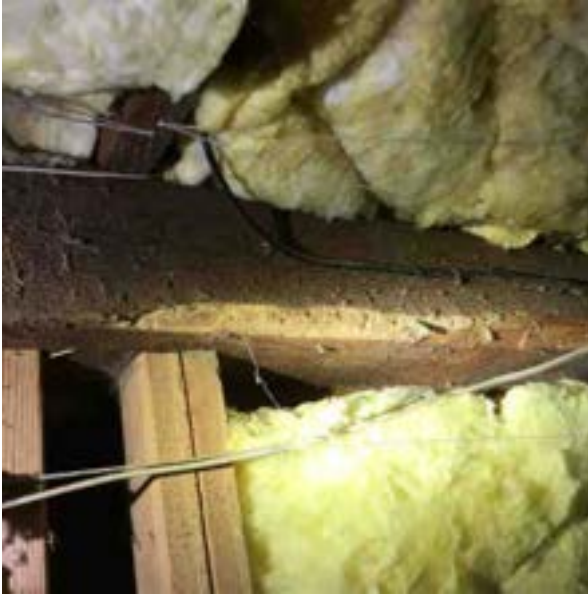
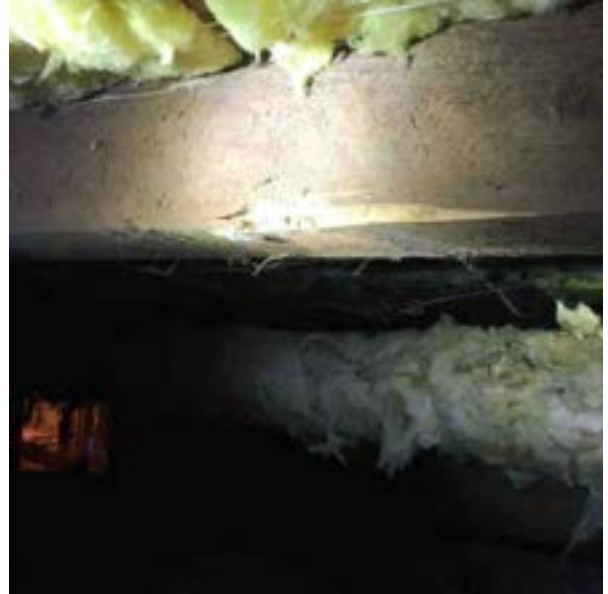
**7.3.2 Evidence of old wood destroying insect activity and surface damage noted along a few beams. Find out from seller if the house has been exterminated/evaluated. If not, further evaluation and correction of all issues found is advised. (Original Crawlspace)**

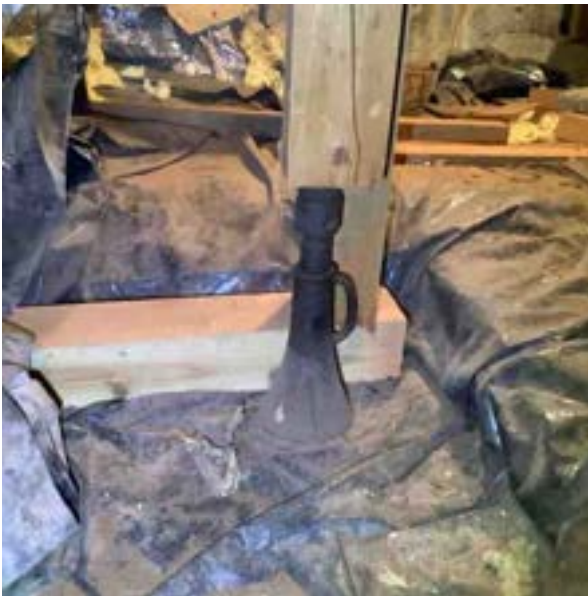
**7.3.3 Extensive sub-structure repairs noted in the crawlspace and possible incorrect pillar supports. Obtain all documentation from the seller regarding all work done in the crawlspace for warranty purposes. If concerned further evaluation and correction is advised. (Original Crawlspace)**

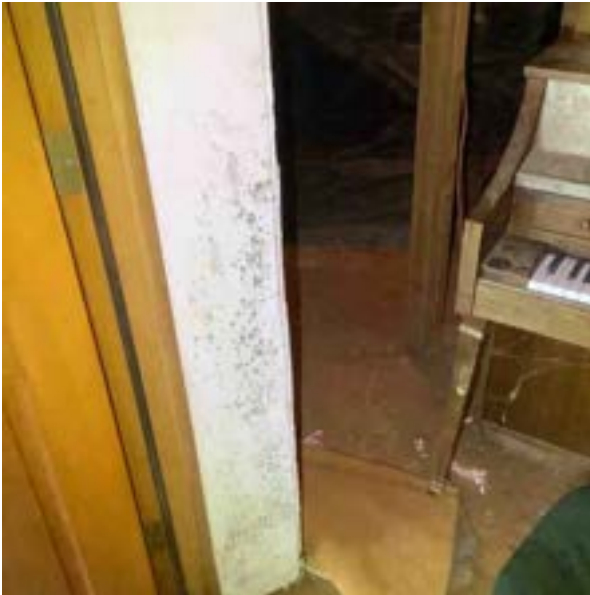
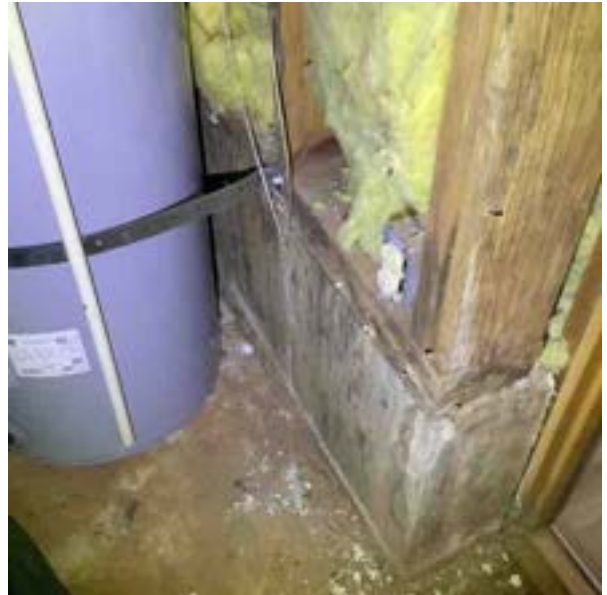
**8.2.2 Fungal growth noted and could possibly be from a previous water heater leak. Furth evaluation and correction is advised. (Crawlspace)**

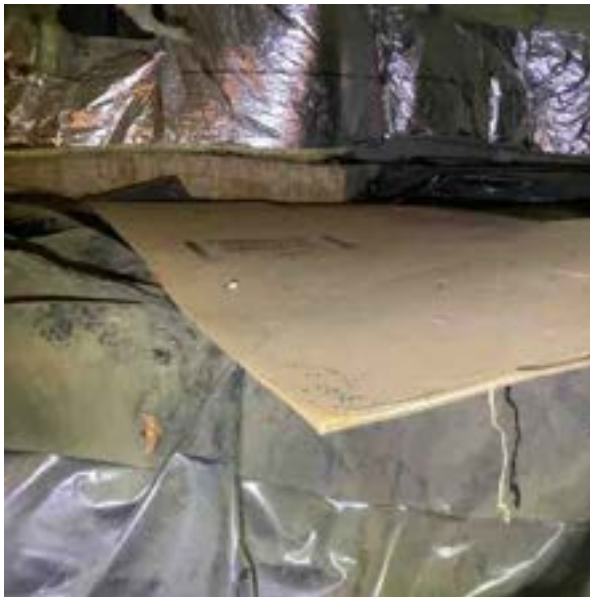
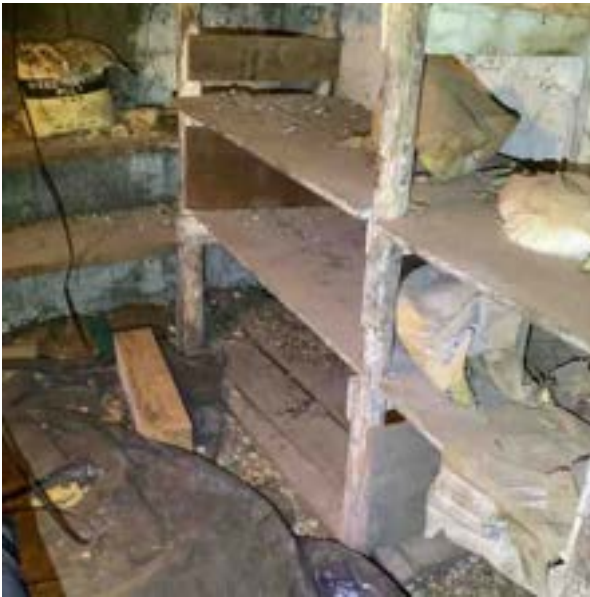
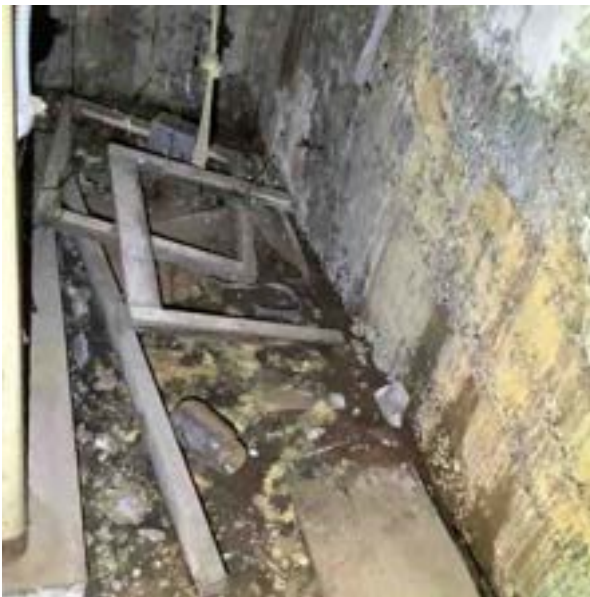
8.3.1 Cellulose debris was noted in the crawlspace. Removal of all cellulose (loose wood, wood or cardboard forms, plants, or any other debris) large enough to be picked up by a standard garden rake is advised to reduce the chance of infestation by wood destroying insects.

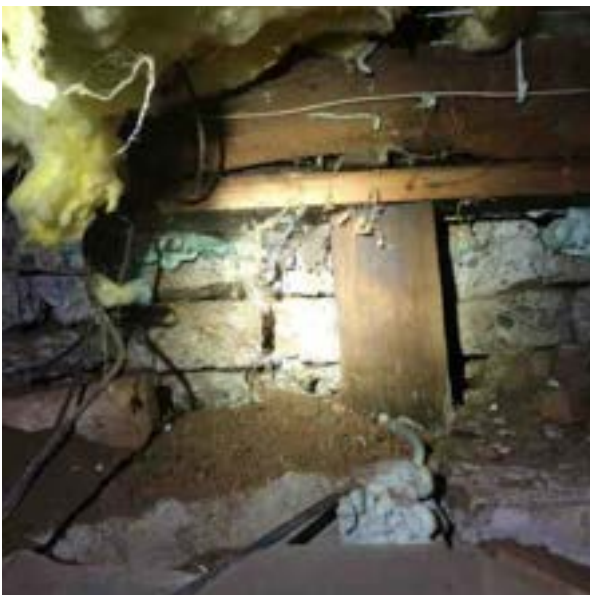
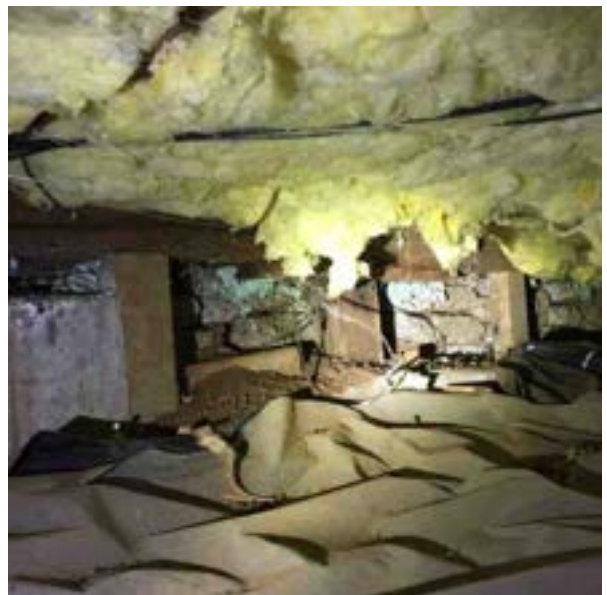
**8.3.2 Earth to wood contact noted at the west crawlspace. Further evaluation and correction of all issues found is advised. (Original Crawlspace)**

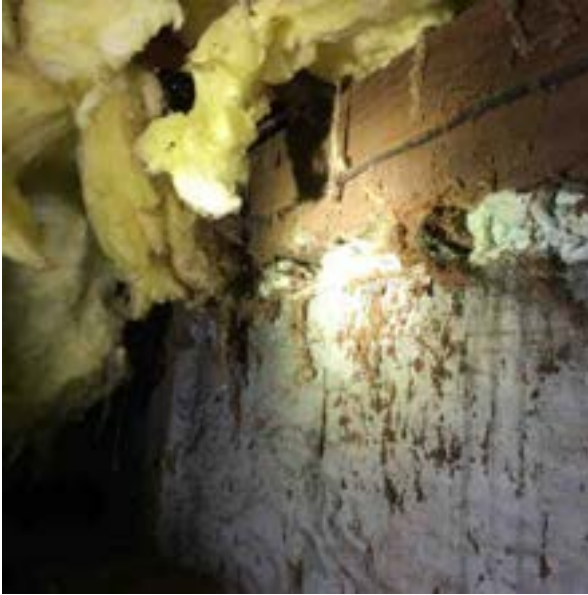
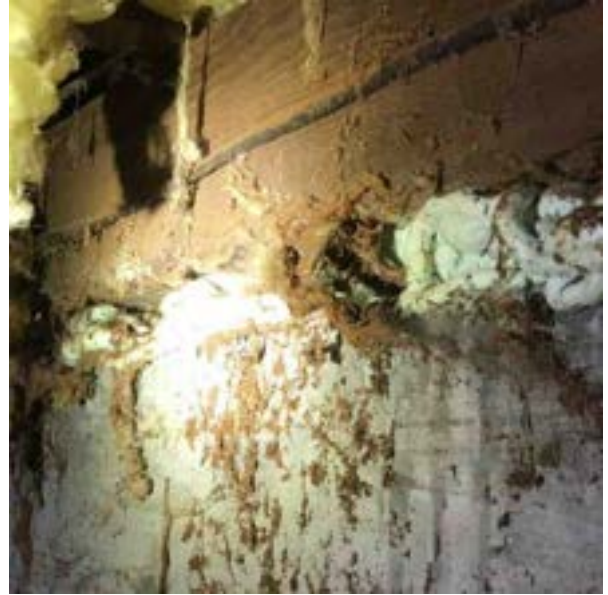
**8.3.3 Possible Frass from wood destroying insects noted. Unable to determine if activity is current or damage has occurred. Further evaluation and correction of all issues found is advised.**

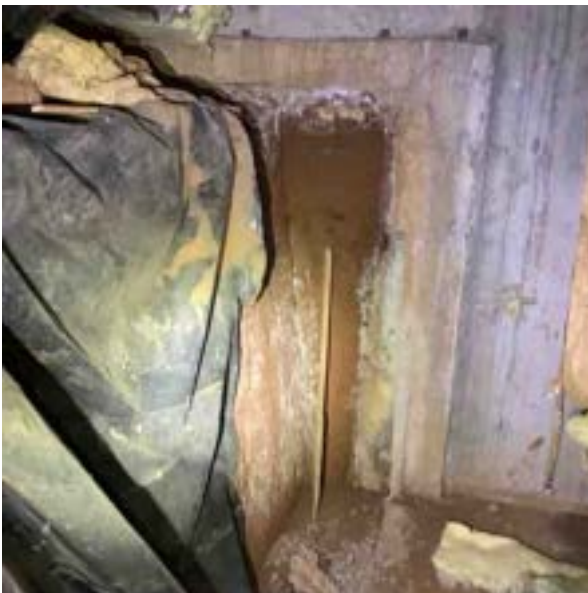
8.7.2 There are some areas of dirt that are uncovered. Recommend correction.

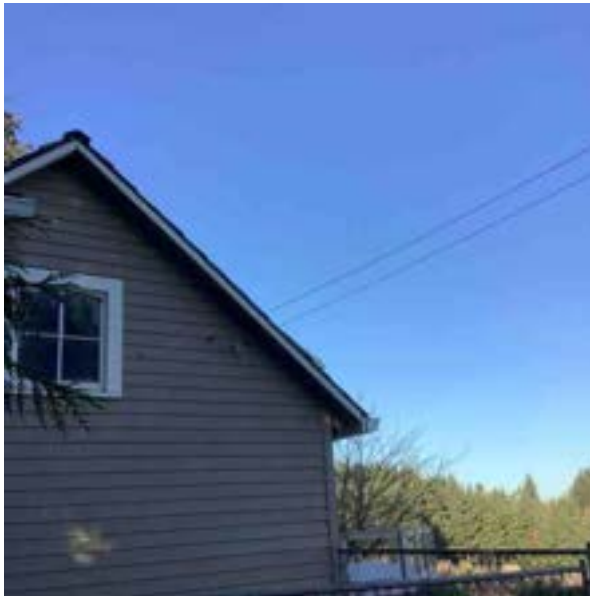
9.2.1 **Low hanging unprotected electrical line to barn noted. Further evaluation and correction of all issues found is advised.**

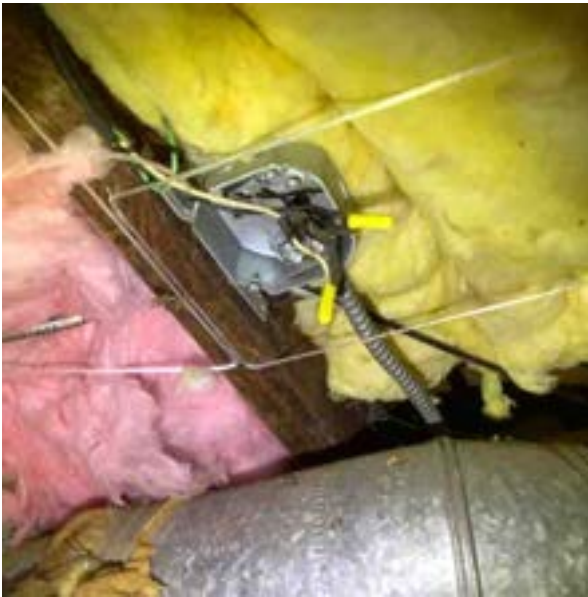
**9.6.2 A missing junction box cover was noted. Correction advised. (Original Crawlspace)**

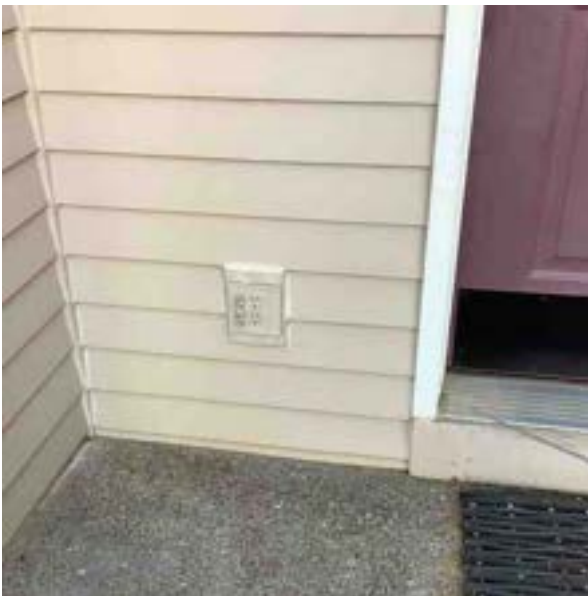
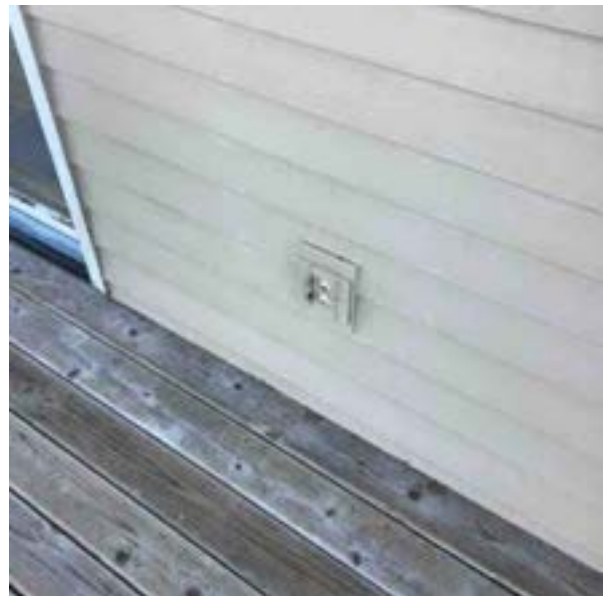
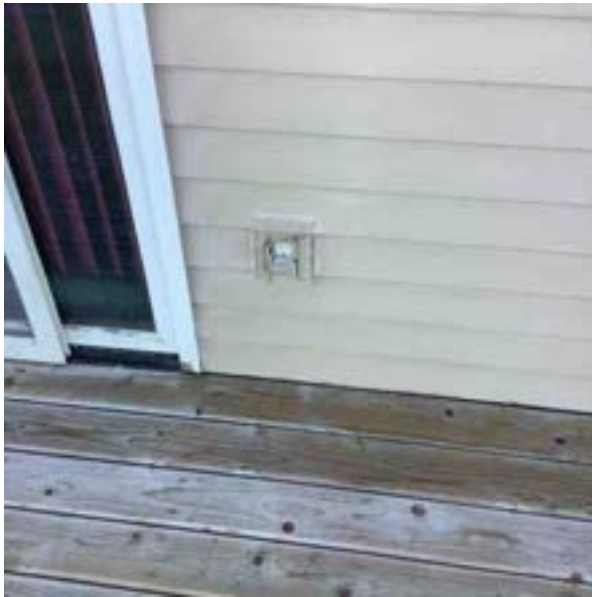
9.7.4 **All outdoor receptacles should have approved covers for safety. Correction advised. (Exterior Front)**

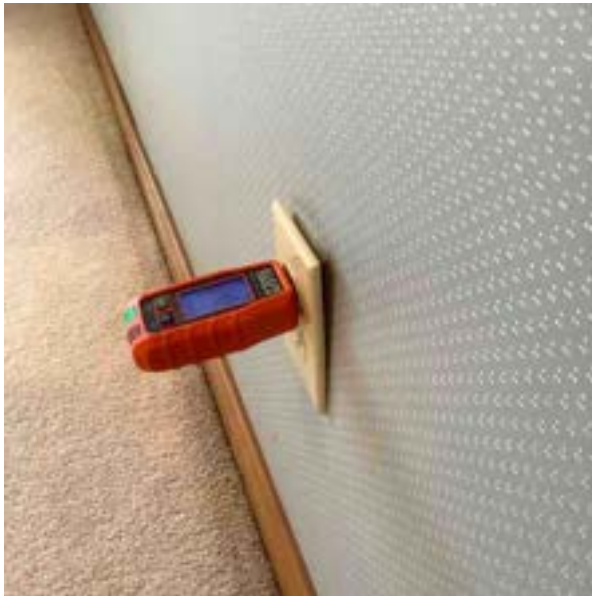
9.7.5 Receptacle is loose. Further evaluation and correction of all issues found is advised. **(Dining room)**

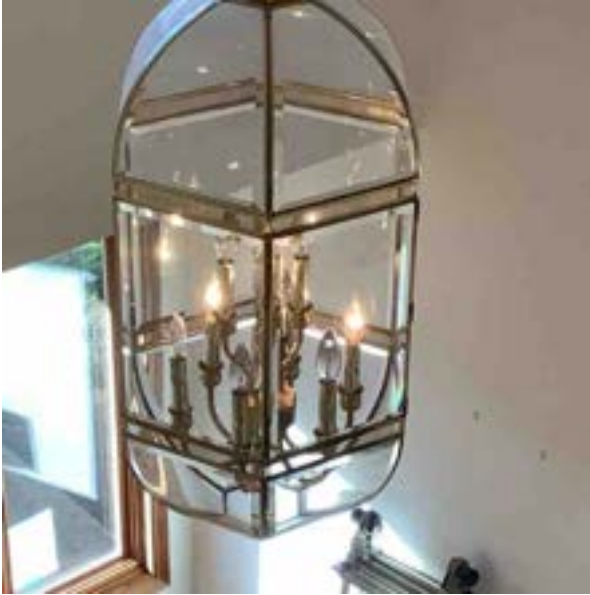
9.8.2 Foyer chandelier, some Lights are not working. Further evaluation and correction of all issues found is advised. **(Entry)**

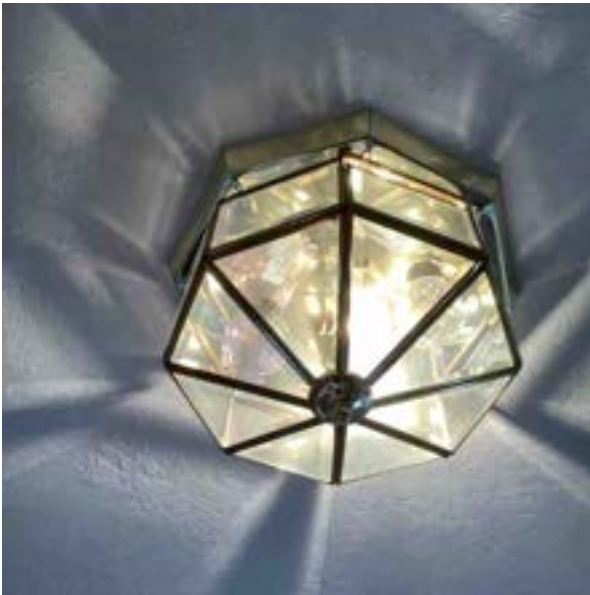
9.8.3 Lights are not working. Further evaluation and correction of all issues found is advised. **(Laundry)**

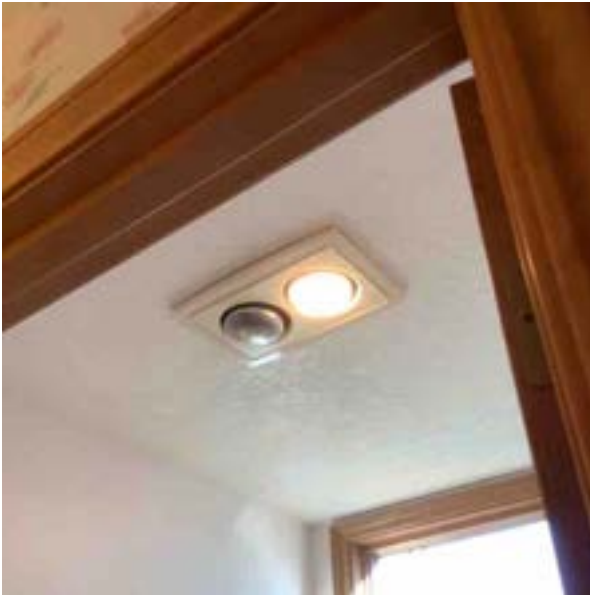
9.8.4 One Light is not working. Further evaluation and correction of all issues found is advised. **(Primary Bathroom)**

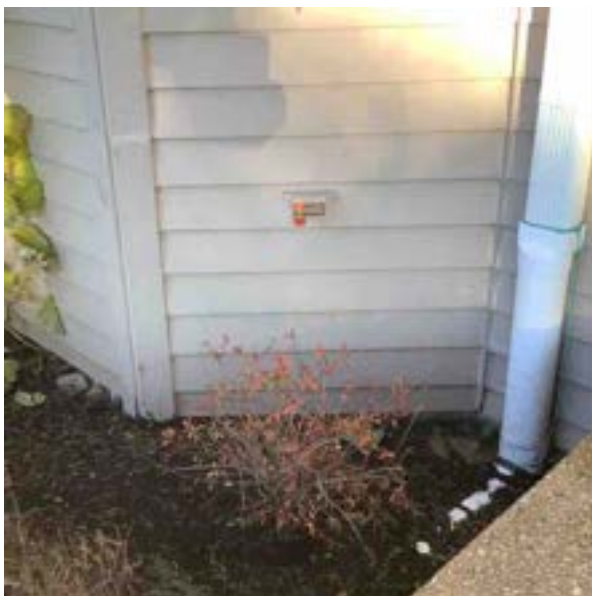
9.10.3 **GFCI receptacle will not trip. Further evaluation and correction of all issues found is advised. (Exterior: Front Porch)**

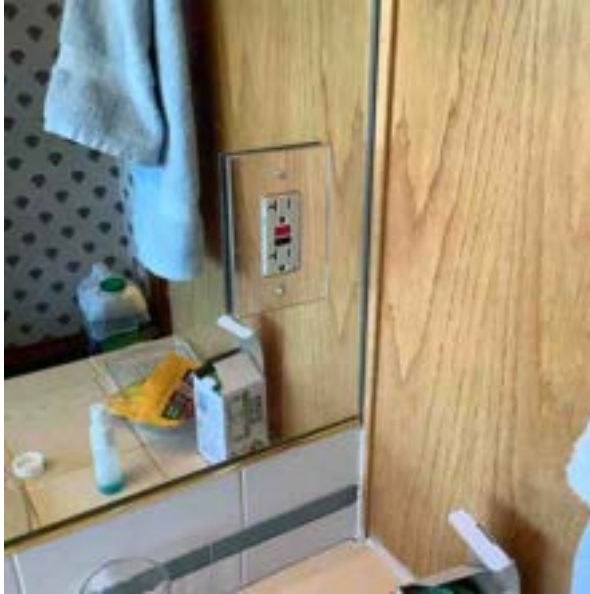
9.10.4 When the GFCI receptacle is tripped it turns off everything else, including the lights, in the bathroom. This can be a safety hazard if it is dark when this happens. Further evaluation and correction is advised. (1st Floor SW Bathroom)

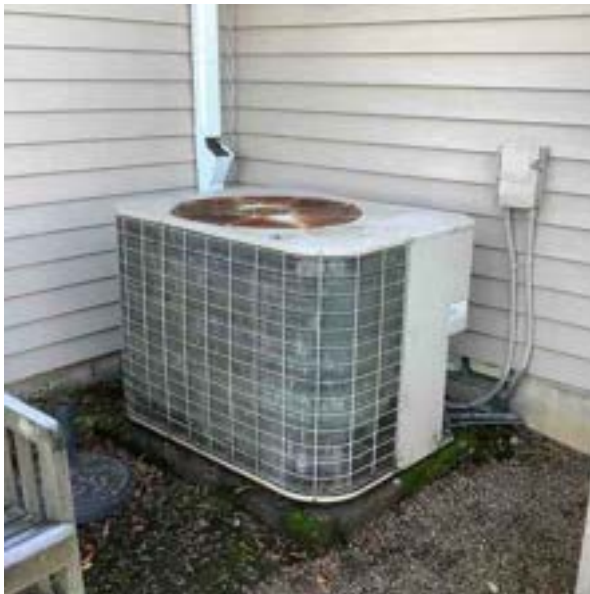
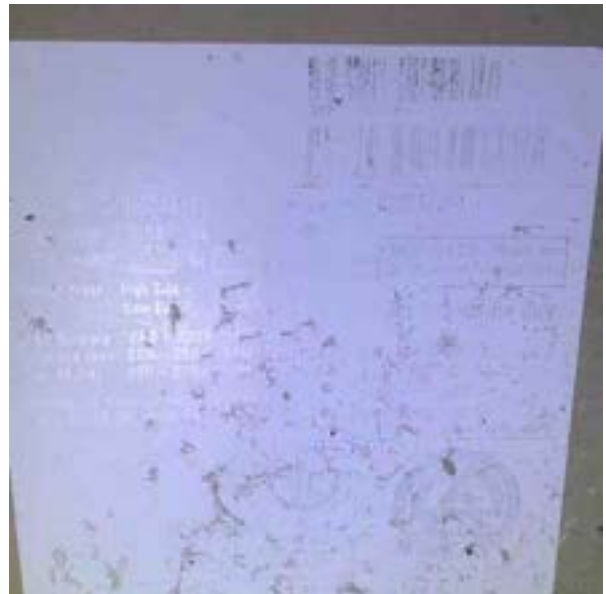
10.5.2 The heat pump is at the end of its typical life expectancy. Budget for replacement.

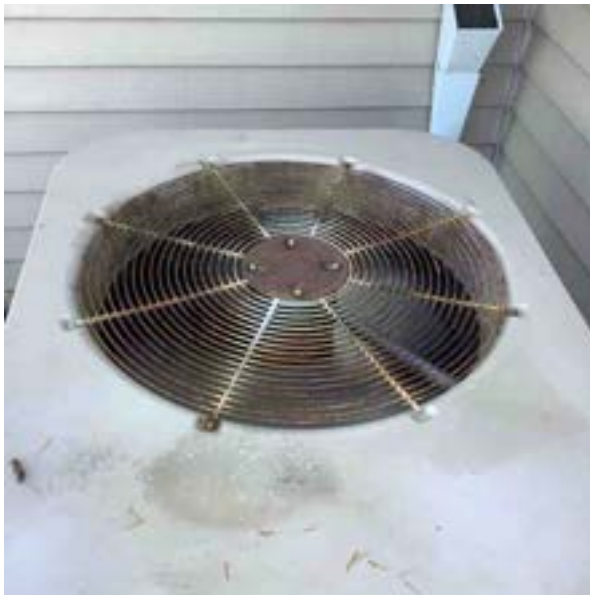
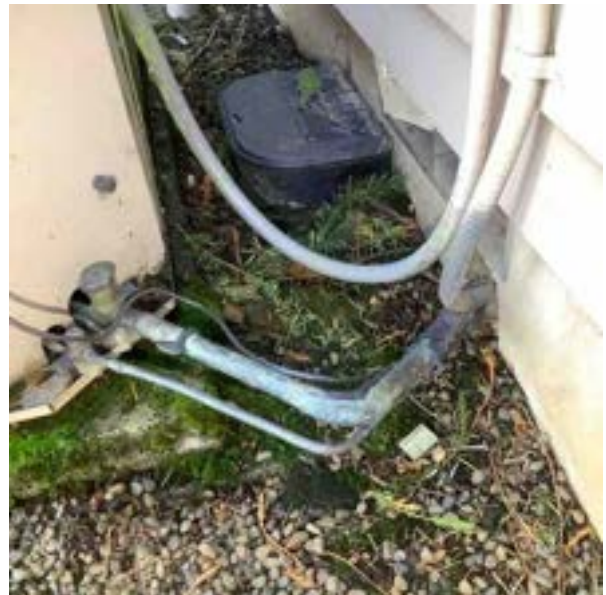
10.5.5 The outside of the heat pump is rusting. Further evaluation and correction of all issues found is advised.

Refrigerant line has damaged insulation, this will lower the efficiency. Further evaluation and correction of all issues found is advised.

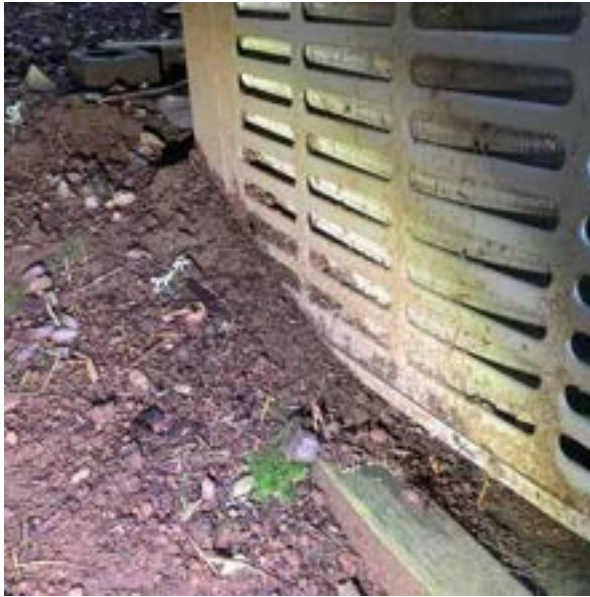
10.5.6 System is dirt and there is earth up against the unit. Further evaluation and correction of all issues found is advised. (Exterior Left)

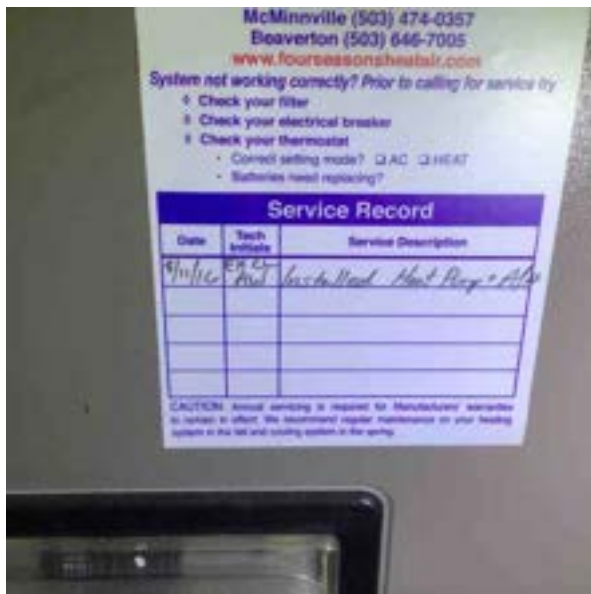
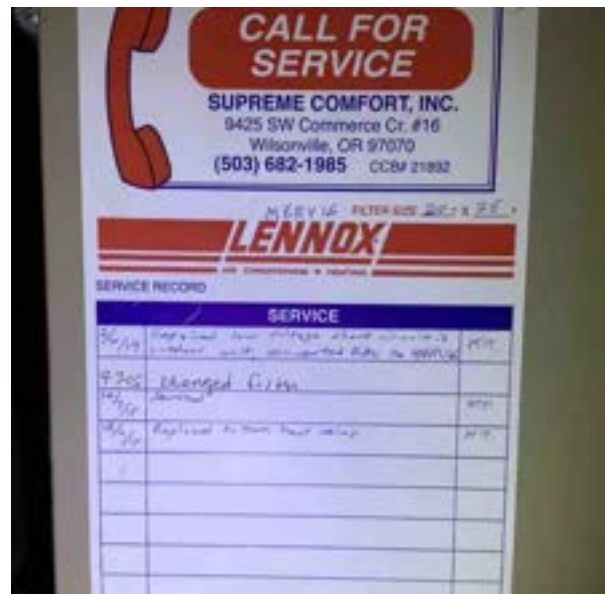
- Attic: Upper
- Crawl space

10.6.2 The HVAC system is in need of a service call; it does not appear this has been done in some time. Have the entire HVAC system inspected, tuned-up, any issues found corrected and the system cleaned by a licensed heating contractor prior to closing to extend the life of the system. Sometimes this has been done recently but the contractor only checked and serviced things ( did not clean them and put a service sticker on it and all I can go off is what I see) so if the above has been done recently, get a copy of the paperwork and talk to the service tech if you have any questions or concerns.

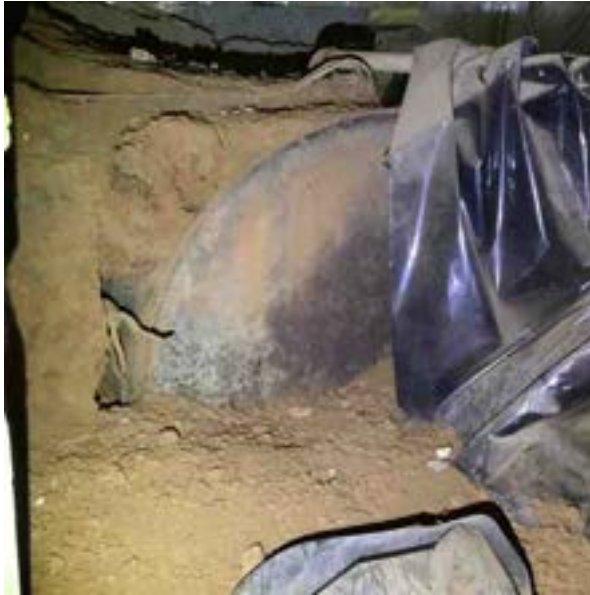
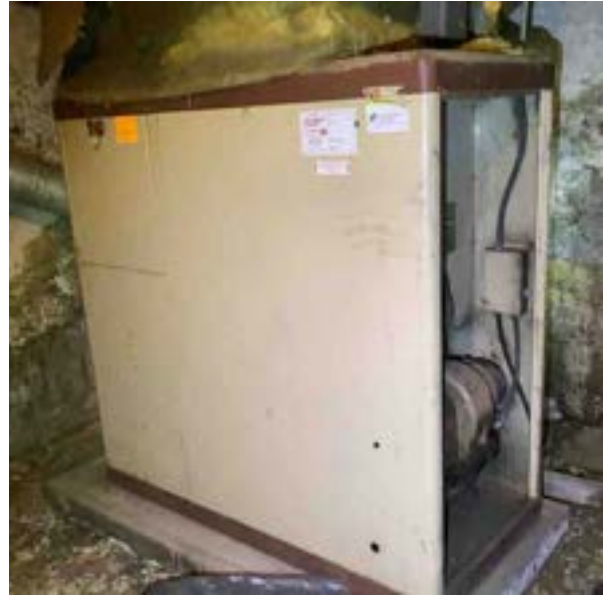
10.10.1 **Original crawlspace:**

**There is an underground oil storage tank for the defunct oil furnace. Further evaluation and correction of all issues found is advised.**

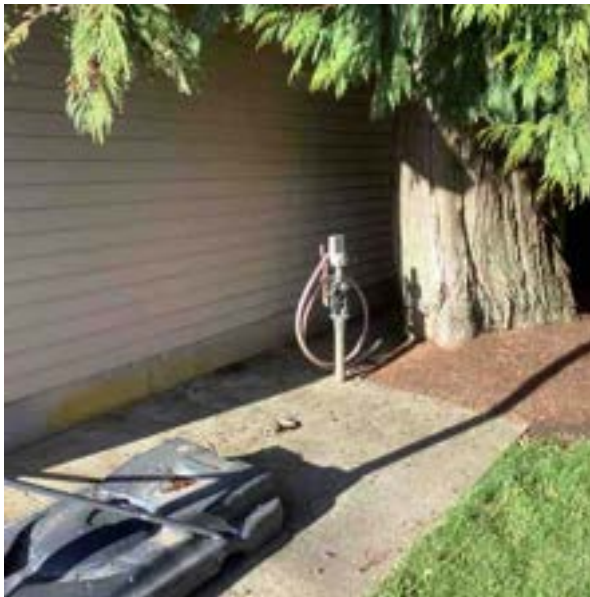
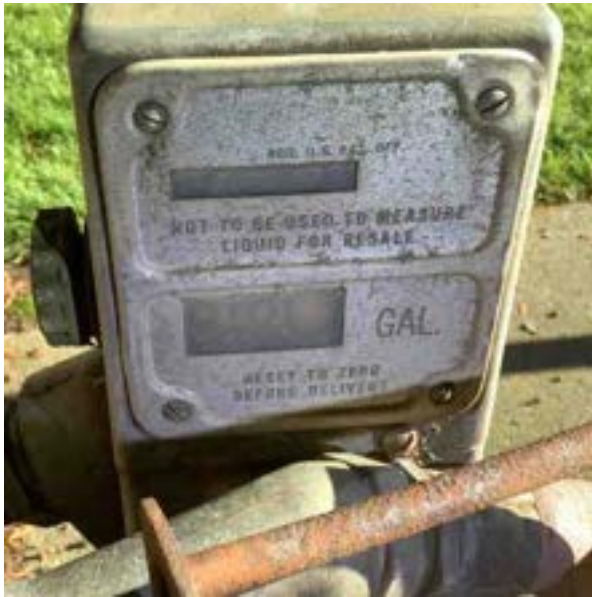
10.10.2 **Behind the garage, there is what appears to be a fuel pump and underground storage tank. Ask the sellers about this. Further evaluation and correction of all issues found advised.**

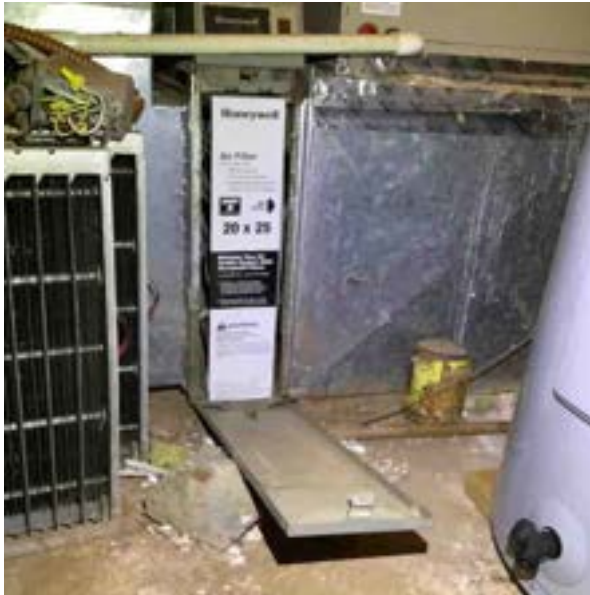
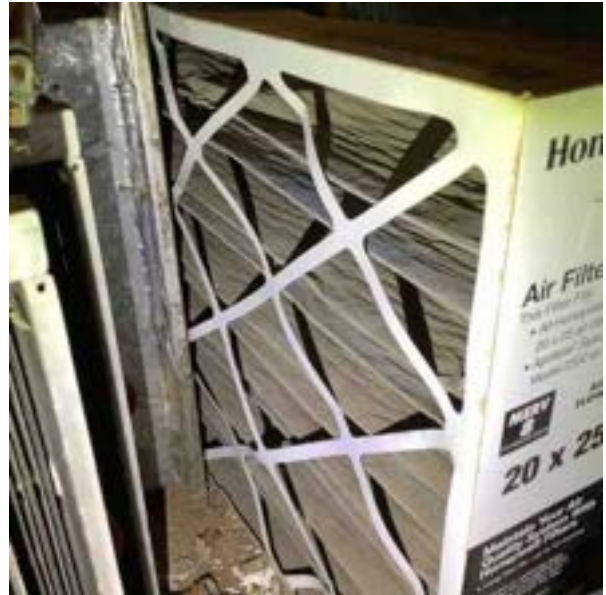
10.11.5 Electronic air filter is not functioning but has a disposable filter inside now. Inspection by a licensed heating contractor recommended if you want this working. **(Crawlspace)**

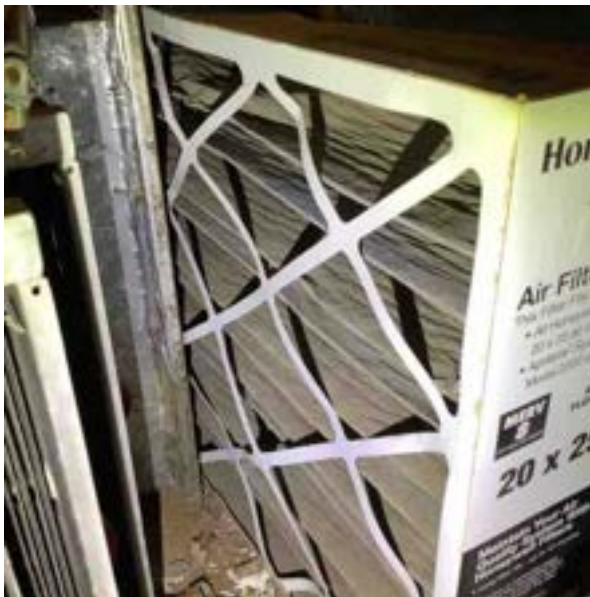
10.11.6 The air filter is dirty. Correction advised. **(Crawlspace)**

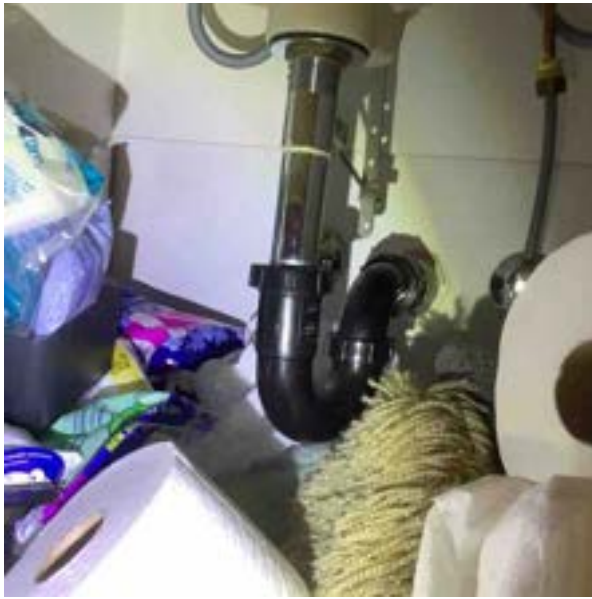
11.7.4 Left hand sink Stopper is not functioning correctly. Correction advised. **(2nd Floor Hall Bathroom)**

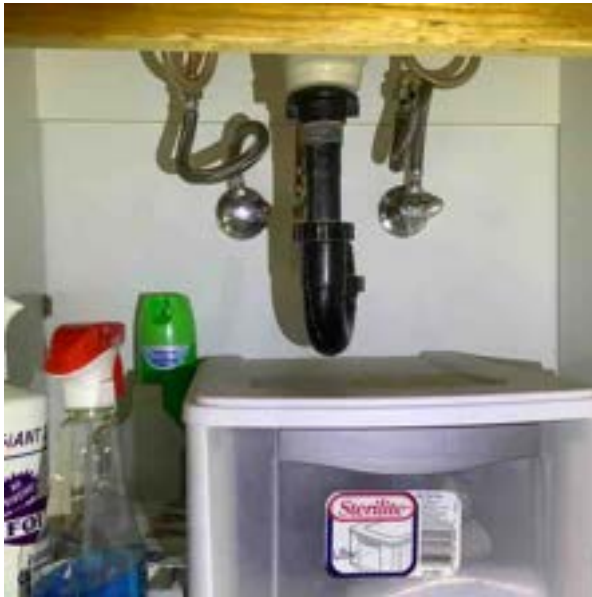
Evidence of previous leaking noted under the sink but no leaking was noted at this time. **(Primary Bathroom)**

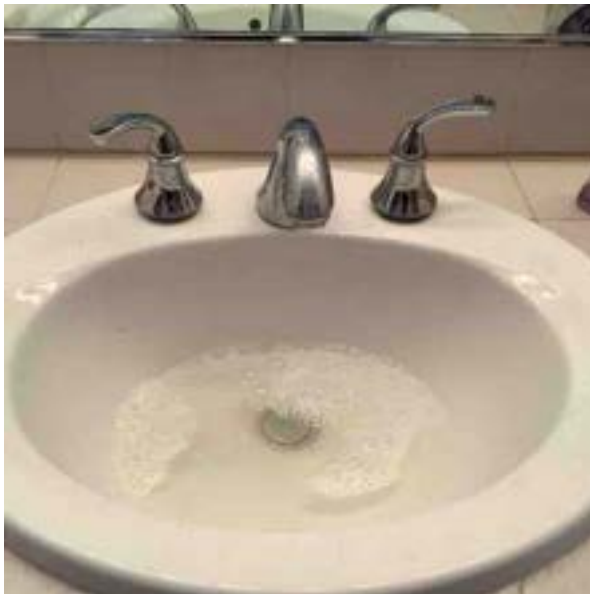
**11.7.8 Sink drains slowly. Further evaluation and correction is advised. (Primary Bathroom)**
