# INSPECTION REPORTS

Job Site Address: 15771 SW OBERST LN

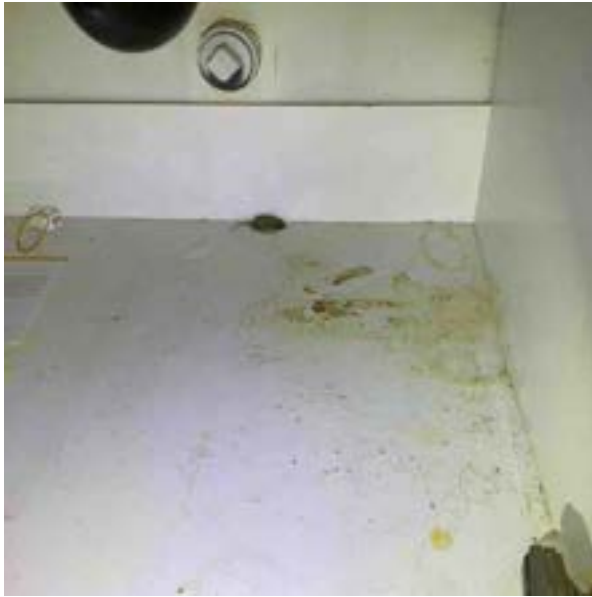
11.7.9 Staining noted under the sink but no active leaks were found at this time. Ask the seller about this and further evaluation and correction of any issues found is advised. **(1st Floor SW Bathroom)**

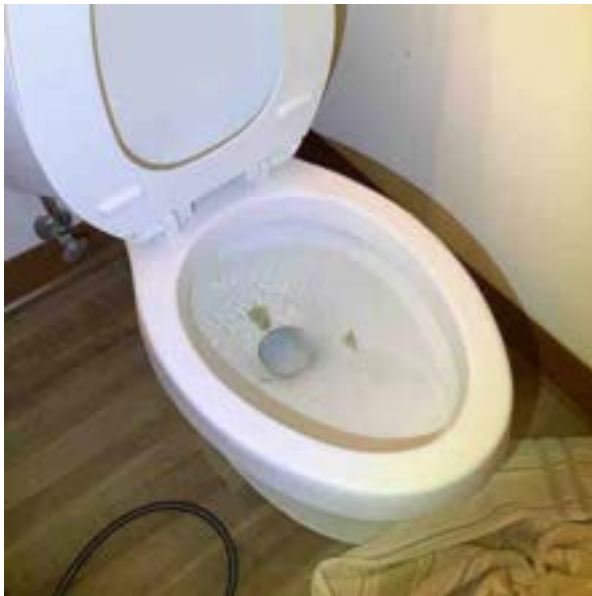
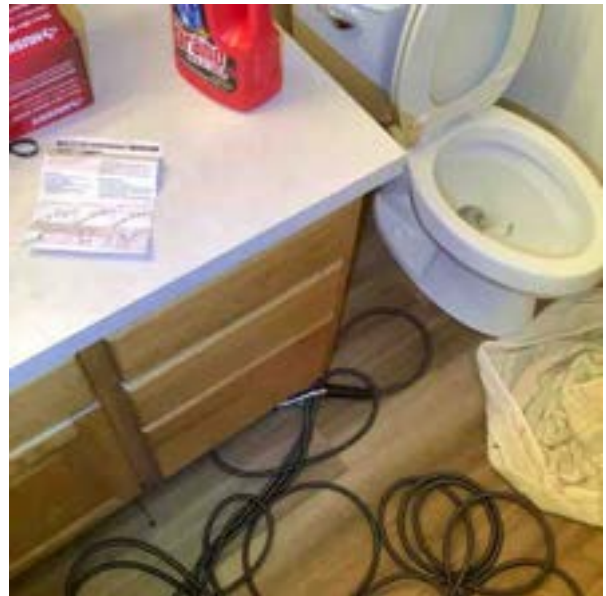
11.8.2 Toilet appears to be clogged. There is Drano and toilet snake near fixture too. Further evaluation and correction of all issues found is advised. (Basement bathroom)

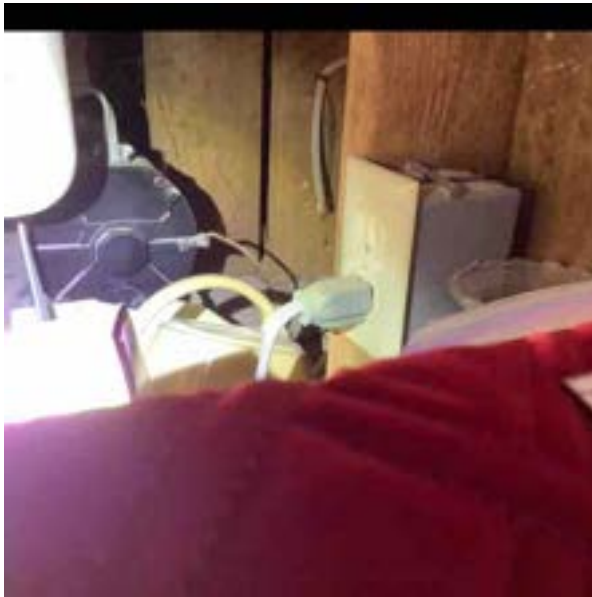
**11.9.2 View under jetted tub. (1st Floor SW Bathroom)**

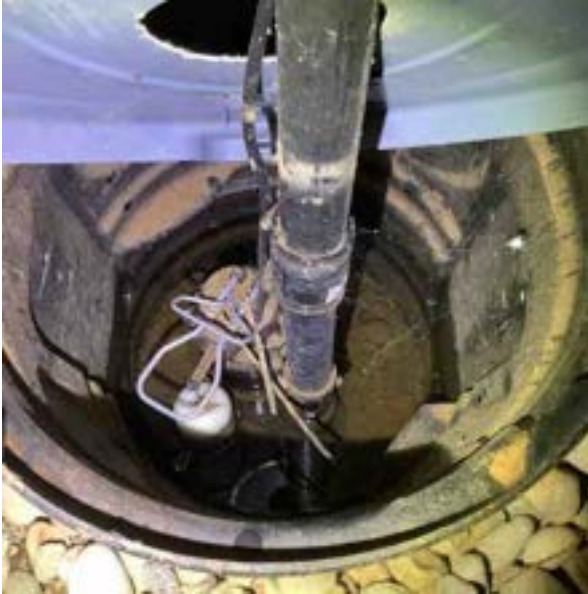
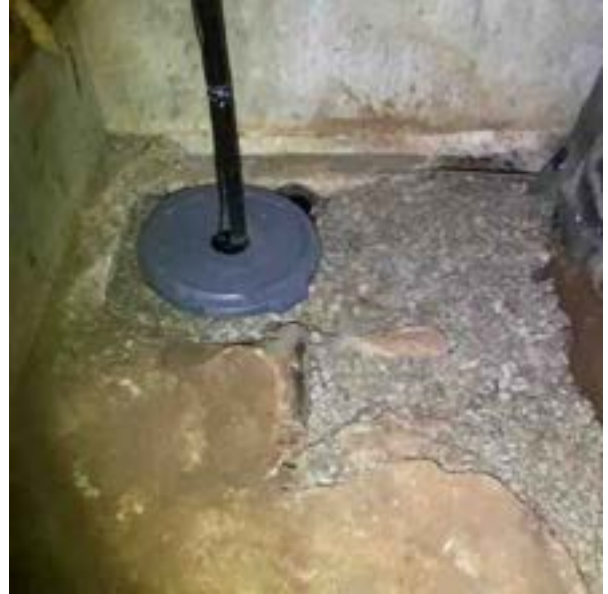
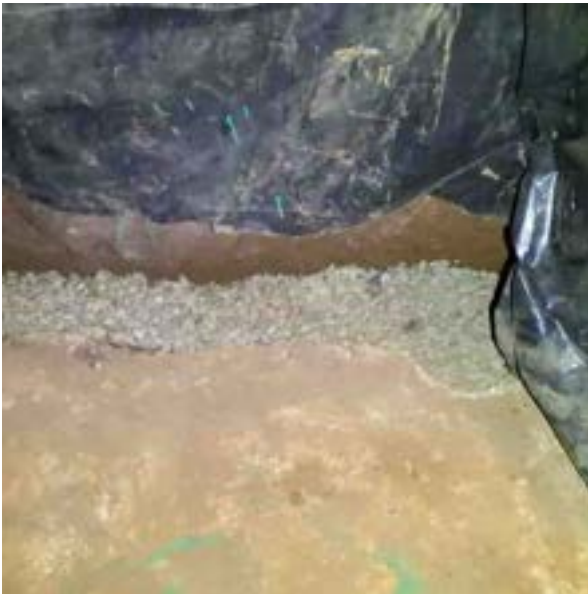
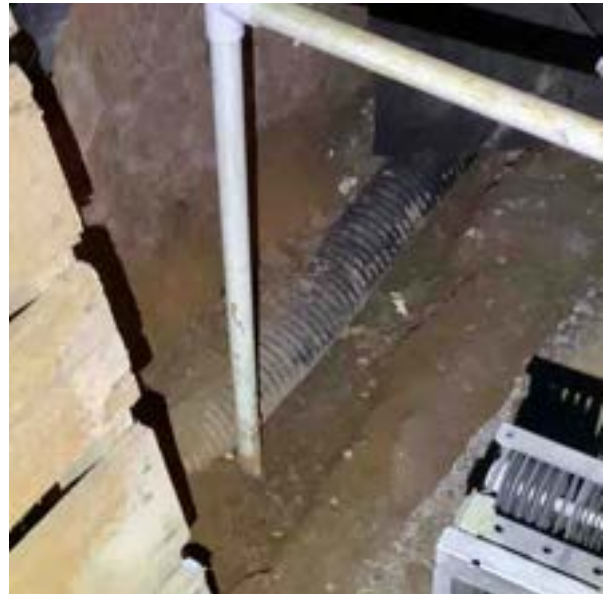
**11.10.2 View of sump pump.**

Drainage work, including the installation of a sump pump, was done under the house. Advise obtaining all documentation from the seller regarding this work. **(Crawlspace)**

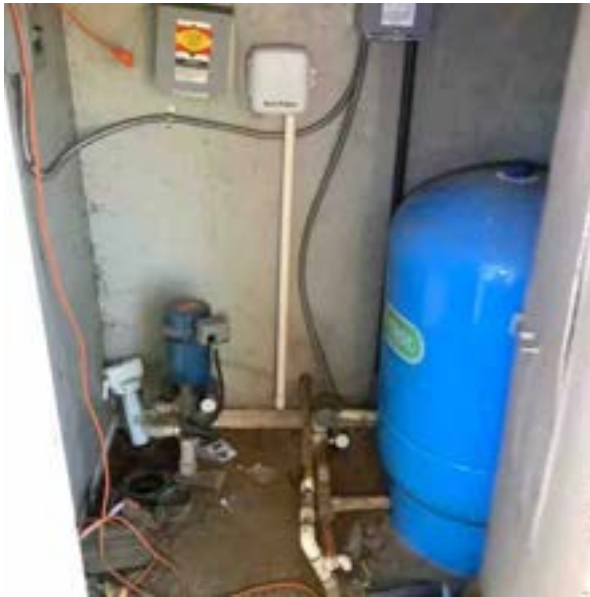
11.11.2 Visible well components. System is not part of a home inspection.

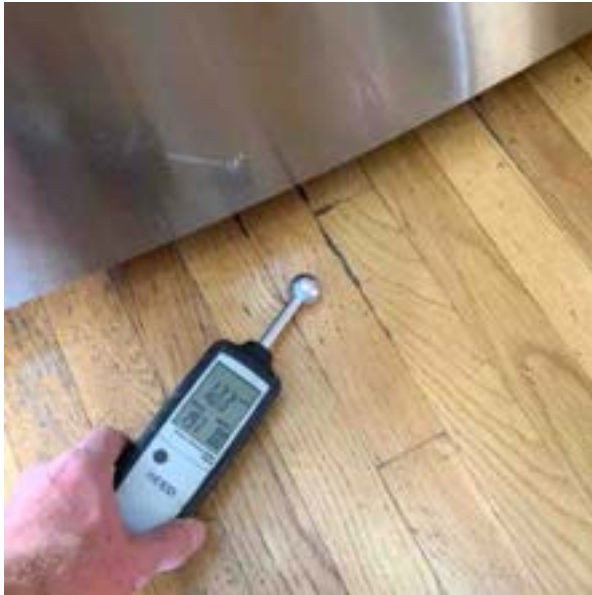
12.3.3 Staining noted. No moisture detected. Ask the seller about this and if still concerned, evaluation and correction of any issues found is advised. **(Kitchen)**

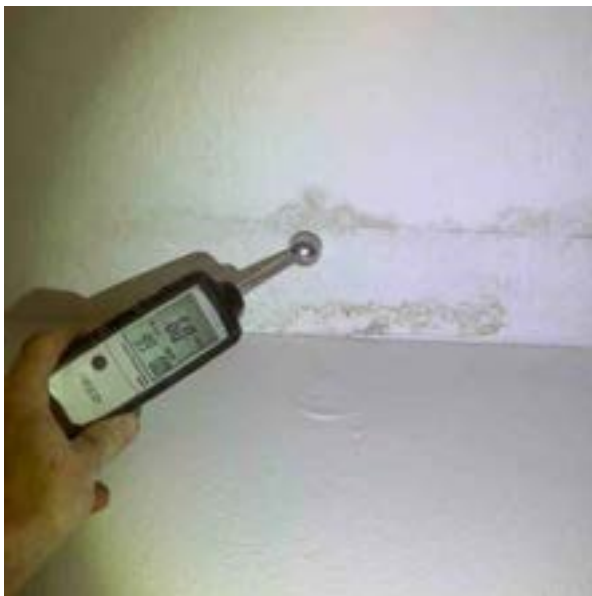
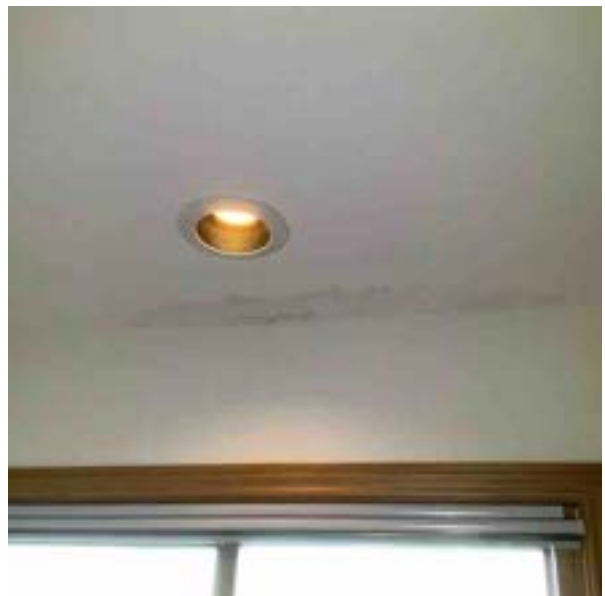
12.4.4 **Stains noted but no moisture or damage detected. Ask the seller about this and if still concerned, evaluation and correction of any issues found is advised. (2nd Floor Hall Bathroom)**

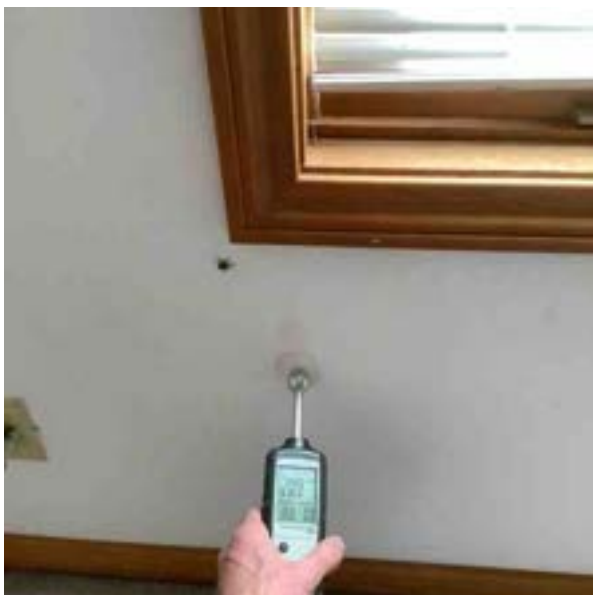
12.4.5 Stains noted but no moisture or damage detected. Ask the seller about this and if still concerned, evaluation and correction of any issues found is advised. **(Primary Bedroom)**

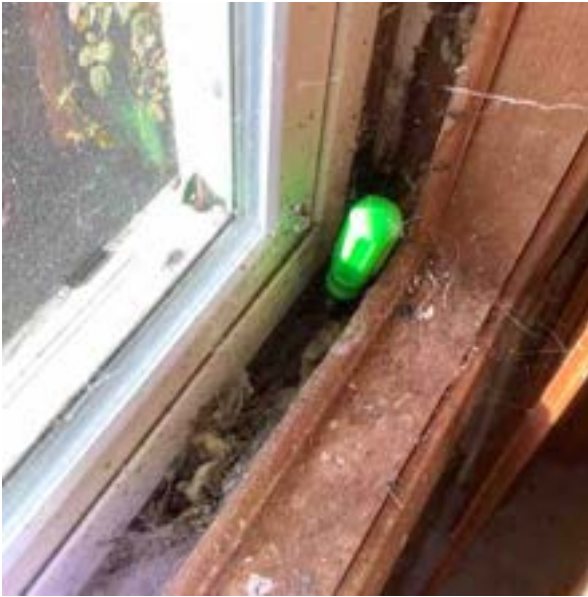
12.5.5 Rot found in sill. Unable to determine extent of damage. Further evaluation and correction of all issues is advised. (Garage)

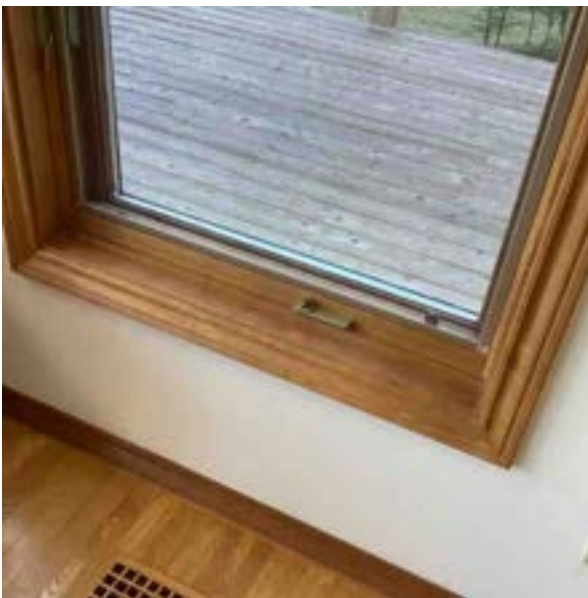
12.5.6 Crank handle(s) missing, unable to test window. Further evaluation and correction of all issues found is advised. (Living Room)

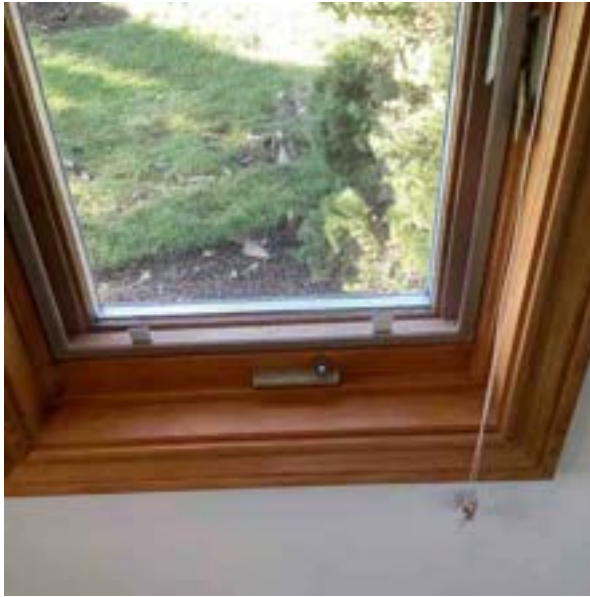
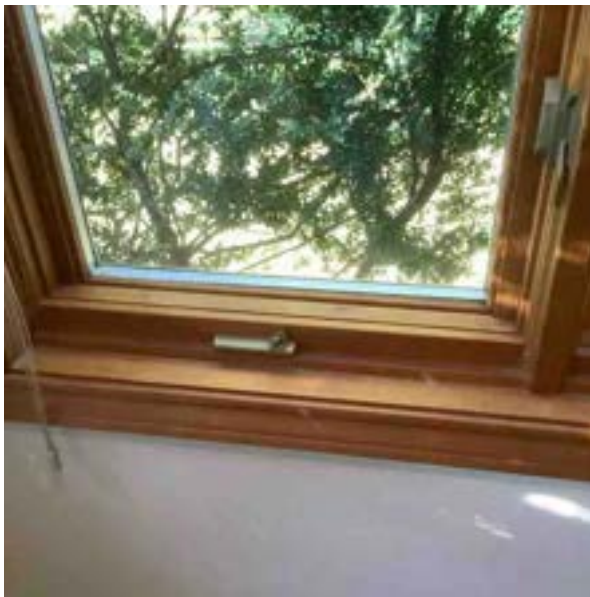
12.5.7 Crank handle(s) missing, unable to test window. Further evaluation and correction of all issues found is advised. **(1st floor SW bedroom)**

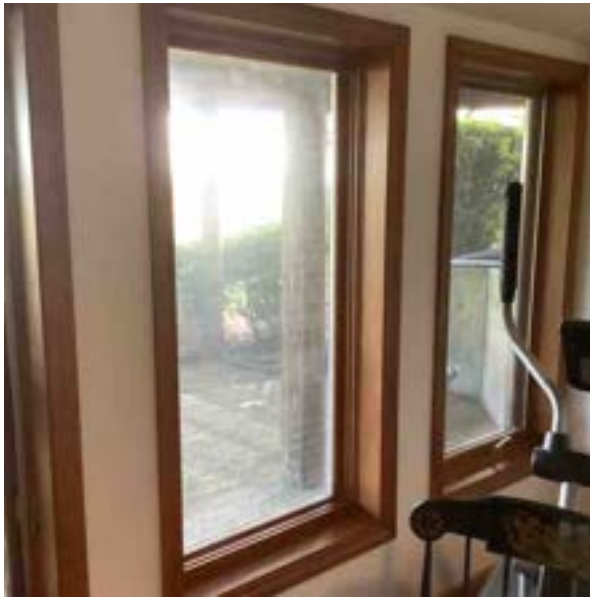
- Basement Family Room
- Entry

12.5.8 **Thermopane seals are broken causing moisture staining/discoloration between the panes of glass. Replacement/repair may be desirable but this is a cosmetic issue and will not cause damage.**

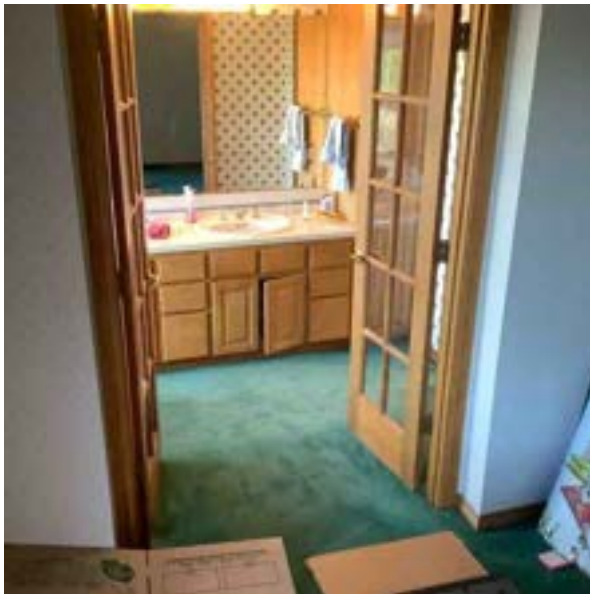
12.6.3 **Doors rub on carpet so they are unable to function properly. Further evaluation and correction is advised. (1st Floor SW Bathroom)**

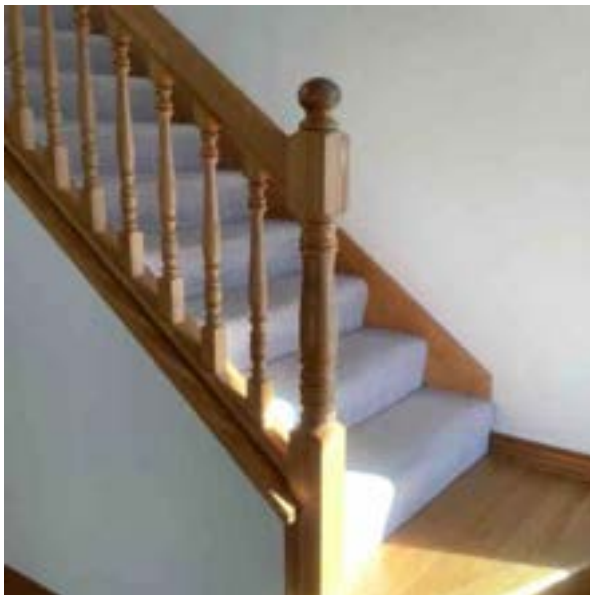
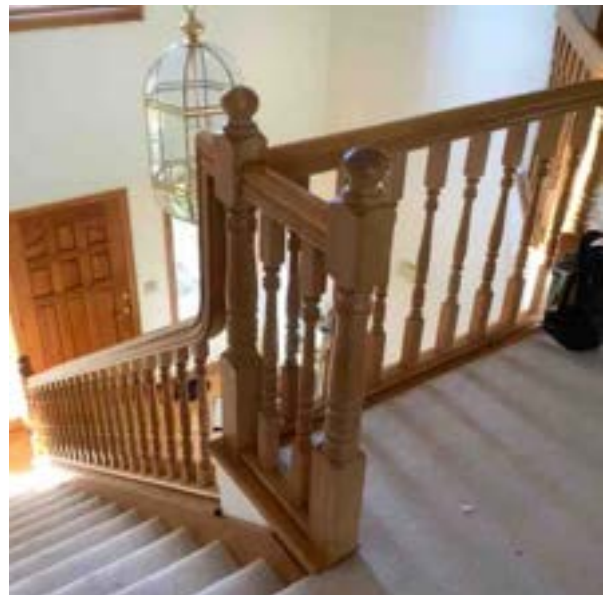
12.8.4 **Handrail is loose. Further evaluation and correction of all issues found is advised.**

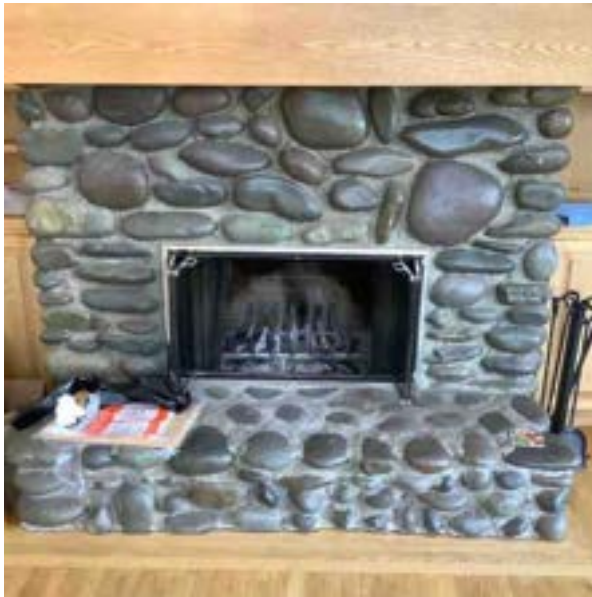
**13.2.2 View of fireplace. (Living Room)**

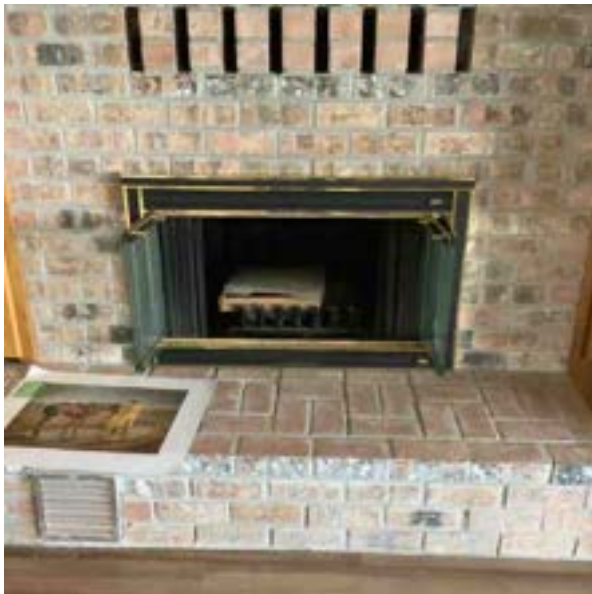
**13.2.3 View of fireplace. (Basement Family Room)**

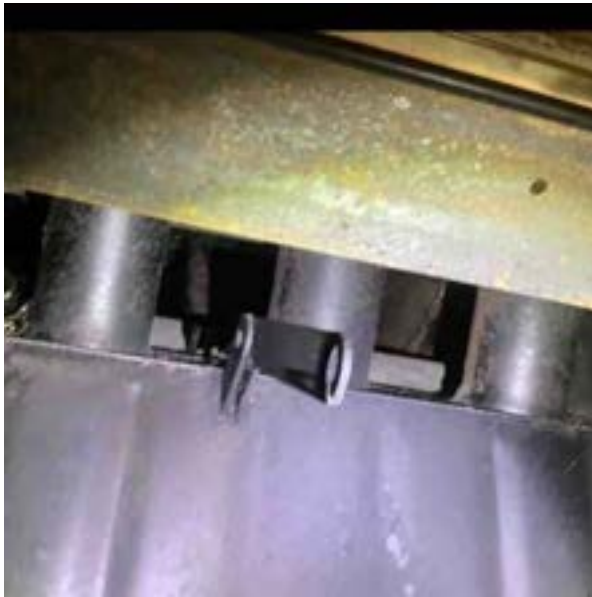
**13.3.2 Damper will not move. Further evaluation and correction is advised. (Basement Family Room)**

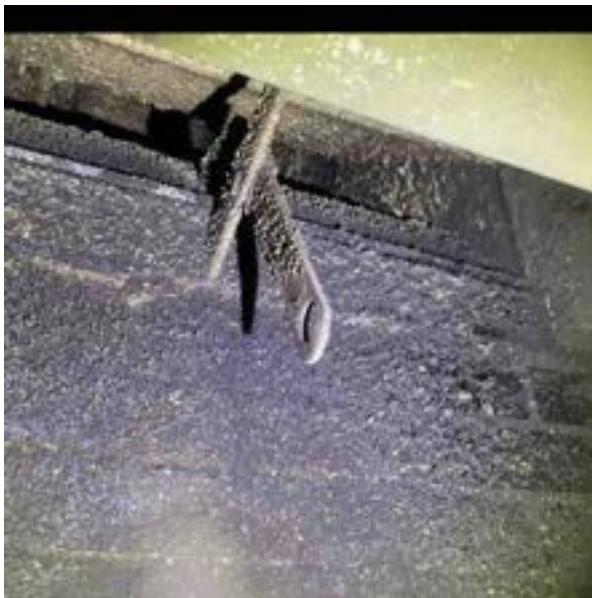
**13.4.1 Creosote/soot buildup noted in the firebox and flue. Further evaluation and correction of all issues found is advised. (Living Room)**

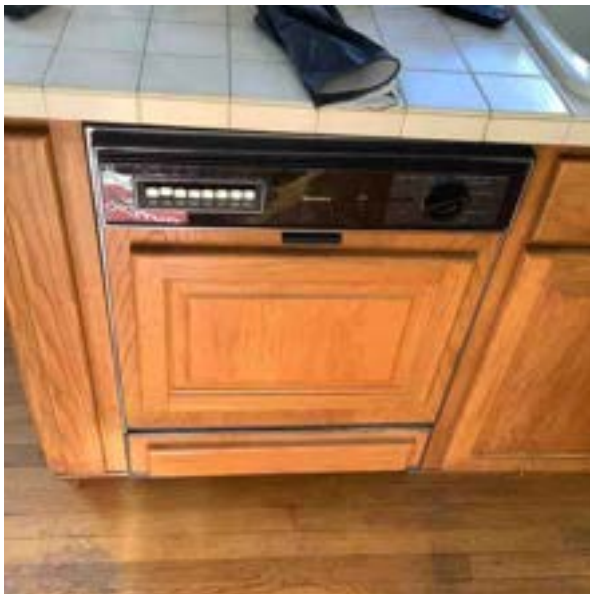
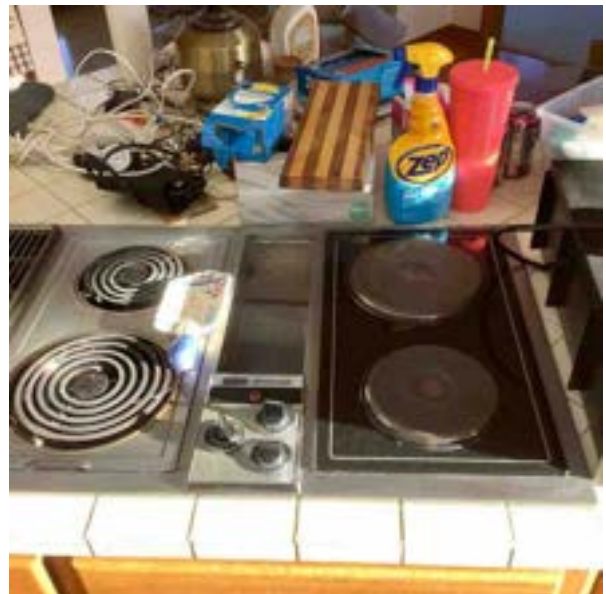
14.2.2 Some Appliances are older and at the end of their lifespan. Budgeting for replacement is advised.

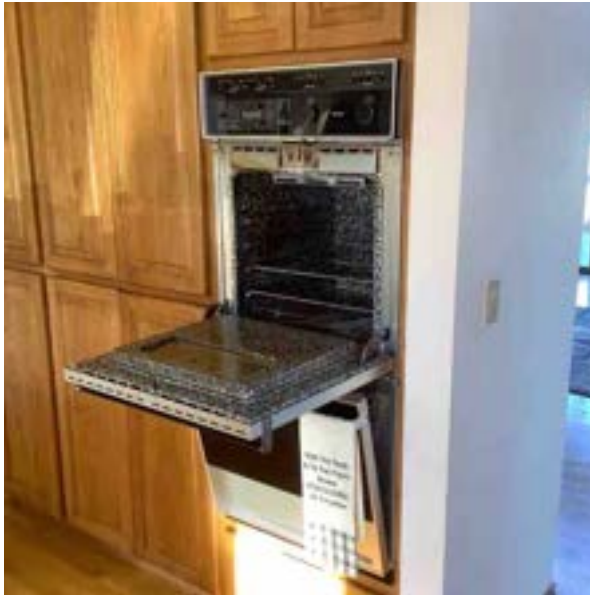
14.4.2 **Oven door falls open. Correction advised.**

**Oven light is not working. Correction is advised.**

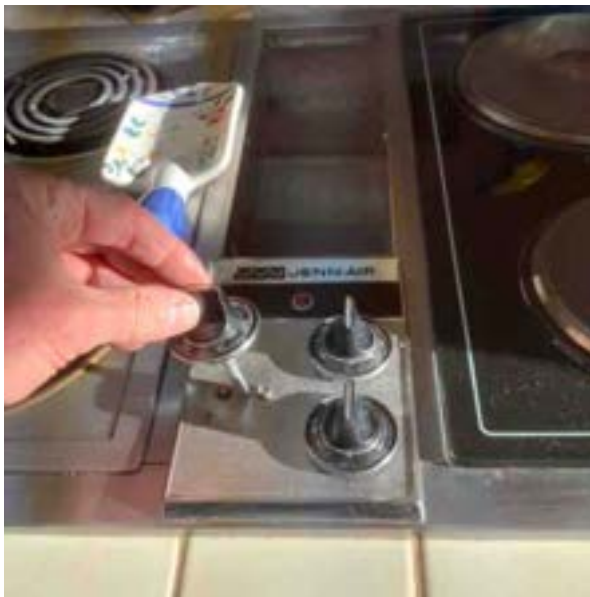
14.4.3 **Knob is damaged, unable to test the feature it controls. Further evaluation and correction of all issues found is advised.**

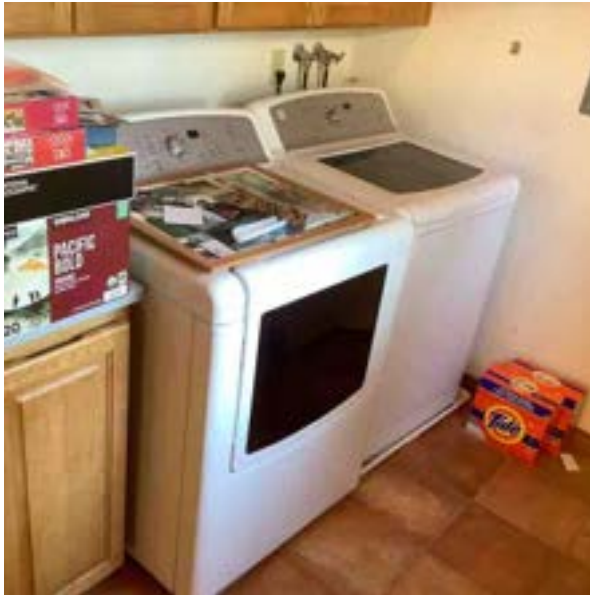
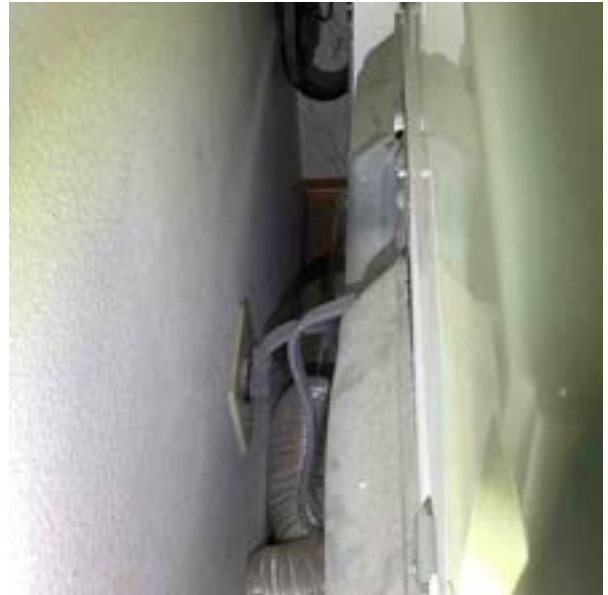
14.9.1 View of laundry appliances.

View behind laundry appliances. **(Laundry)**

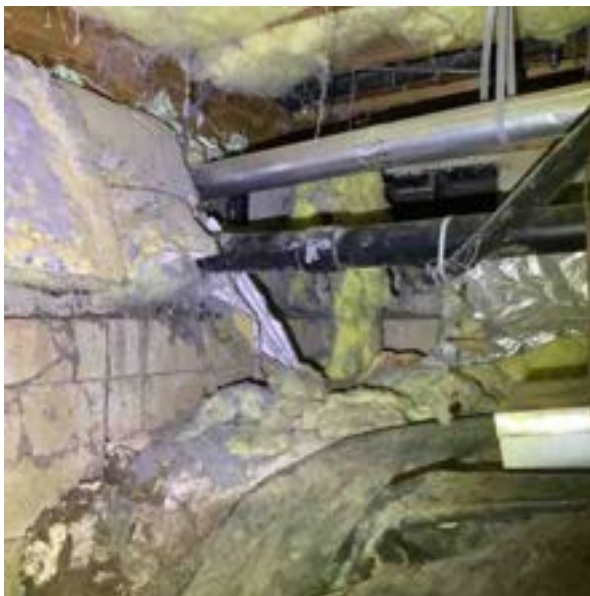
14.10.2 **The dryer vent cover has quite a bit of lint caught in it and is blowing into the crawlspace. Further evaluation and correction of all issues found is advised. (Crawlspace)**
