8527 STAYTON RD

TURNER, OR

Home

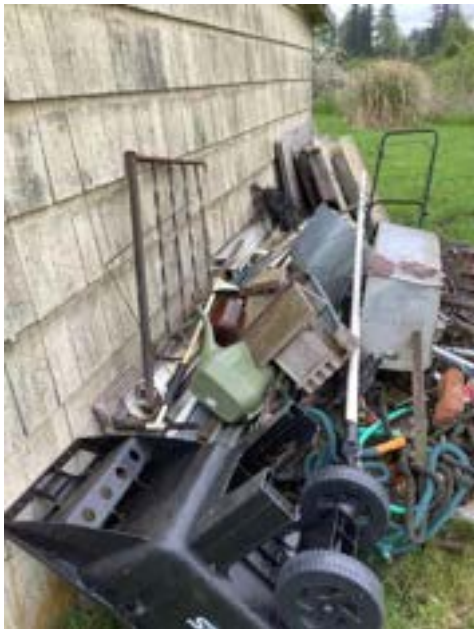
At the time of the inspection, the residence was occupied and as such various obstructions were present limiting the inspectors ability to fully assess the exterior of the home, the interior ceiling surfaces, walls, floors, electrical outlets and switches, the associated components, and portions of the systems that are present.

Limitations/Obstructions - Exterior
(Representative Picture)

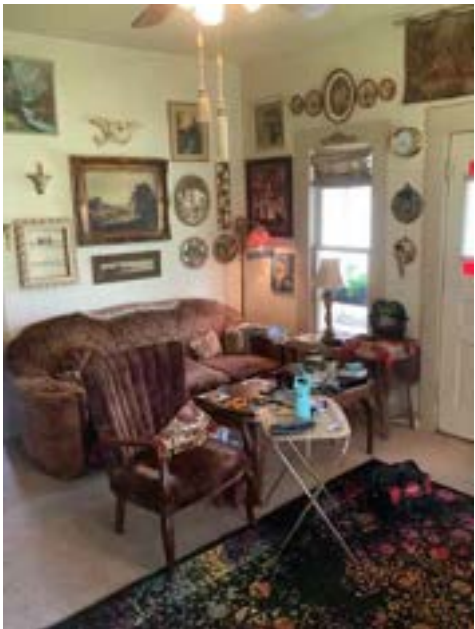
Limitations/Obstructions - Interior
(Representative Picture)

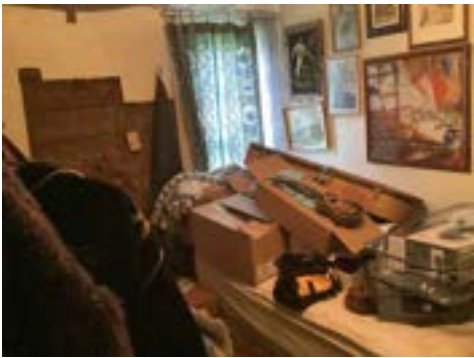
Limitations/Obstructions - Interior
(Representative Picture)

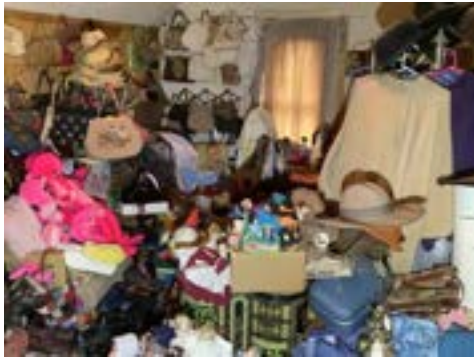
Limitations/Obstructions - Interior
(Representative Picture)

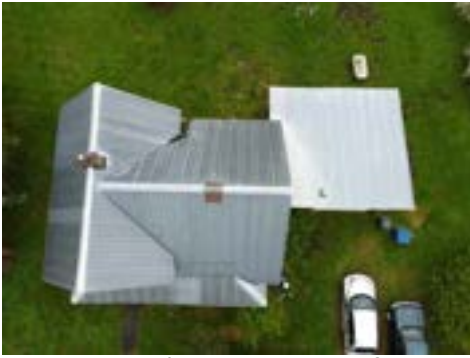
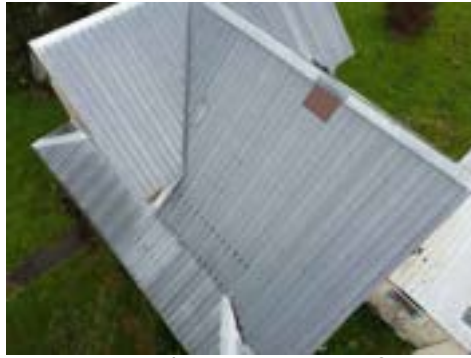
General
UNABLE TO FULLY INSPECT/ASSESS
ROOF

Due to the type of roof covering and the slope of the roof in conjunction with the lack of an anchor/tie-off system on the roof, the inspector was unable to traverse the roof for safety concerns. As such, the inspector was unable to fully assess the portions of the systems that are present such as, the condition of the roofing material, gutters, vents, and other such roofing system components. If desired, we recommend that a roofing contractor assess the status of the complete roof, and determine if any repairs are needed. Additionally, the inspector used a drone to assess portions of the roof and the associated system and components on present on the roof. The use of drone technology is limited to a visual assessment only and can be impacted by the conditions present on the day of the inspection.

Limitations/Obstructions - Roof
(Representative Picture)

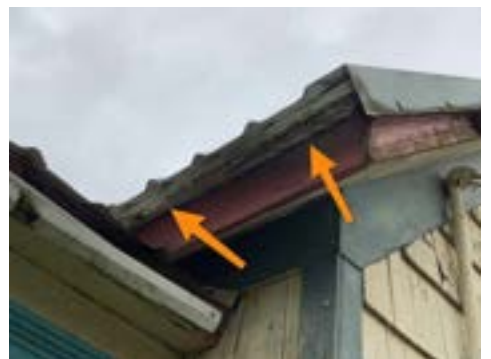
The roof has a previous shingle layer underlying the outer metal roof covering; please note, deterioration of the shingles was noted on the observable portions of the underlying layer. Two layers of roofing material can trap more heat, which in turn can damage and shorten the life span of the roof; additionally, depending upon manufacturer recommendations, layering over the existing roof cover could also shorten or even void a warranty associated with the roofing material. Adding a second layer of roof covering increases the weight of the roof and puts additional stress on the roof decking and associated structures, which can pose issues in wet weather or areas with heavy snowfall. Further, layering over the existing roof cover limits access to the underlying roofing material and decking should issues arise and repairs are needed. We recommend further evaluation and correction by a licensed roofing contractor.

Multiple Roofing Layers
(Representative Picture)

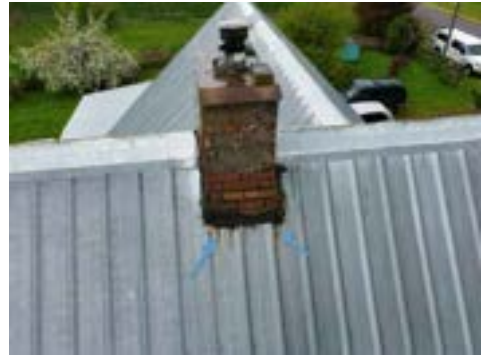
CORRODED ROOFING MATERIAL

Portions of the metal roof covering appear to be corroded. We recommend a qualified individual clean and paint these areas to prevent further corrosion and possible deterioration of the material.

Corroded Roof Covering
(Representative Picture)

Contact a qualified professional.

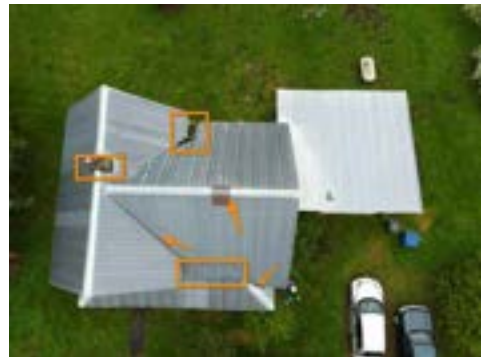
Areas of what appear to be patching was observed on the roof. We recommend further evaluation by a licensed roofing contractor to ensure the patching has been appropriately installed and no issues are present.

Roof Patching

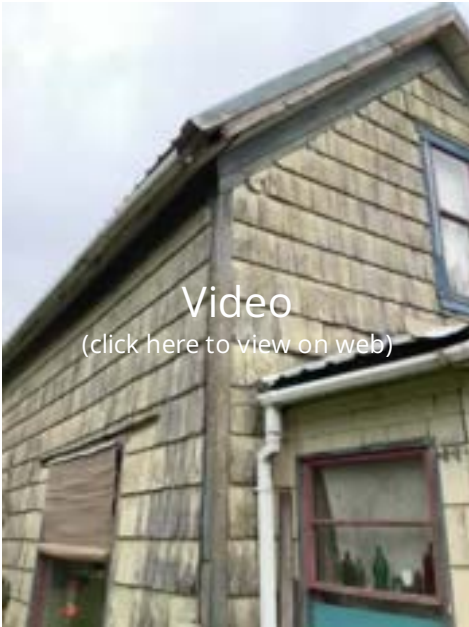
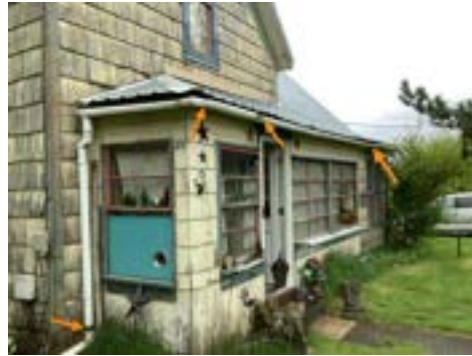
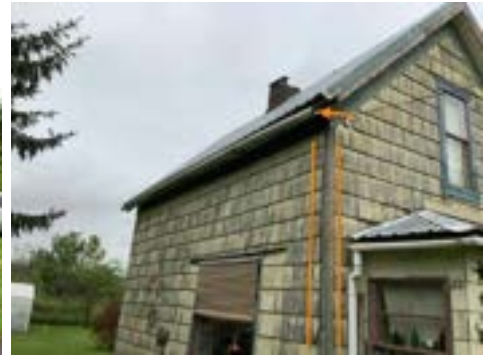
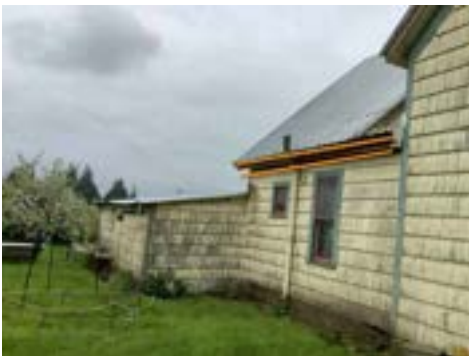
GUTTER SYSTEM DAMAGED/NOT PRESENT

Sections of the gutter rails and associated downspouts are damaged and/or missing on **all** sides of the home. If left unaddressed, the damage could lead to corrosion and further deterioration of the gutter rails/downspouts, moisture accumulation in the fascia and eaves, and water discharging from the gutters/downspouts around the foundation; which can lead to excessive moisture accumulation in the soil around the foundation and possible foundation/structural movement. We recommend a licensed gutter contractor assess and repair as necessary.

Gutter System Damaged/Not Present
(Representative Picture)

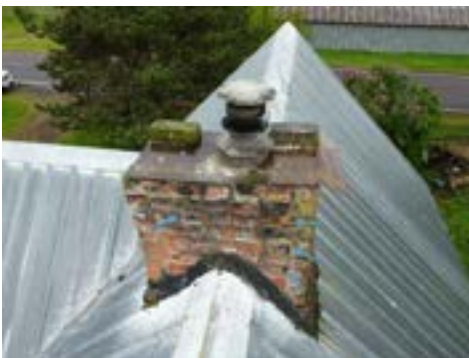
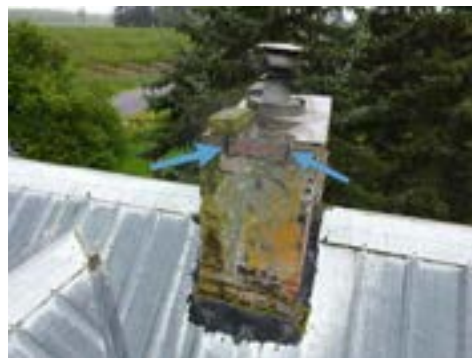
CHIMNEY MORTAR DETERIORATING

The mortar is deteriorating between the bricks in the chimney structure, located on the center ridgeline; please note, due to limitations on the roof the inspector was unable to fully assess the chimney for structural instability. We recommend evaluation and repair by a licensed chimney contractor.

Chimney Mortar Deteriorating - Center
Ridgeline

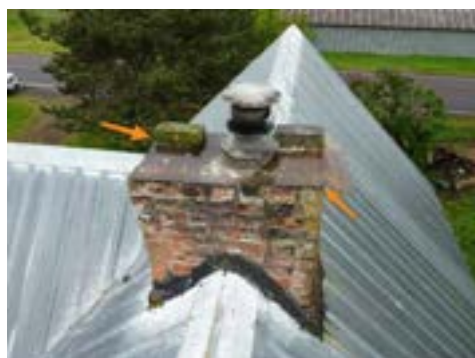
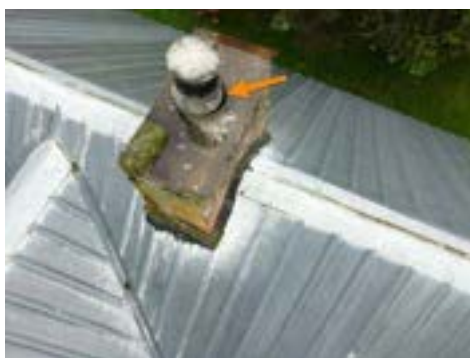
A metal sheet has been placed on top of the chimney on the center ridgeline, to serve as a make-shift chimney crown; please note, the sheet has been secured with bricks. Additionally, this has caused a gap between the crown and the vent stack. The absence of a properly installed chimney crown could lead to moisture damage resulting in deterioration of the concrete structure, the chimney flue liner, and possible moisture penetration into the interior structure of the home. We recommend assessment by a licensed chimney contractor for possible repairs to ensure the life and serviceability of the chimney.

Chimney Crown Not Properly Installed
- Center Ridgeline

Gap Around Vent Stack - Center
Ridgeline

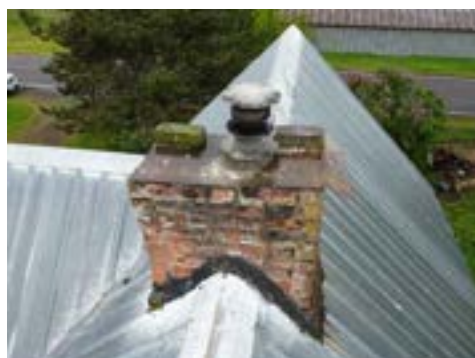
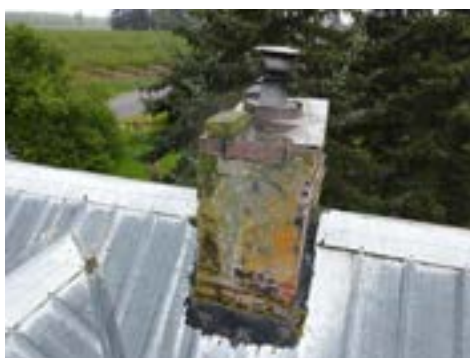
Moss growth was observed on **all** sides of the chimney structure on the center ridgeline. While this can be a common occurrence in wet weather climates, if left unaddressed, this can lead to further deterioration of the mortar resulting in structural instability. We recommend a knowledgeable/skilled individual clean the moss growth from the chimney and continued monitoring to ensure no deterioration of the structure occurs.

Moss Growth on Chimney Structure -
Center Ridgeline (Representative
Picture)

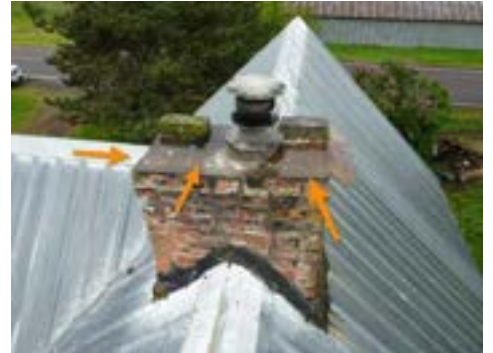
CHIMNEY CROWN CORRODED

Corrosion was observed on the chimney crown located on the center ridge line. With continued exposure to the elements the corrosion could become more extensive, leading to deterioration of the material. We recommend a knowledgeable/skilled individual assess and correct as needed to protect and extend the life of the material.

Corroded Chimney Crown - Center Ridgeline

Contact a handyman or DIY project

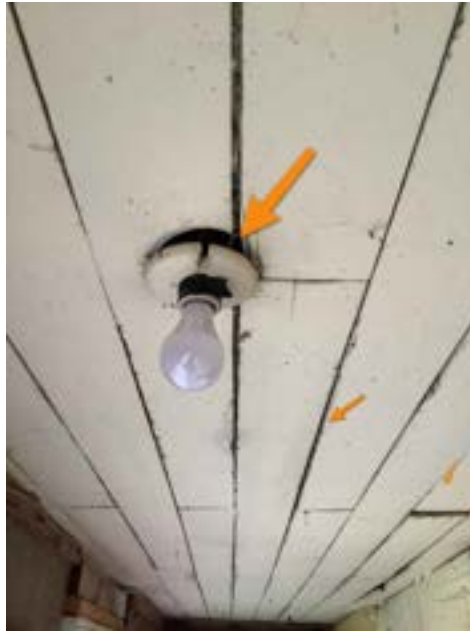
- Between the eave panels on **all** sides of the home, to include the enclosed porch; please note, several panels are missing (Pictures 1a, 1b)
- Between the fascia and eaves on **all** sides of the home; please note, the fascia and eaves appear to be warped from moisture intrusion (Picture 2)

This can create a point for possible moisture intrusion, pest infestation, as well as deterioration of the surrounding material, if not addressed. We recommend a licensed roofing contractor assess and repair as needed to prevent.

Picture 1b - Eave Panel Gaps
(Representative Picture)

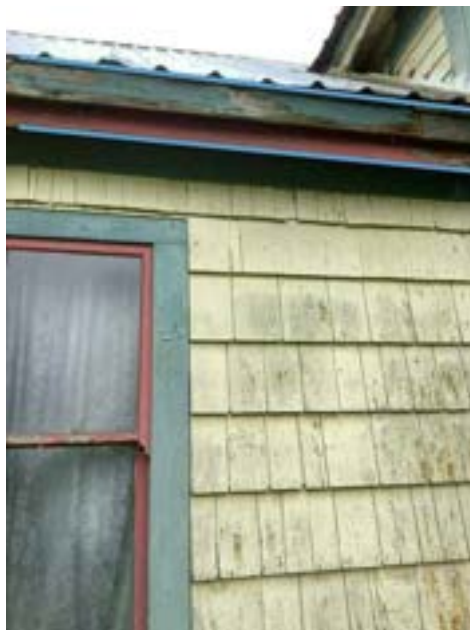
FASCIA/EAVE PAINT DETERIORATING

Fascia/Eave Paint Deteriorating
(Representative Picture)

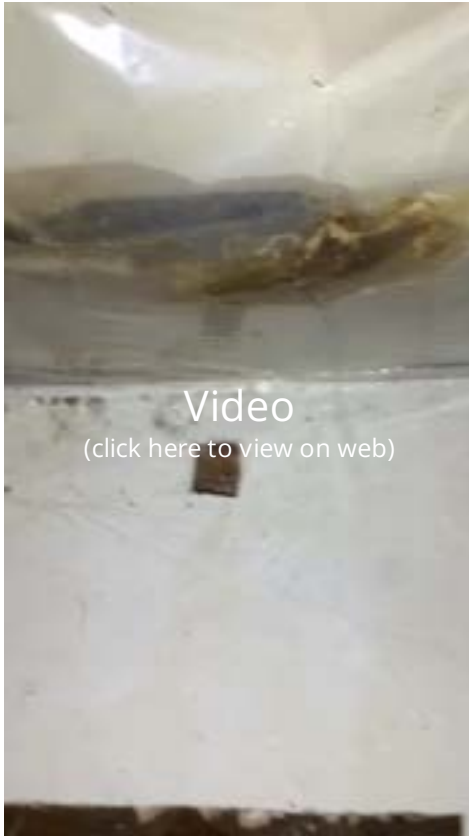
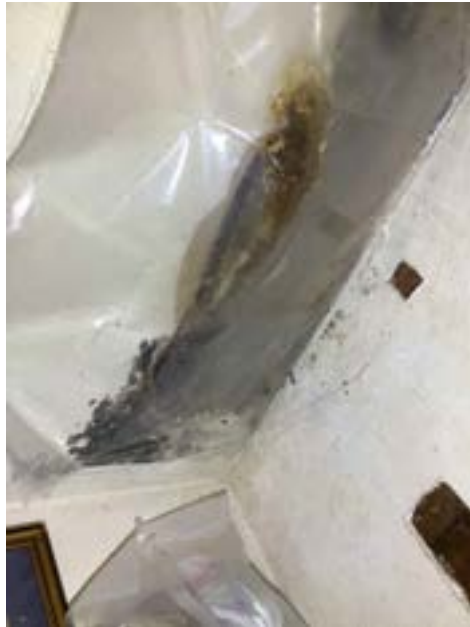
SIGNS OF AN ACTIVE LEAK

Signs of An Active Leak - Bedroom (First Floor - On Right)

Contact a qualified roofing professional.

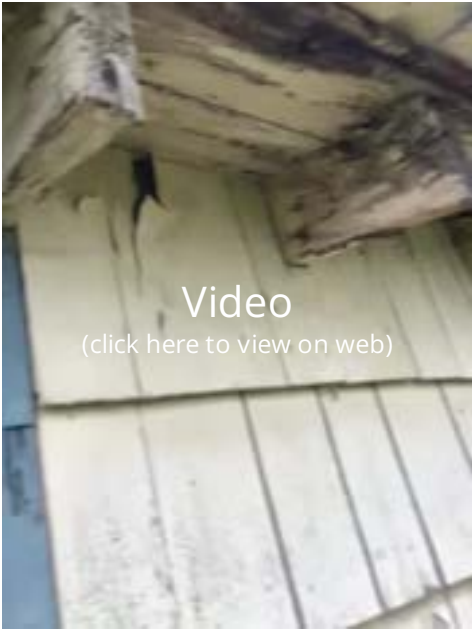
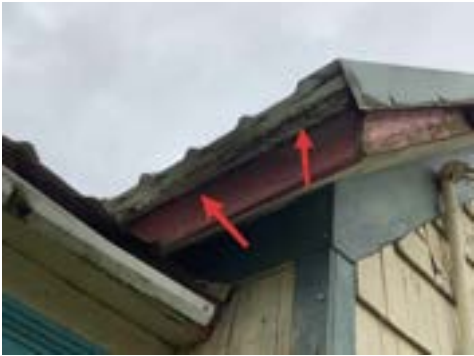
Roof Decking Wood Rot
(Representative Picture)

Contact a qualified roofing professional.

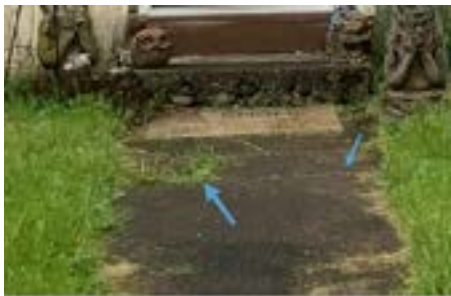
Crack(s) were observed in the walkway on the front side (Side A) of the home, which may indicate movement in the underlying soil. This is common for the age of the home, and can occur as the material ages, lack of maintenance or cleaning, in conjunction with continued exposure to the elements. We recommend monitoring to ensure the cracks do not worsen; if the condition worsens, we recommend a licensed concrete contractor assess for possible repairs.

Walkway Crack(s) - Side A
(Representative Picture)

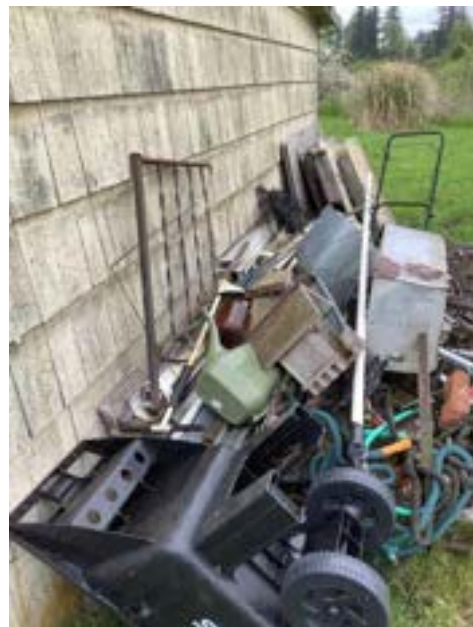
Various obstructions along the exterior right side (Side B) limited the ability of the inspector to fully assess and view the siding and associated structural components. We recommend removal of the obstructions and a re-inspection by a qualified/skilled individual to ensure no issues are present.

Limitations/Obstructions - Side B

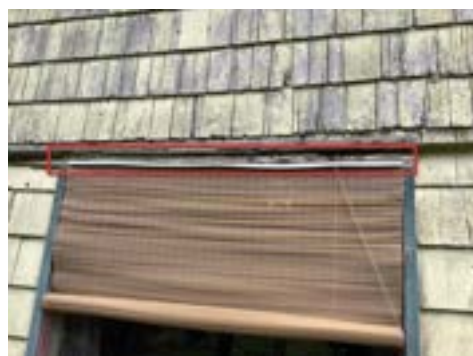
Siding/Trim Wood Rot (Representative Picture)

Contact a qualified siding specialist.

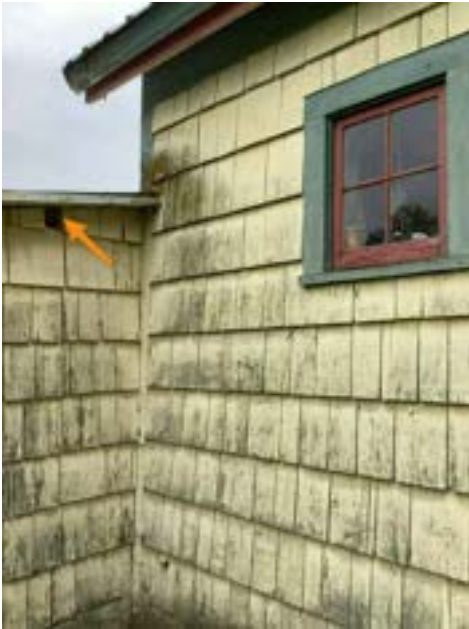
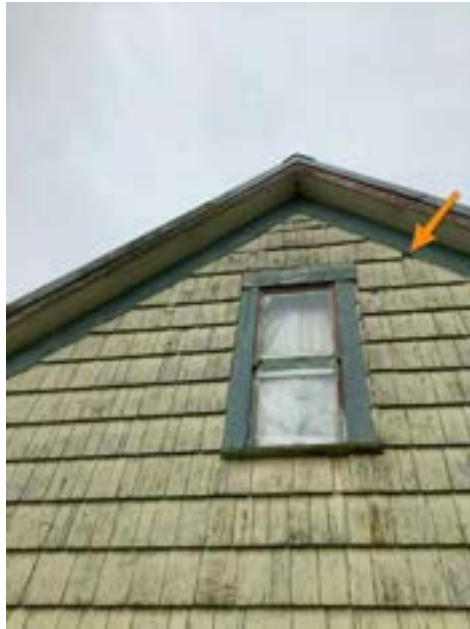
Section(s) of Missing Siding
(Representative Picture)

Contact a qualified siding specialist.

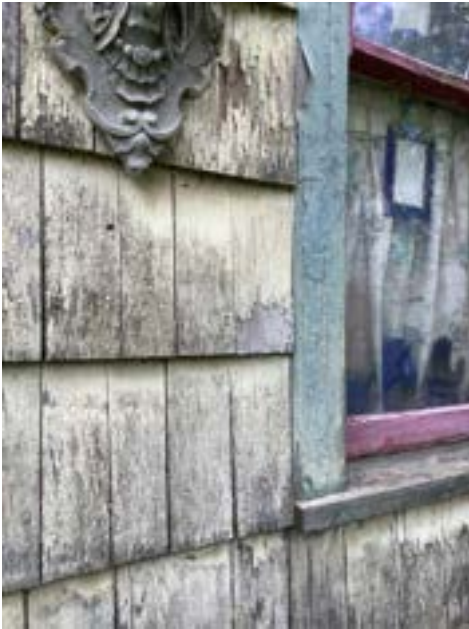
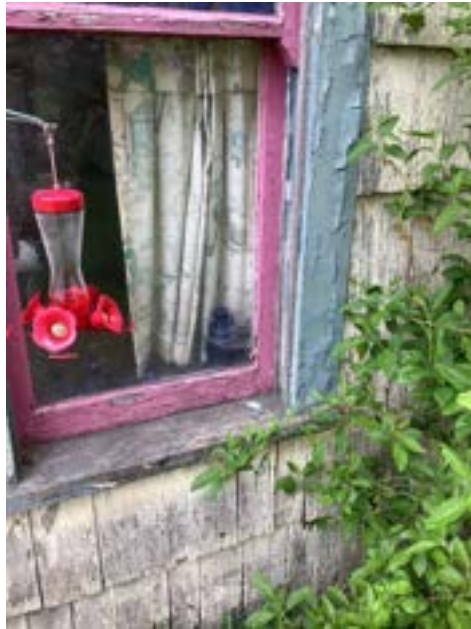
Siding/Trim Paint Deteriorating
(Representative Picture)

Contact a qualified painting contractor.

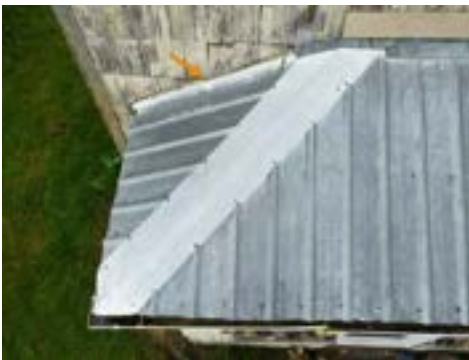
Siding in Contact With Roof
(Representative Picture)

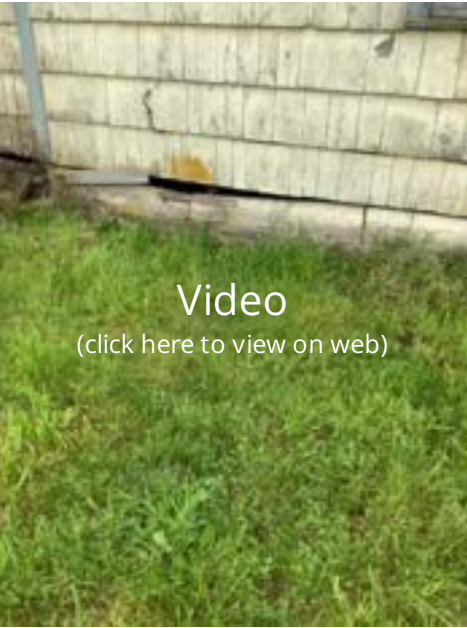
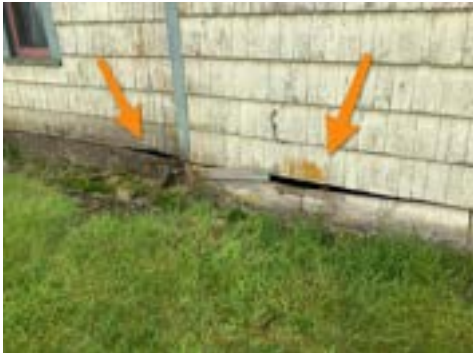
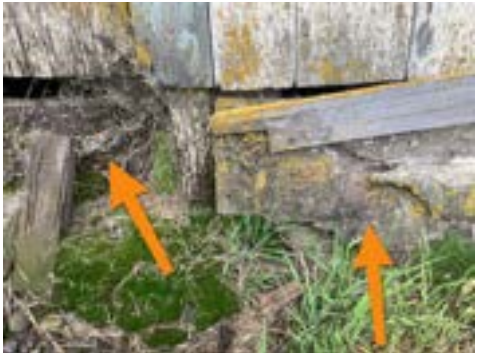
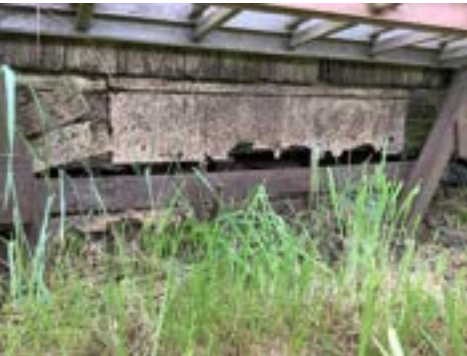
Skirting Wood Rot (Representative Picture)

Contact a qualified general contractor.

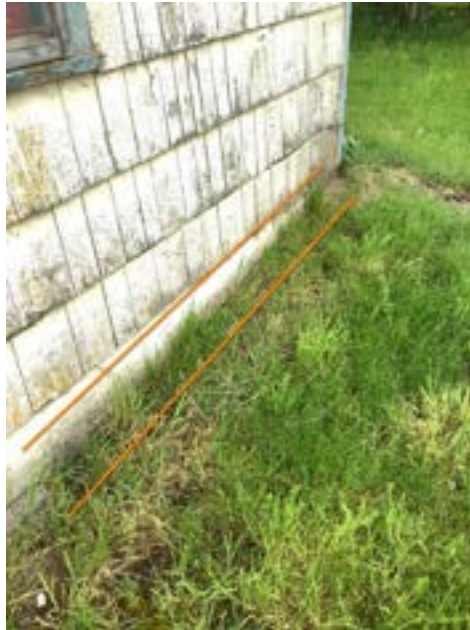
Skirting in Contact With the Ground
(Representative Picture)

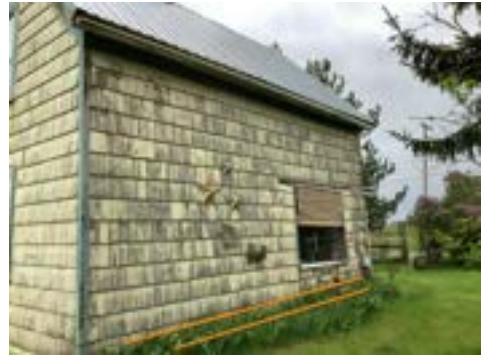
Skirting in Contact With the Ground
(Representative Picture)

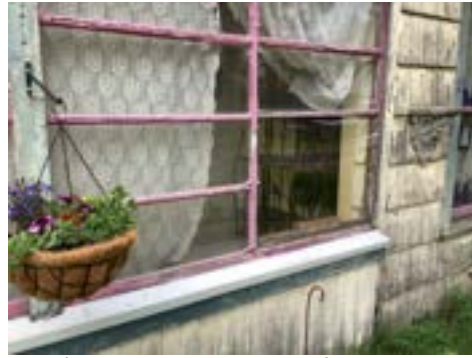
Significant wood rot was identified in the window trim **and** frames on **all** sides of the home. The wood rot was deemed significant due to the extent of deterioration of the material, which has resulted in several loose windowpanes, and caused several panes to fall out of the frames. We recommend a licensed window contractor assess and repair as needed to prevent further deterioration of the trim/frames, and further damage to the glass panes.

Window Trim/Frame Wood Rot
(Representative Picture)

Contact a qualified window repair/installation contractor.

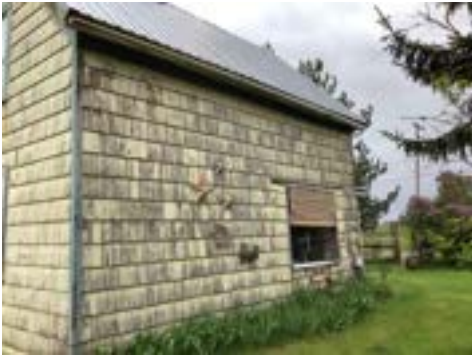
Picture 1 - Side A

- Front Side of the Home (Side A) (Picture 1)
- Right Side of the Home (Side B) (Picture 2)
- Back Side of the Home (Side C) (Picture 3)

The single biggest issue in regard to plant material growing near or on the structure of the home is the presence of moisture, which can accelerate the deterioration of the siding/exterior cladding and create a possible avenue for pests to enter the home. Additionally, larger shrubs and/or trees growing near the foundation can cause instability of the structural integrity of the foundation, as the root systems continue to grow and disturb the supporting soil around the foundation structure.

We recommend that the plants and/or shrubbery near/along of the home be either removed or trimmed back in the following locations:

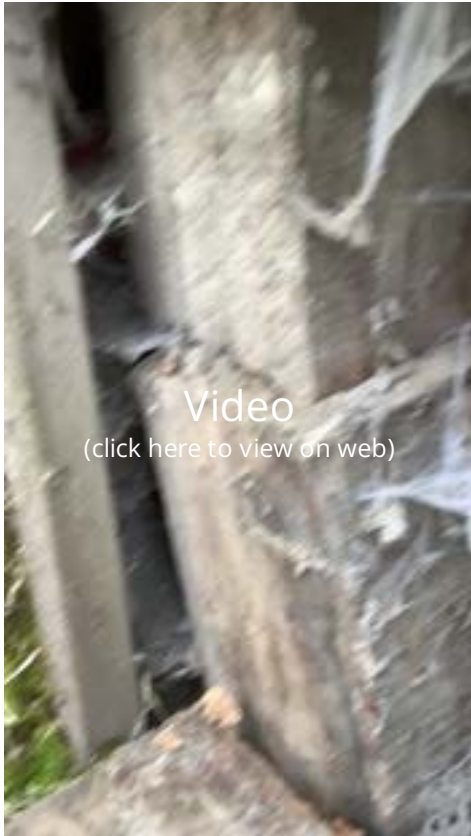
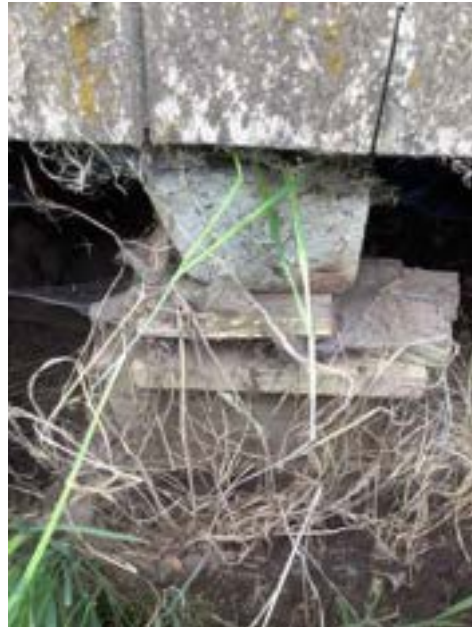
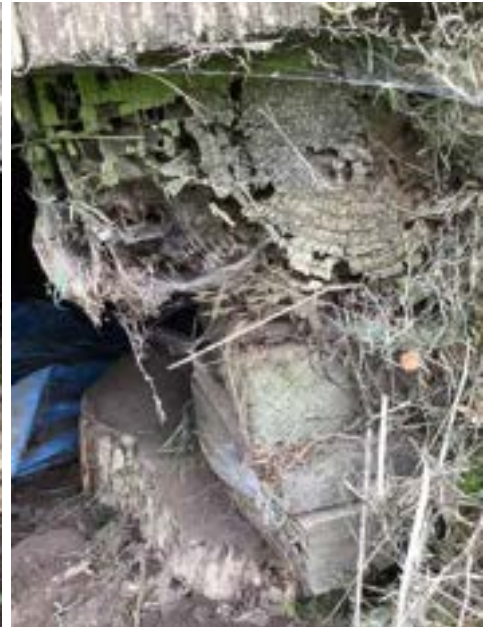
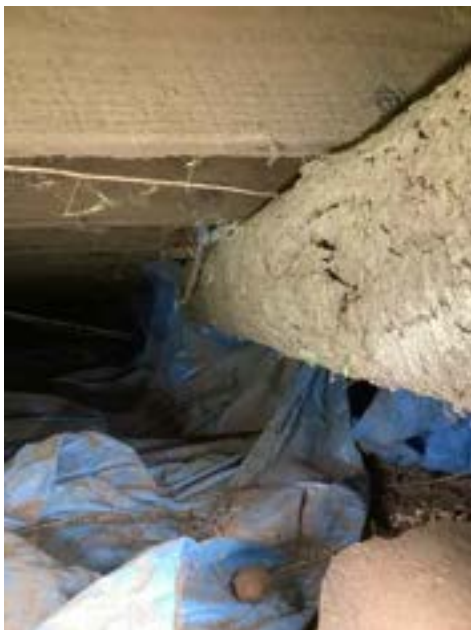
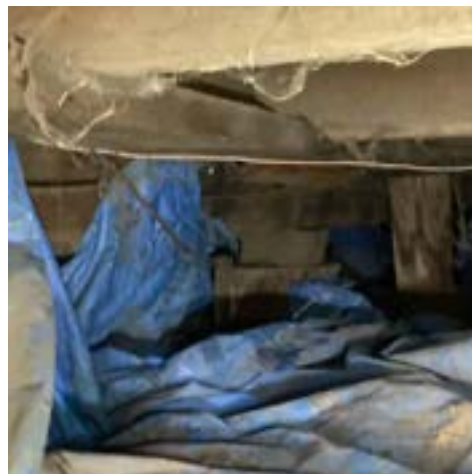
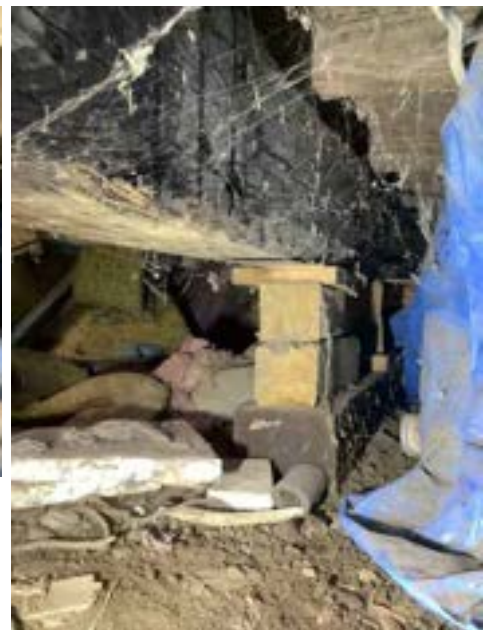
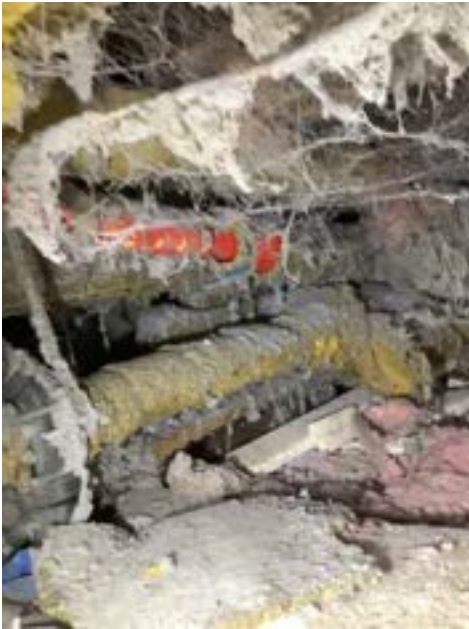
Due to the presence of obstructions and possible instability of the sub-floor structure within the crawl space, there was limited ability to fully assess the underlying portions of the structures, the sub-floor structure (framing), and portions of the plumbing, HVAC ductwork, and other components/systems that are present.

Limitations/Obstructions - Crawl Space
(Representative Picture)

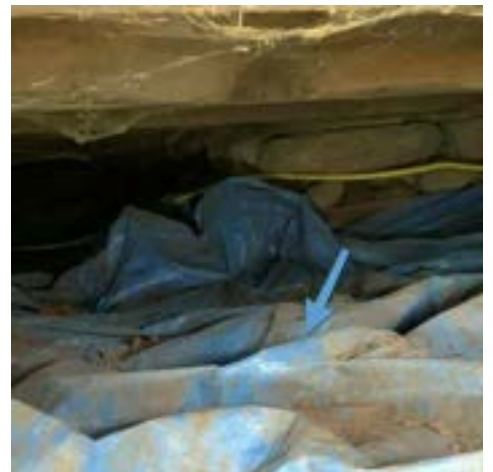
An incorrect type of vapor barrier has been used on the floor of the crawl space; the material appears to be that of a general tarp. It is recommended that 6-mil thick polyethylene plastic, with 12 inches of overlap is present on each seam of the vapor barrier to prevent moisture intrusion, which can seep from the ground into the crawl space. If left unaddressed, excessive moisture in the crawlspace can cause corrosion to ductwork, wood rot to the framing members, and possibly create an environment suitable for the development of microbial growth, such as mold. As such, we recommend a licensed insulation contractor assess and correct.

Incorrect Type of Vapor Barrier Material
- Crawl Space (Representative Picture)

Contact a qualified insulation contractor.

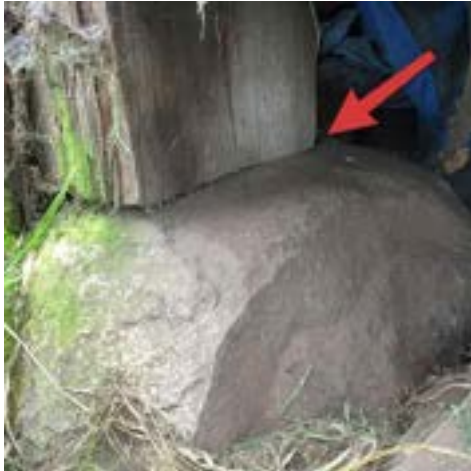
The sub-floor structure is improperly braced in multiple areas in the observable portions of the crawl space. The support columns appear to be stacked scrap wood and/or stone, and are unstable and not adequately supporting the floor beam. We recommend further evaluation by a structural engineer assess and repair as needed to ensure stability of the columns and the overhead sub-floor structure.

Floor Structure Improperly Braced - Crawl Space (Representative Picture)

Contact a qualified structural engineer.

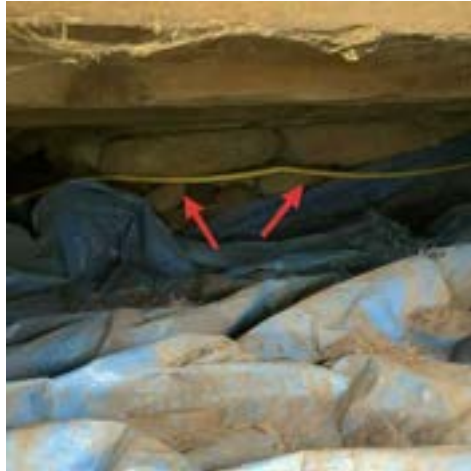
Floor Structure Improperly Braced - Crawl Space (Representative Picture)

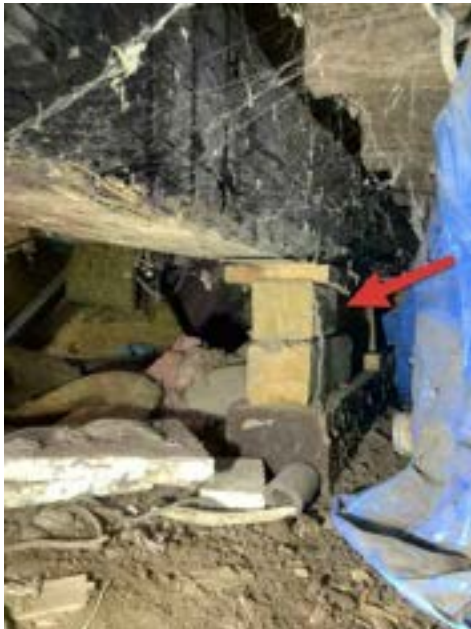
Floor Structure Improperly Braced - Crawl Space (Representative Picture)

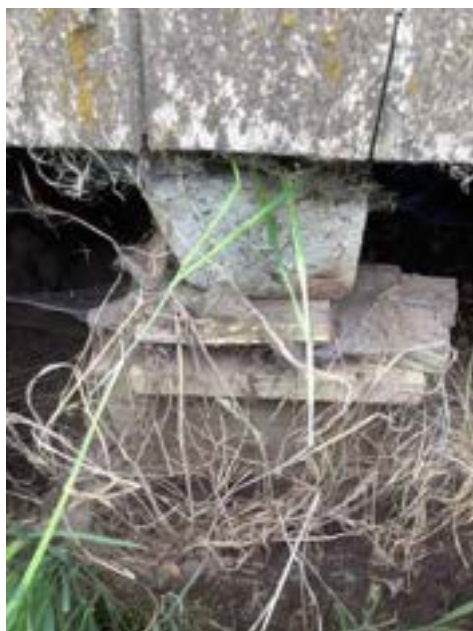
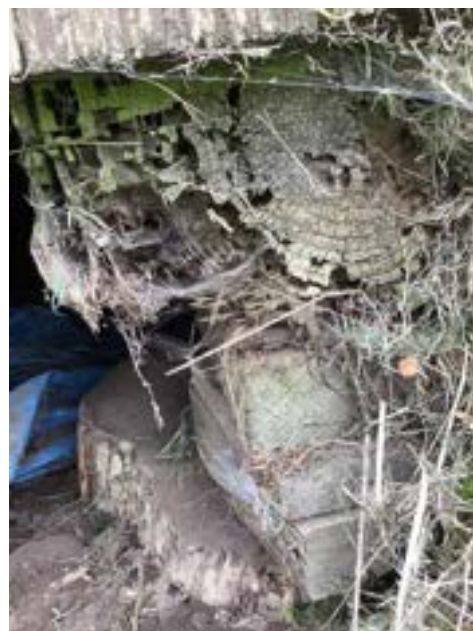
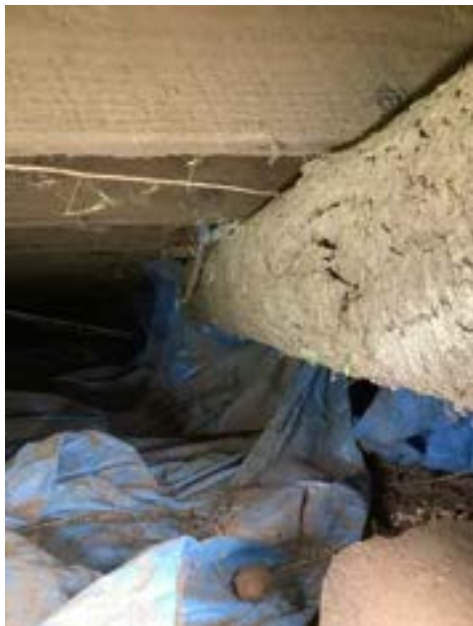
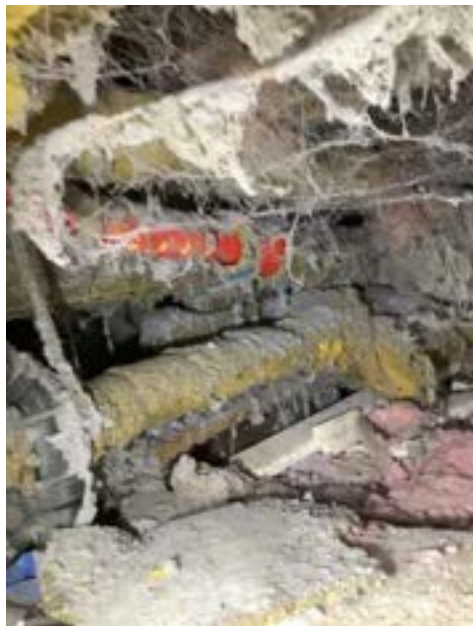
Due to the presence of obstructions and possible instability of the sub-floor structure within the crawl space the inspector was unable to evaluate the condition of the water supply distribution lines, determine if leaks are present, and/or inspect the associated systems and components.

Limitations/Obstructions - Crawl Space
(Representative Picture)

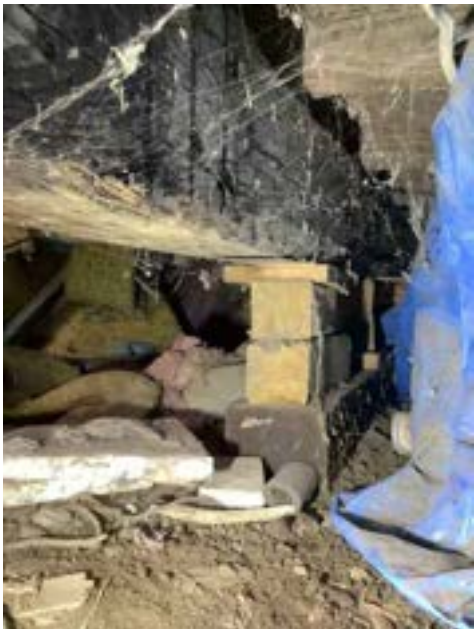
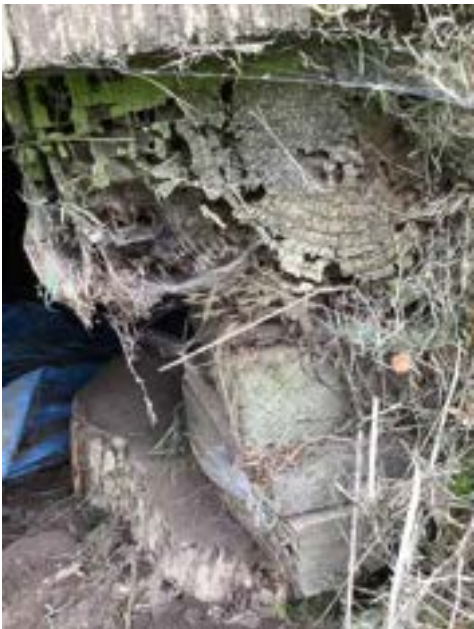
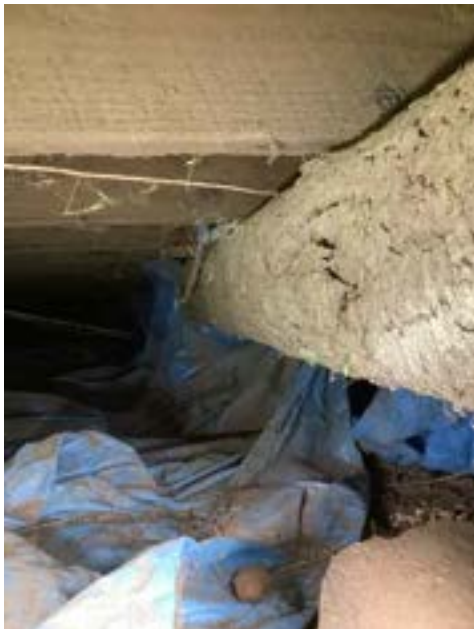
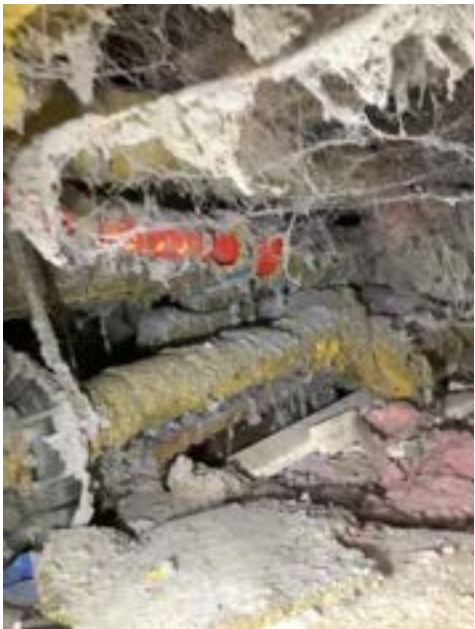
Additionally, due to the presence of obstructions and possible instability of the sub-floor structure within the crawl space the inspector was unable to evaluate the condition of the drain/waste piping, determine if leaks are present, and/or inspect the associated systems and components.

Limitations/Obstructions - Crawl Space
(Representative Picture)

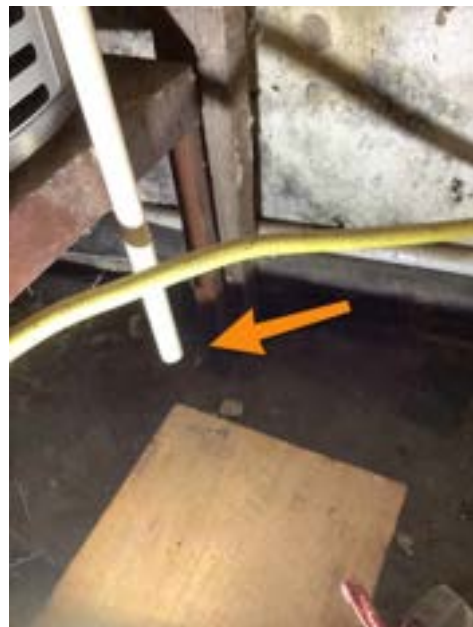
It was observed that the temperature-pressure relief valve discharges directly onto the floor next to the water heater in the first floor utility room. Temperature-pressure relief or TPR valves are safety devices installed on water heating units, such as boilers and domestic water supply heaters, and are designed to automatically release water in the event that the pressure or the temperature in the water tank exceeds safe levels. It is recommended that the discharge from the relief valve be piped to the floor if in a garage or basement, to the outside of the home/building, or to an indirect waste receptor located inside the home/building. This is to ensure that the valve is installed in a manner that does not cause personal injury or property damage, and that is readily observable by the building occupants. We recommend assessment and repair by a licensed plumber to ensure that the TPR valve discharges to the appropriate receptacle and/or area.

TPR Valve Discharges Onto Floor - Utility Room (First Floor)

Contact a qualified plumbing contractor.

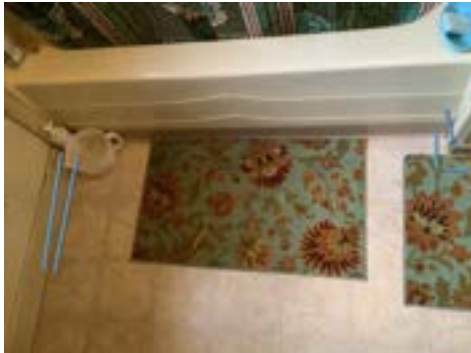
Picture 1 - Full Bathroom (First Floor)

BATHTUB(S)/SHOWER(S) SEALANT DETERIORATING/NOT PRESENT

Contact a handyman or DIY project

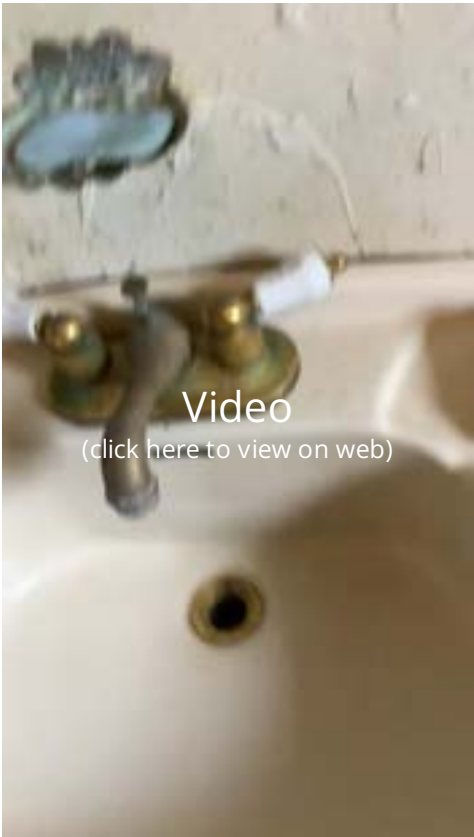
At the time of inspection, low water pressure was observed from the sink faucet in the first floor full bathroom; please note, this occurred during assessment of **both** the hot water and cold water functions. Over time, the water pressure could continue to decrease, and further impact the functions of the fixture. We recommend a licensed plumbing contractor further evaluate and repair as necessary.

Contact a qualified plumbing contractor.

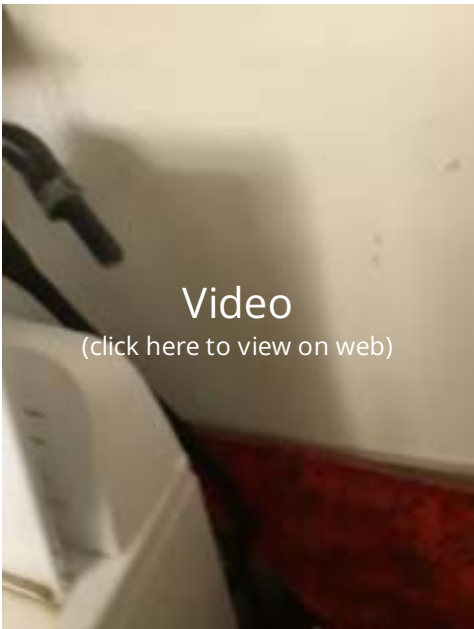
The drain piping for the washing machine has collapsed and per the tenant is no longer useable; please note, this section of the piping is located within the slab floor. A make-shift drain system has been set-up to expel the wastewater when the washing machine is in use. We recommend further evaluation and repair by a licensed plumbing contractor to ensure the washing machine is draining to the appropriate drain connection.

Recommendation
Contact a qualified plumbing contractor.

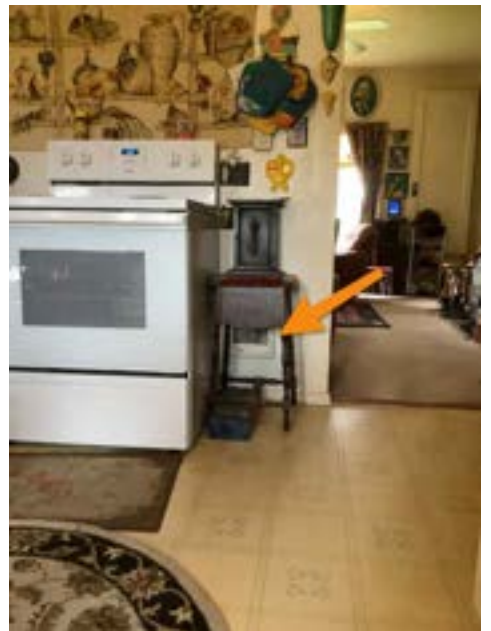
Picture 3 - Kitchen (First Floor)

- a). The electric wall heater on the left side wall (Picture 3)

As such, the inspector was unable to assess the thermostat functions for these heaters, determine if they are properly functioning, and identify any issues that may be present. We recommend removal of the obstructions and a re-inspection of the thermostats by a qualified individual.

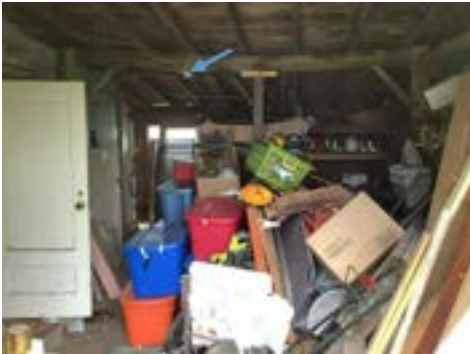
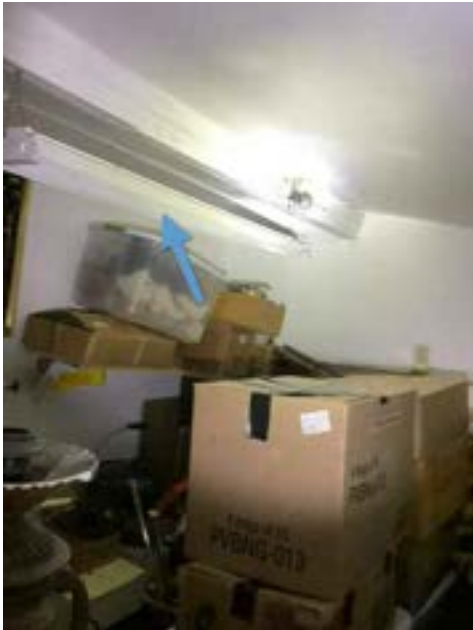
Several bulbs were missing from the light fixtures in the garage, at the time of the inspection. This could be due to a burned out/expired bulb that needs replacing; however, if the problem persists, we recommend assessment and repair by a licensed electrical contractor.

Light Bulb(s) Not Present - Garage
(Representative Picture)

Recommendation
Contact a handyman or DIY project

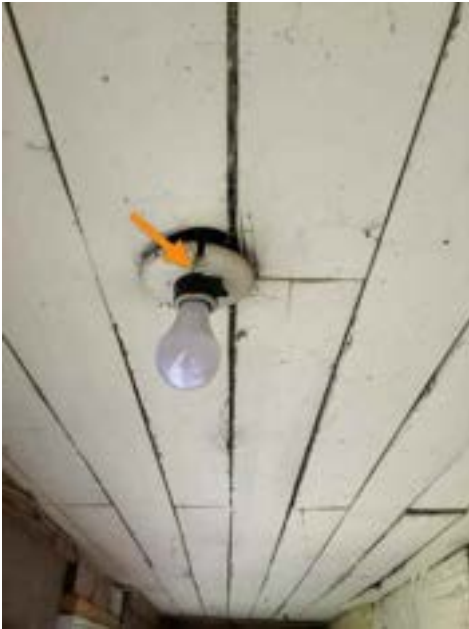
Light Fixture Damaged - Side A

Contact a handyman or DIY project

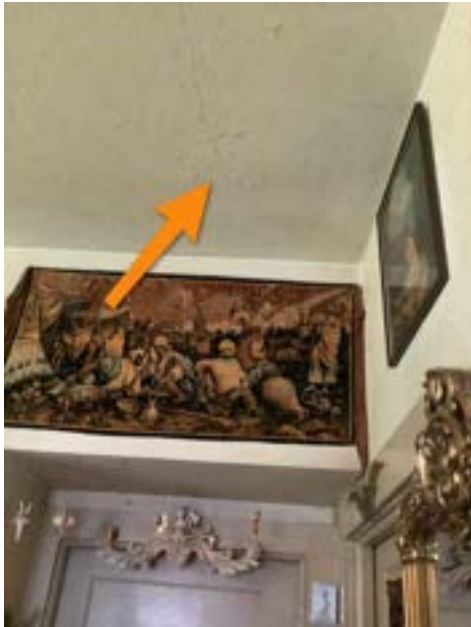
Smoke Detector(s) Not Present - First Floor (Representative Picture)

Contact a handyman or DIY project

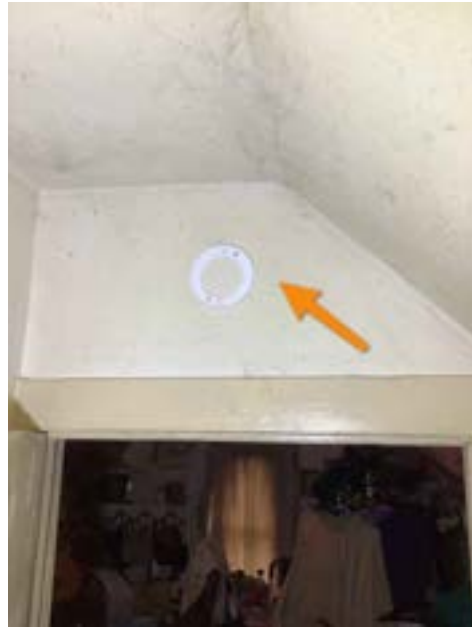
Smoke Detector(s) Not Present - Second Floor (Representative Picture)

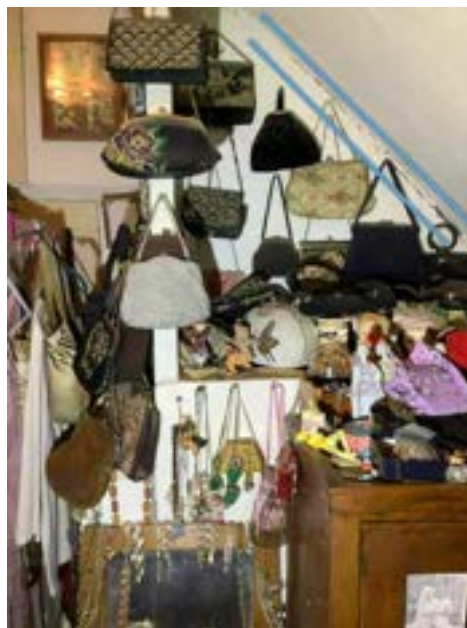
Minor cracks were observed in the wall surfaces, in various areas, throughout the home. Cracks of this nature can be due to settling of the home, in conjunction with temperature changes, resulting in contraction and expansion of the structure, or improper installation of the materials. We recommend monitoring, and if the cracks or condition worsens, contact a licensed drywall contractor for assessment and repairs.

Wall Surface Crack(s) (Representative Picture)

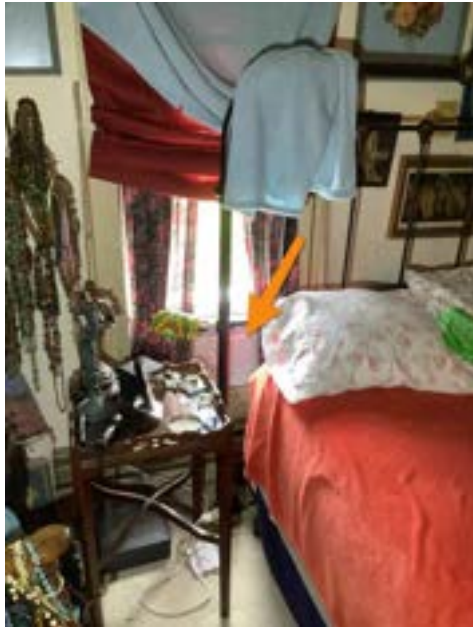
Limitations/Obstructions - Interior
(Representative Picture)

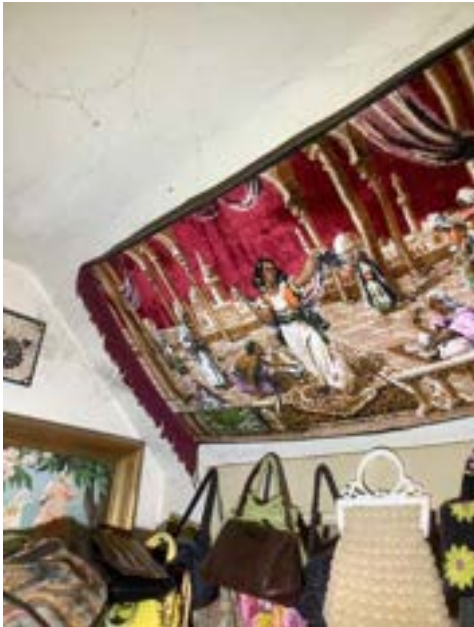
Limitations/Obstructions - Interior
(Representative Picture)
