8527 STAYTON RD

TURNER, OR

Home

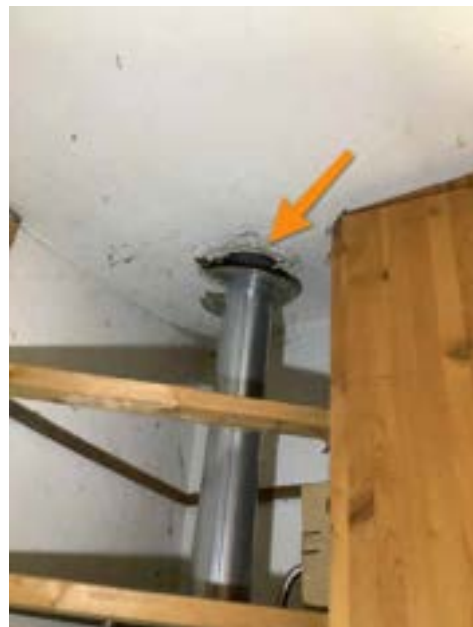
There is moderate damage to the first floor utility room ceiling, above the water heater; please note, the damage has created a gap between the ceiling and the upper flange on the exhaust ducting. If left unaddressed, this could lead to further deterioration of the material, create a point of pest intrusion within the interior of the home, and allow for uncontrolled air seepage from the interior ceiling structure to enter into the main living space, decreasing the energy efficiency of the home. We recommend a licensed drywall contractor assess and repair as needed.

Ceiling Damaged - Utility Room (First Floor)

Contact a qualified drywall contractor.

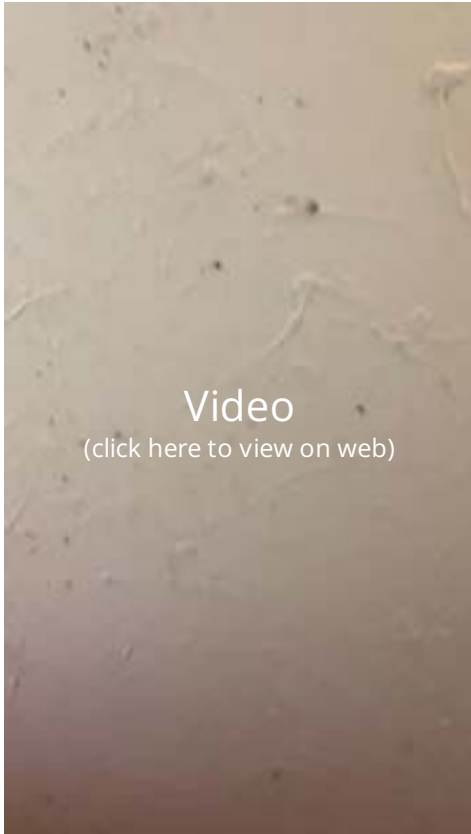
Staining/discoloration was observed on ceiling in the first floor full bathroom; moisture readings indicate a 0% saturation level at the time of the inspection. While the staining/discoloration appears to be surface level at this time, this could be associated with the lack of an exhaust fan and the accumulation of condensation. We recommend further evaluation by a licensed contractor.

Ceiling Surface Staining/Discoloration - Full Bathroom (First Floor)

Contact a qualified general contractor.

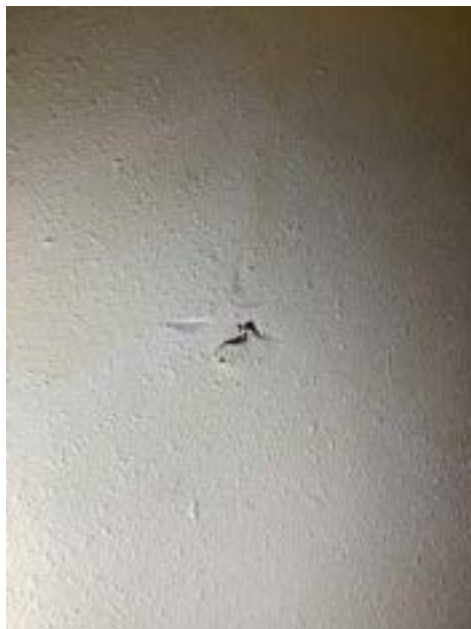
Minor damage to the wall surfaces was observed in various areas throughout the home. The drywall/plaster material is exposed and if left unaddressed, this could lead to further damage and/or deterioration of the wall surfaces. We recommend a knowledgeable/skilled individual patch/repair the damage, and the wall surfaces be finished to match the existing wall surfaces.

Wall Surface Damage (Representative Picture)

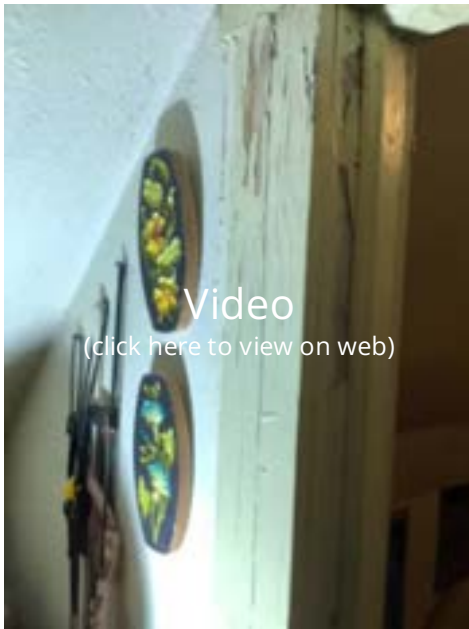
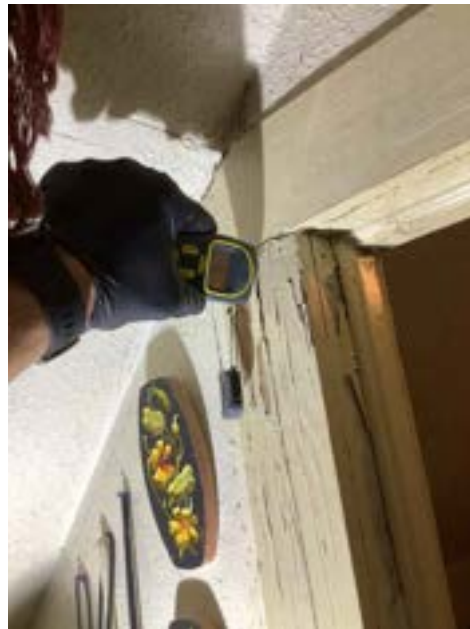
Signs of moisture damage are present on the left side of the door from the second floor bedroom into the hallway; moisture readings indicate a 5.9% saturation level and the paint on the door frame is cracked and peeling. The tenant has stated that during heavy rain, water has been observed leaking from the ceiling down the wall/door frame in this area. We recommend a licensed contractor evaluate and correct as needed to ensure no deterioration of the wall surface/structure occurs.

Signs of Moisture Damage - Bedroom
(Second Floor)

Contact a qualified general contractor.

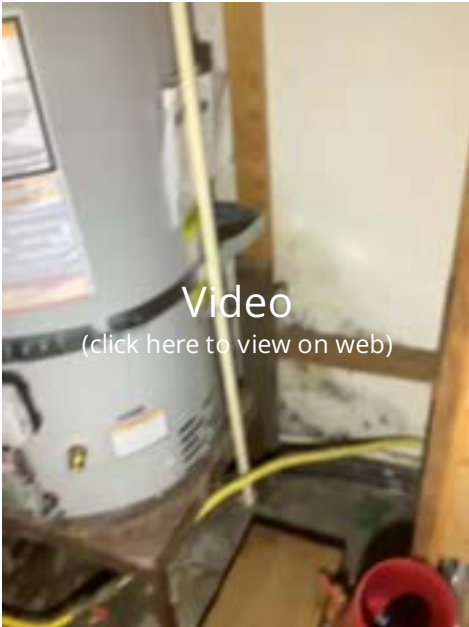
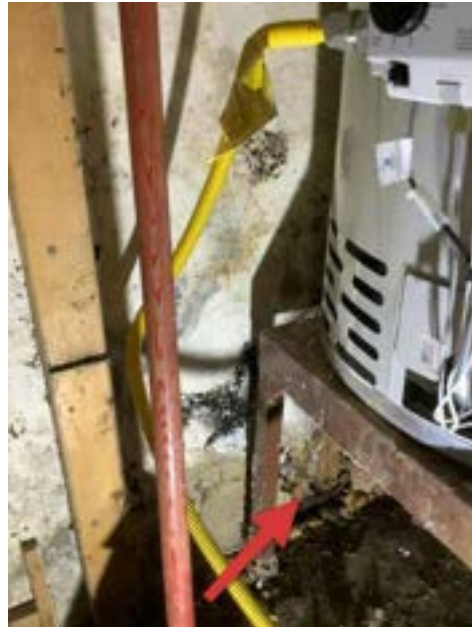
Staining/discoloration associated with moisture intrusion was observed on the front side and right side walls in the first floor utility room; additionally, wood rot was identified in the framing members along the lower portions of the walls. Moisture readings indicate a 50% saturation level at the time of the time of the inspection. If left unaddressed, this could lead to further deterioration of the wall and interior framing structure, possibly causing instability of the wall structures. We recommend a licensed contractor further evaluate and repair as needed.

Signs of an Active Leak - Utility Room
(First Floor)

Contact a qualified general contractor.

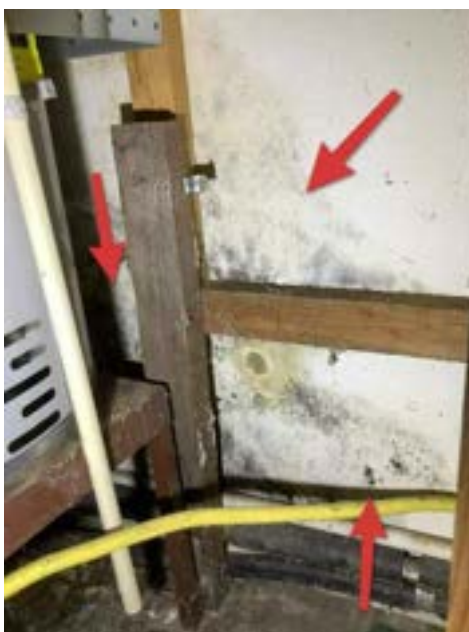
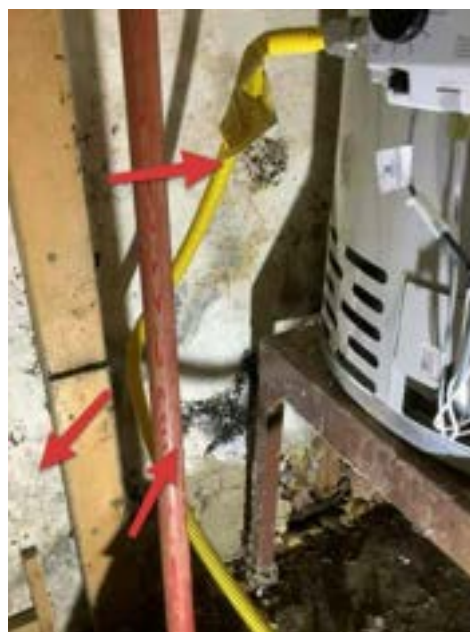
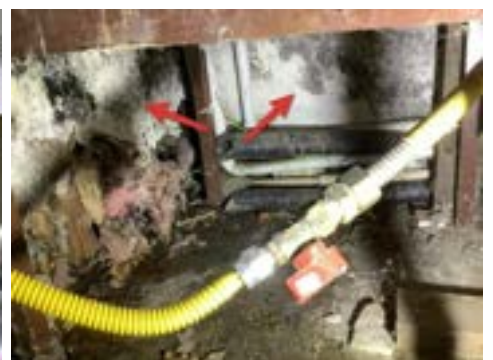
Staining/discoloration was observed on the wall surfaces in the first floor utility room, indicating the possible presence of microbial growth. As microbial growth can appear as a discoloration, staining, or fuzzy growth on the surface of building materials and furnishings, we recommend that the area is assessed and tested by a licensed mold contractor to ensure that no forms of microbial growth, such as mold, are present.

Signs of Possible Microbial Growth -
Utility Room (First Floor)

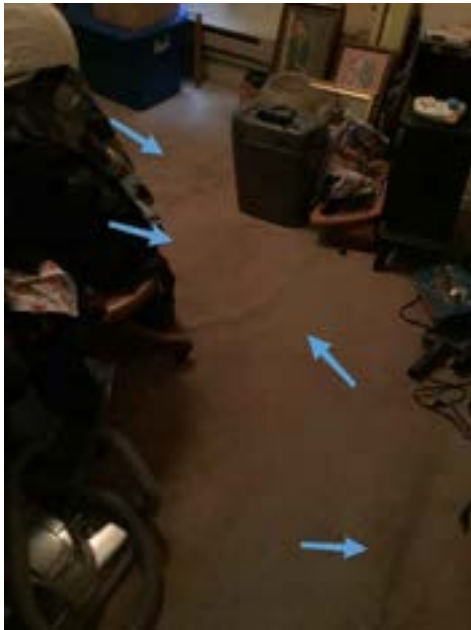
The carpet appears to be loose, in various areas, throughout the home. This commonly occurs when the carpet comes loose from the tack-less strips, or if the tack-less strips come loose from the floor. Once loose, the carpet is no longer taut and wrinkling can occur over time, which can create a potential trip hazard, and possible deterioration of the material. We recommend assessment and repair by a licensed flooring contractor.

Loose Carpet (Representative Picture)

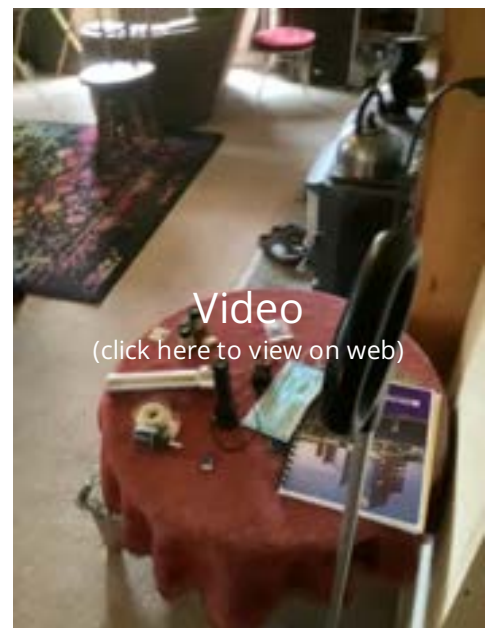
The flooring appears to be uneven throughout the first floor, sloping towards the back/right side of the home. This could be due to an improperly braced floor structure, improper installation of the flooring, and/or significant settling of the home. If left unaddressed, this could pose a safety hazard and lead to deterioration of the flooring. We recommend a structural engineer assess and repair as needed.

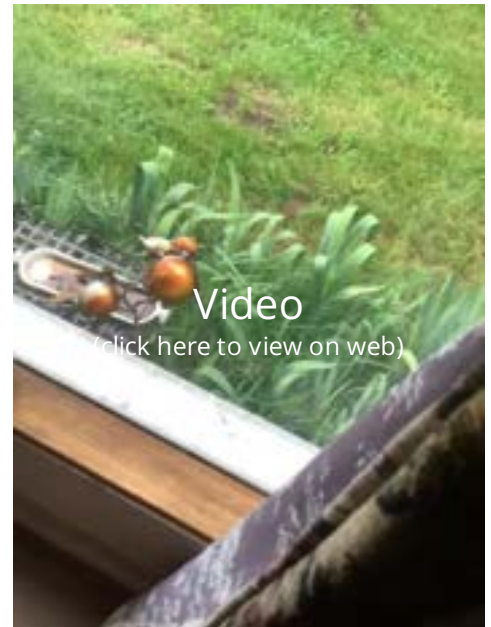
Single pane windows are present throughout the home. Single pane windows have poor insulating properties as heat easily moves through the glass panes, and typically, do not serve as a buffer to dampen exterior sounds. Additionally, single pane windows are not made from tempered glass and pose a possible safety issue if they should crack and/or break. We recommend a licensed window contractor evaluate and replace the windows in the home with double pane windows.

Contact a qualified window repair/installation contractor.

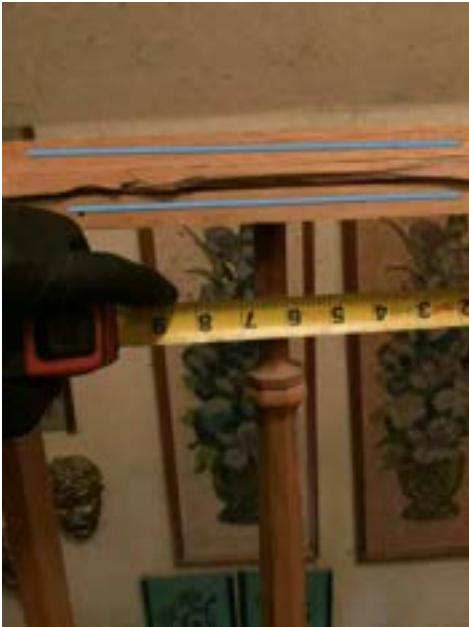
Guardrail Damaged - Hallway (Second Floor)

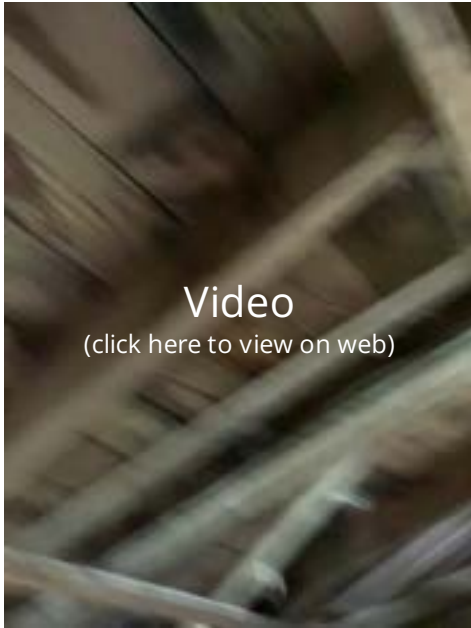
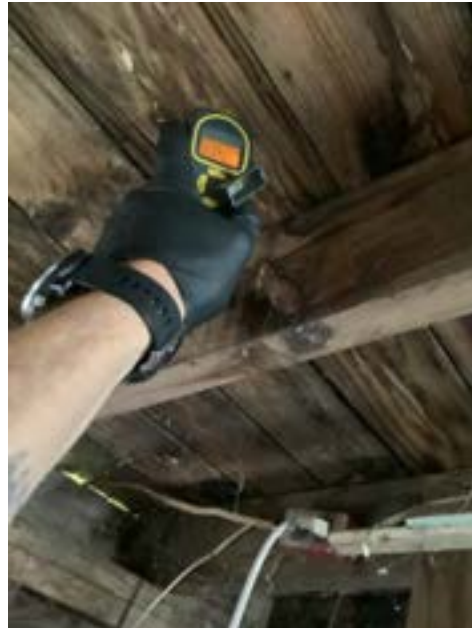
Ceiling Structure Wood Rot - Garage
(Representative Picture)

Contact a qualified general contractor.

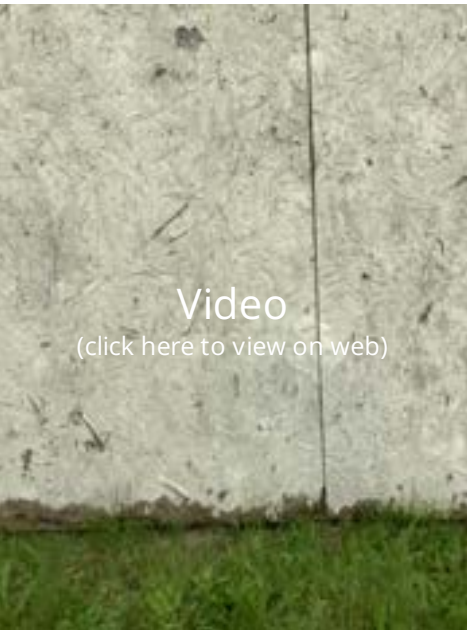
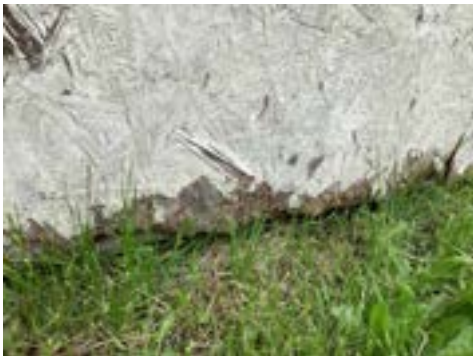
****Note The Video Depicts the Garage Door Wood Rot.****

Garage Door Wood Rot - Side B (Representative Picture)

Recommendation
Contact a qualified garage door contractor.

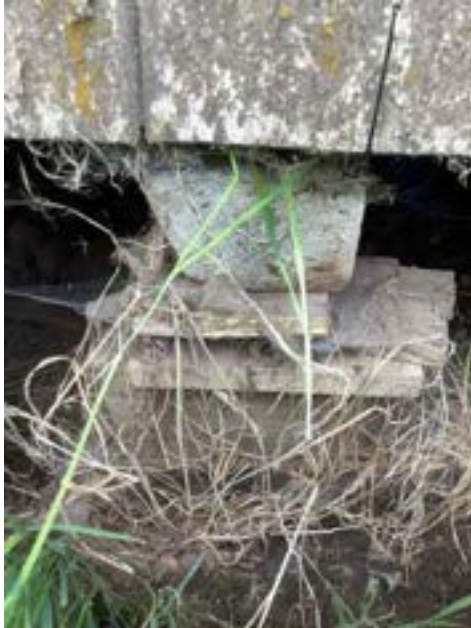
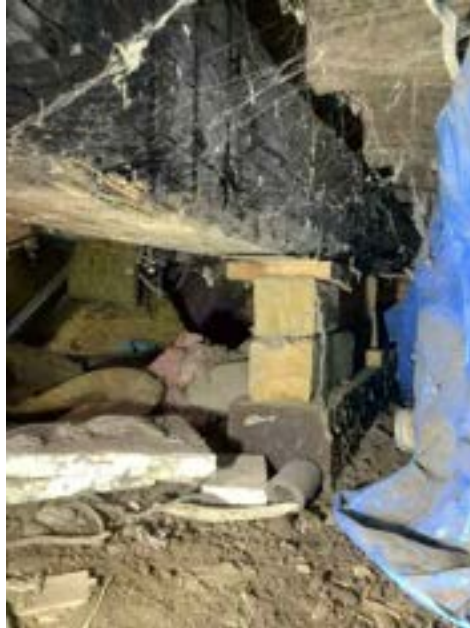
Due to the limitations preventing access to the complete crawl space the inspector was unable to fully evaluate the area for pest/rodent activity. We recommend a re-inspection by a qualified individual to ensure no issues are present.

Limitations/Obstructions - Crawl Space
(Representative Picture)

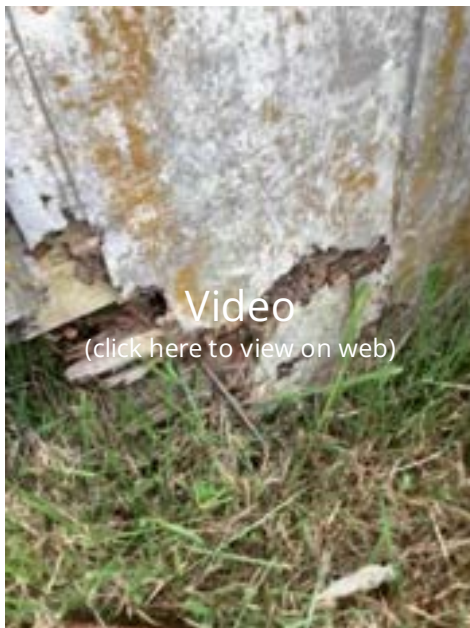
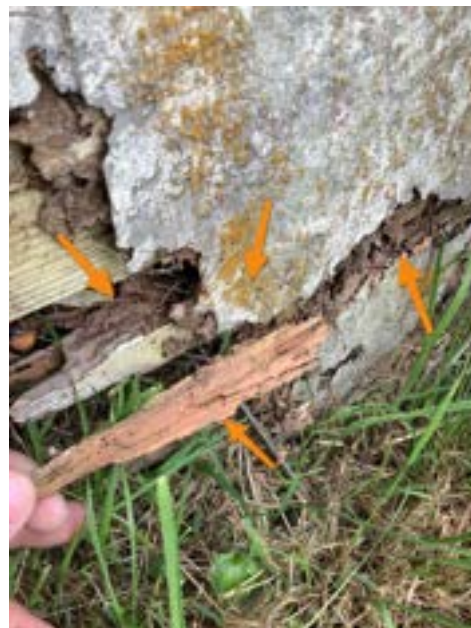
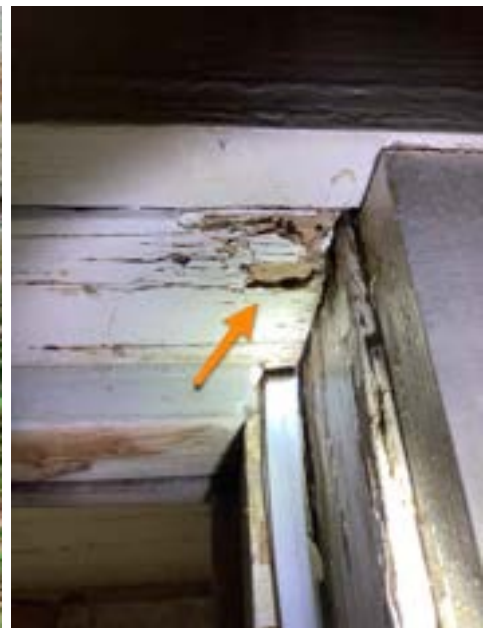
Signs of Wood Destroying Insects
(Representative Picture)

Contact a qualified pest control specialist.
