## TPI HOME INSPECTION REPORT

6139 SH 30 Anderson TX 77830

## PROPERTY INSPECTION REPORT

Concerning: 6139 SH 30, Anderson TX 77830

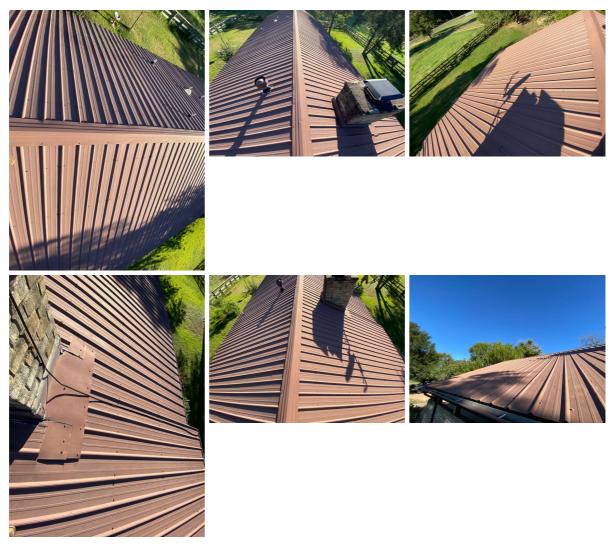
Performance Opinion: Fair - 5 or more years of serviceable life - Inspector Opinion of the roof condition is considered a professional courtesy to assist you in better understanding the condition

Evidence of past repairs noted: None
