# FOLLOW-UP INSPECTION REPAIR REPORT

7207 Laurel Canyon Rd  
07/15/2025

## HOME INSPECTION REPORT - FOLLOW UP 5/26/2025

7207 Laurel Canyon Rd  
Junction City, KS 66441

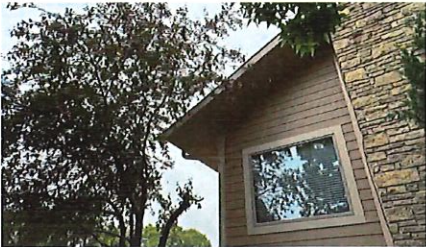
2.7.1 Vegetation

Recommend trimming or removing trees so branches don't rub on the roof and cause damage when blown in the wind.

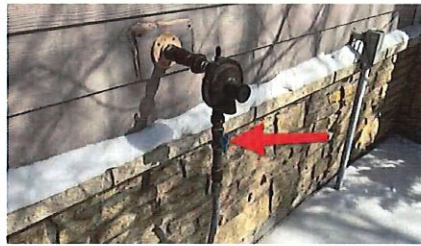
Manufacturers recommend direct bonding of gas piping systems incorporating standard (yellow) or uncoated corrugated stainless steel tubing (CSST) to reduce the risk of fire from lightning strikes. Recommend having an electrician or plumber assure gas line is properly bonded and grounded.

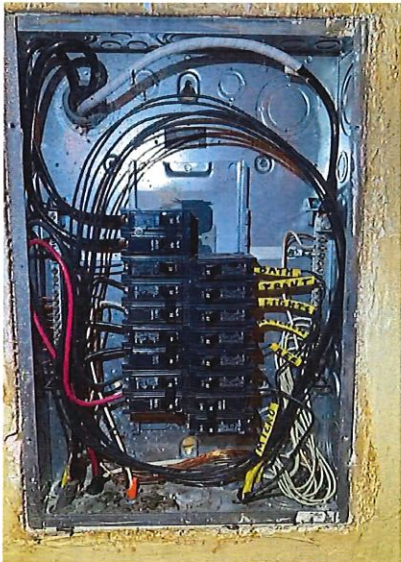
12.4.1 Exterior Service Panel  
**OPEN BREAKER SLOTS**  
EXTERIOR SERVICE ENTRY PANEL

Recommend covers over open breaker slots in electrical panel.

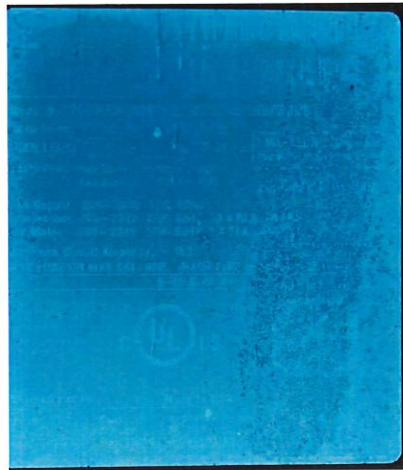
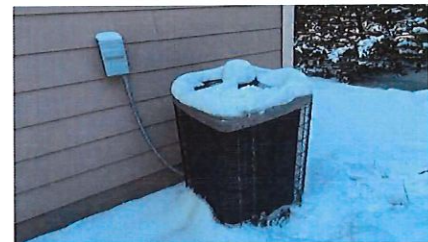
**HVAC System: Return Air**  
Central Air Return**HVAC System: Filter Type**  
Standard**HVAC System: Filter Size**  
20 x 20 x 1 Inches**AC Condenser: Brand**  
Unitary Products Group**AC Condenser: Manufacture Date**  
December 2006?**AC Condenser: Refrigerant Type**  
\*R-22 (Freon)**AC Condenser: AC Condenser Photo**  
Boathouse North Exterior

The average lifespan of an outdoor air conditioning condenser is around 15 years. Based on the age of this system at 17 years old, recommend being prepared for eventual replacement.

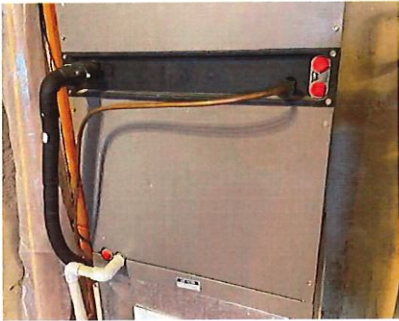
AC Evaporator Coil: Evaporator  
Coil Photo  
Boathouse

**AC Evaporator Coil: Brand**  
Unitary Products Group**AC Evaporator Coil: Manufacture Date**  
July 2007**AC Evaporator Coil: Refrigerant Type**  
R-22 (Freon)**AC Evaporator Coil: Condensate Line Drains to:**  
Exterior**AC Evaporator Coil: Cooling Temperature Differential**  
11 Degrees

The target range for air to cool down is at least 14° but not more than 22°

The average lifespan of an air conditioning system is around 15 years. Based on the age of this system at 17 years old, recommend being prepared for eventual replacement.

The AC was only cooling the conditioned air down 11 degrees. The desired temperature differential range is normally 14-22 degrees although the high humidity from the rain likely made it harder for the AC system to achieve this target. Recommend consulting an HVAC technician.
