## YOUR INSPECTION REPORT

**3157 Horstman Rd  
Berger, MO 63014**

**Prepared By: Jason Ratliff**

**Inspected Date: 9/23/2025  
Report ID: 1109974**

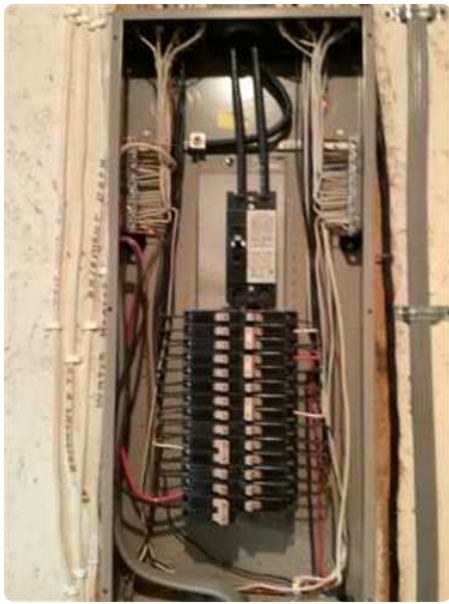
### 5.6 - Service Panels & Subpanels

- The panel cabinet(s) is well secured and there are no apparent signs of arcing or burn marks at the wiring connections and fittings.

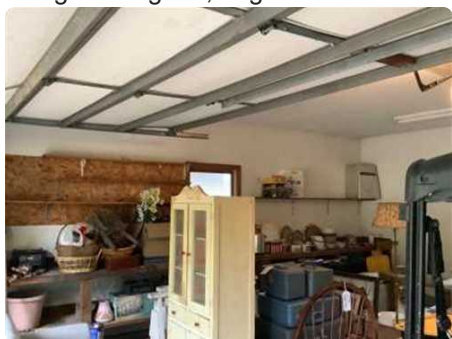
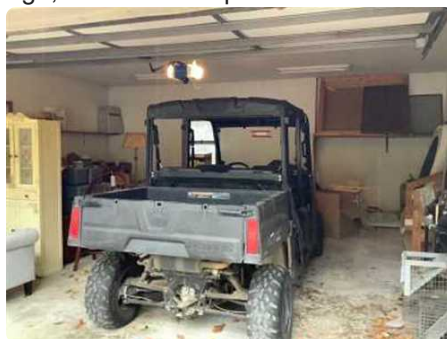
#### 8.3 - Garage Interior

- Large storage or, large amounts of storage, limited the inspection of walls and floors.
