## I. STRUCTURAL SYSTEMS

### A. Foundations

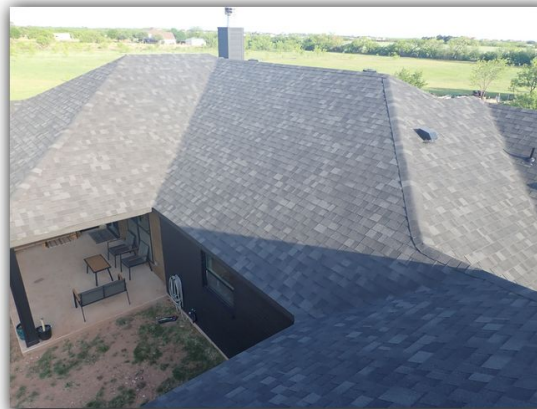
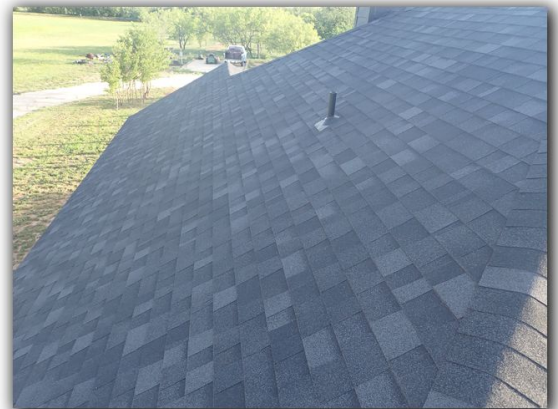
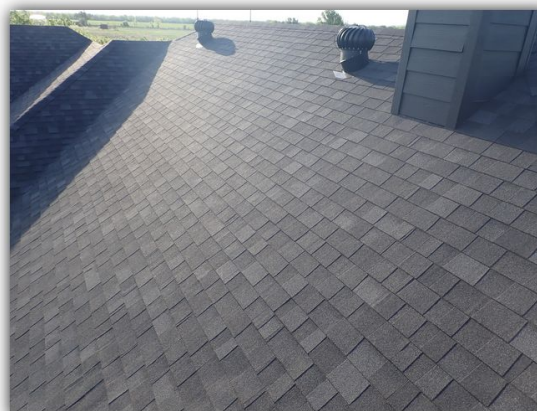
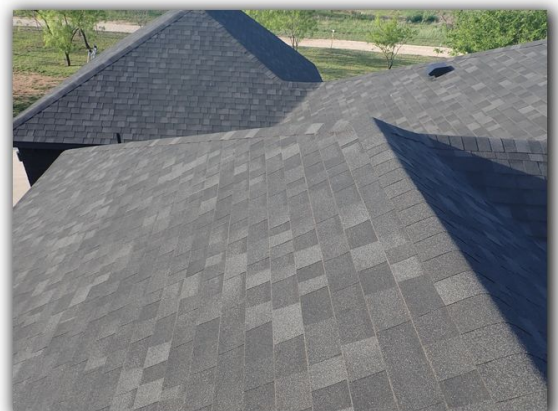
All components were found to be performing and in satisfactory condition on the day of the inspection.

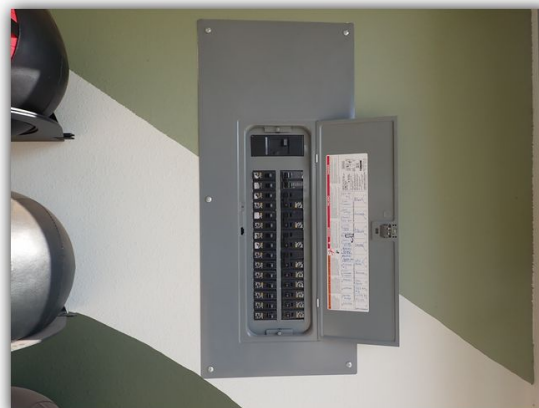
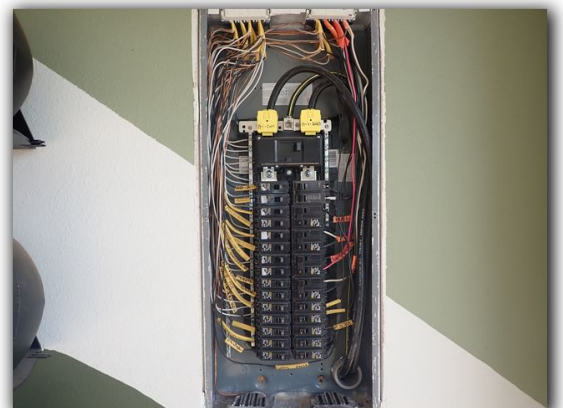
*Cabinet Manufacturer:* Square D

All components appear to be performing adequately at the time of this inspection. They are achieving an operation, function or configuration relative to accepted industry standard practices with consideration of age and normal wear and tear from ordinary use.

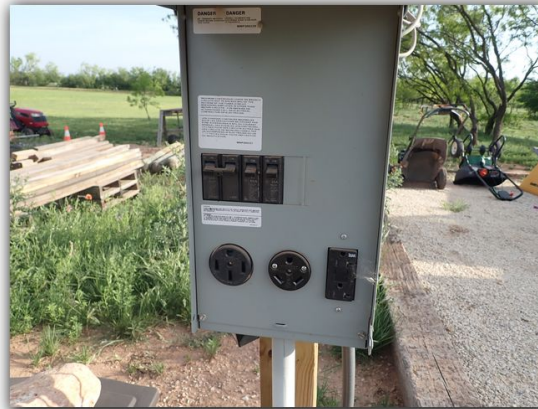
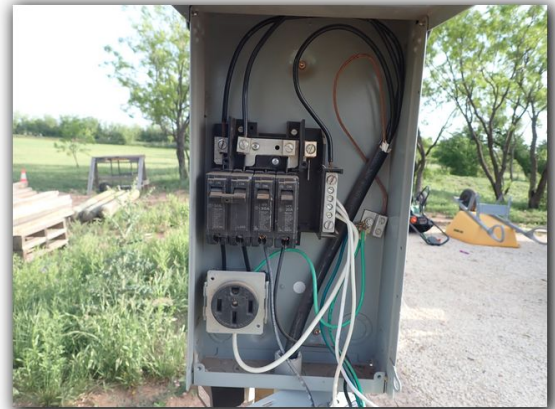
*Cabinet Manufacturer:* General Electric - GE

All components appear to be performing adequately at the time of this inspection. They are achieving an operation, function or configuration relative to accepted industry standard practices with consideration of age and normal wear and tear from ordinary use.

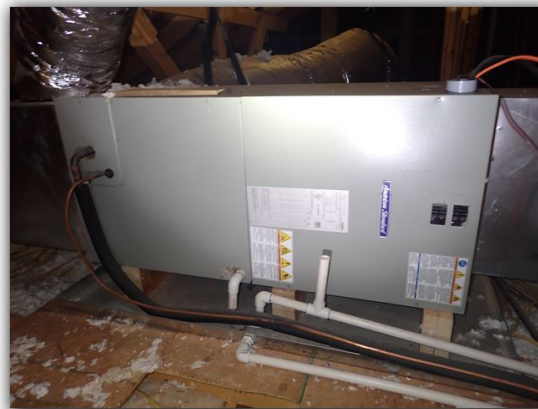
This component appears to be performing adequately at the time of this inspection. It is achieving an operation, function or configuration relative to accepted industry standard practices with consideration of age and normal wear and tear from ordinary use.

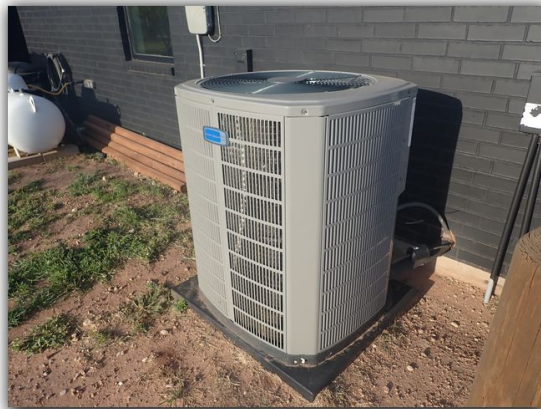
This component appears to be performing adequately at the time of this inspection. It is achieving an operation, function or configuration relative to accepted industry standard practices with consideration of age and normal wear and tear from ordinary use.

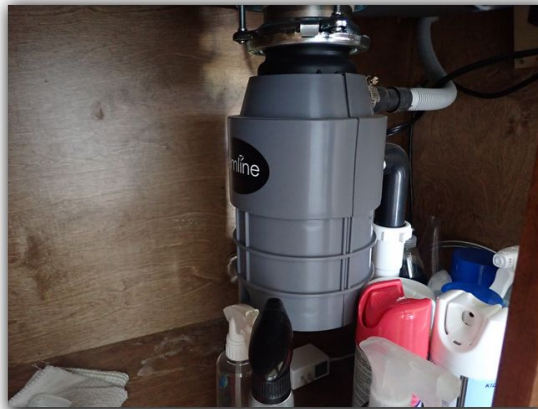
**Brand Name:** Gemline

This component appears to be performing adequately at the time of this inspection. It is achieving an operation, function or configuration relative to accepted industry standard practices with consideration of age and normal wear and tear from ordinary use.

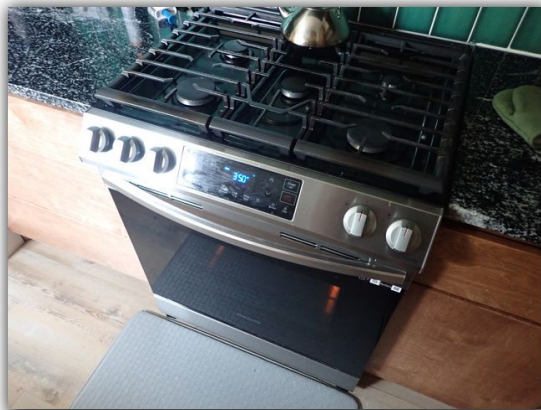
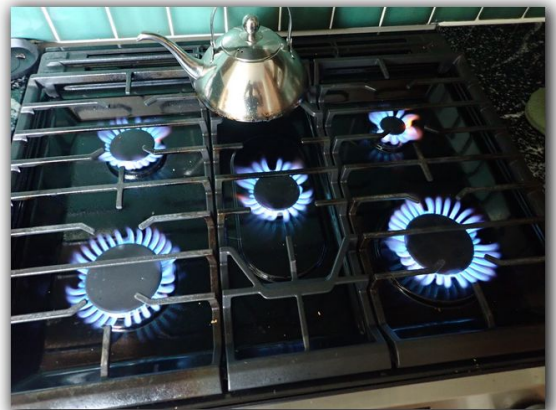
**Range Brand Name:** Samsung

The oven was set to 350 degrees. When tested, at least 30 minutes later, the temperature rose to 345 degrees and held that temperature. A +/- of 25 degrees is considered acceptable.

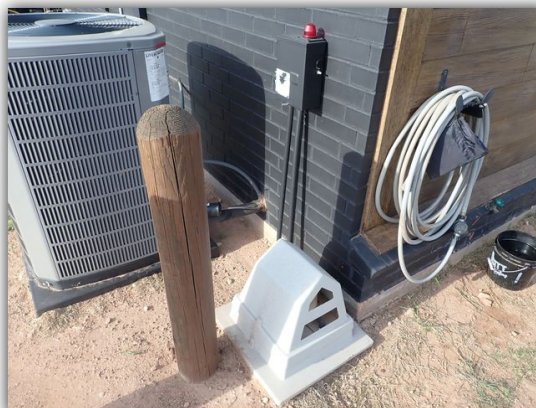
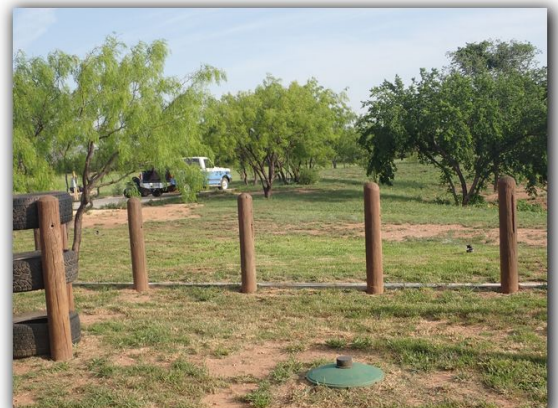
There was no visible evidence of deficiencies in accessible components, stopped main drains and no unusual septic olfactory odors. The water was allowed to run for approximately 20 minutes at all of the water fixtures with drains and there was no visible evidence of deficiencies with functional drain flow. Approximately 80 to 100 gallons of water was added to the system. The inspection included a general visual survey of the probable tank and absorption system areas (surface and perimeter) at the beginning, during and the end of the operational test and there was no visible evidence surfacing water in the drain field.
