County: Hampshire

ON-SITE SEWAGE DISPOSAL SYSTEM  
INSPECTION FORM

Name of Owner: William & Susan Scott Installer: ED SNOOKMAKER  
 Address: 7314 GELSE AVE BALTIMORE, MD 21219  
 Property Location: NORTH RIVER WILDERNESS LOT #37  
 Type of Facility: HOUSE Facility is: New (X) Existing ( ) Lot Size: 5.8 Sq. Ft./Acres  
 Design Loading in gpd/No. Bedrooms: 3 BR Source of Water Supply: well

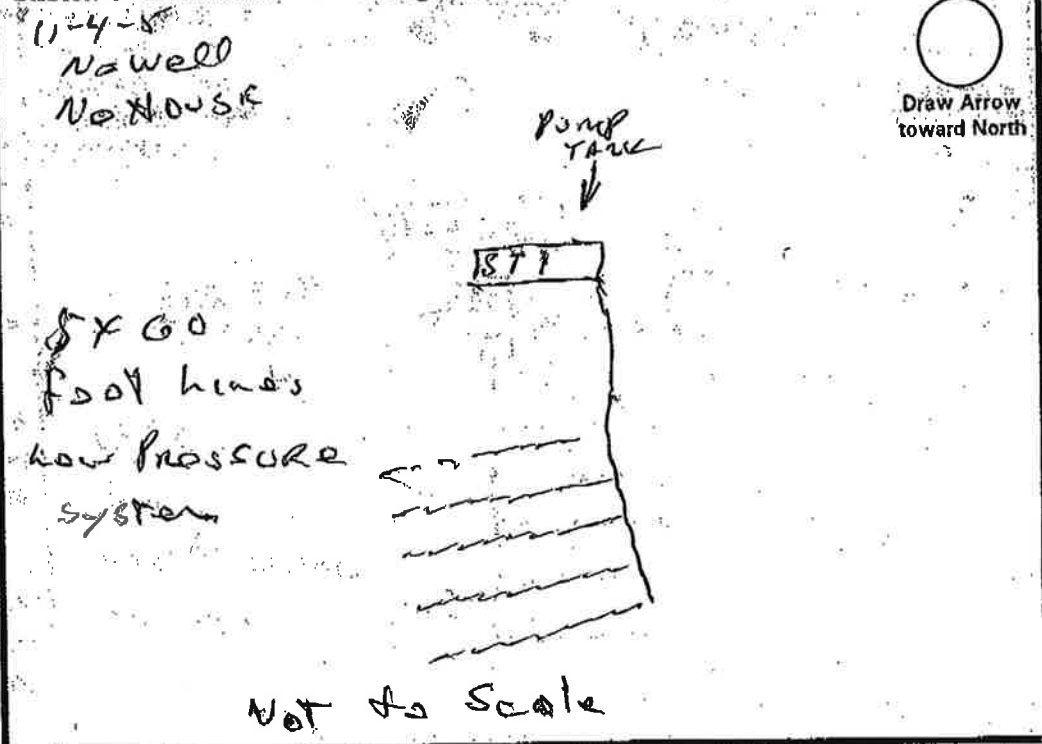
Sketch of Installation with Triangulation or Distance to Specific Landmarks:

No. of Lines: 5 Length (in feet) of Each: 60, 60, 60, 60, 60  
 Width of Trenches: 12 inches/feet Depth to Bottom of Field: 12 inches  
 If Bed, Dimensions (in Feet): \_\_\_\_\_ If Chamber System, Name: \_\_\_\_\_ No. of Units: \_\_\_\_\_  
 Approved and Adequate Materials Used? Yes (X) No ( ) Size Equates to: \_\_\_\_\_ Square Feet of Standard Gravel Field.  
 Distances (in feet) of System to: Dwelling: \_\_\_\_\_ Private ( ) / Public ( ) Water Source: \_\_\_\_\_ Property Line: 10'  
 Remarks: \_\_\_\_\_

DOES MEET (X).
