Permit No.: ST-36-07-603

County: Buckhannon-36
ON-SITE SEWAGE DISPOSAL SYSTEM
INSPECTION FORM

Name of Owner: Frederick W. Trante Installer: Larry Scott
 Address: 112 Pine St. - Wincennes, DE 19934
 Property Location: Sumner Hill Rd, Buckhannon, Lot #2
 Type of Facility: New Res. Facility is: New () Existing () Lot Size: 6.87 Sq. Ft./Acre
 Design Loading in gpd/No. Bedrooms: 3 Bedrooms Source of Water Supply: Ring Well

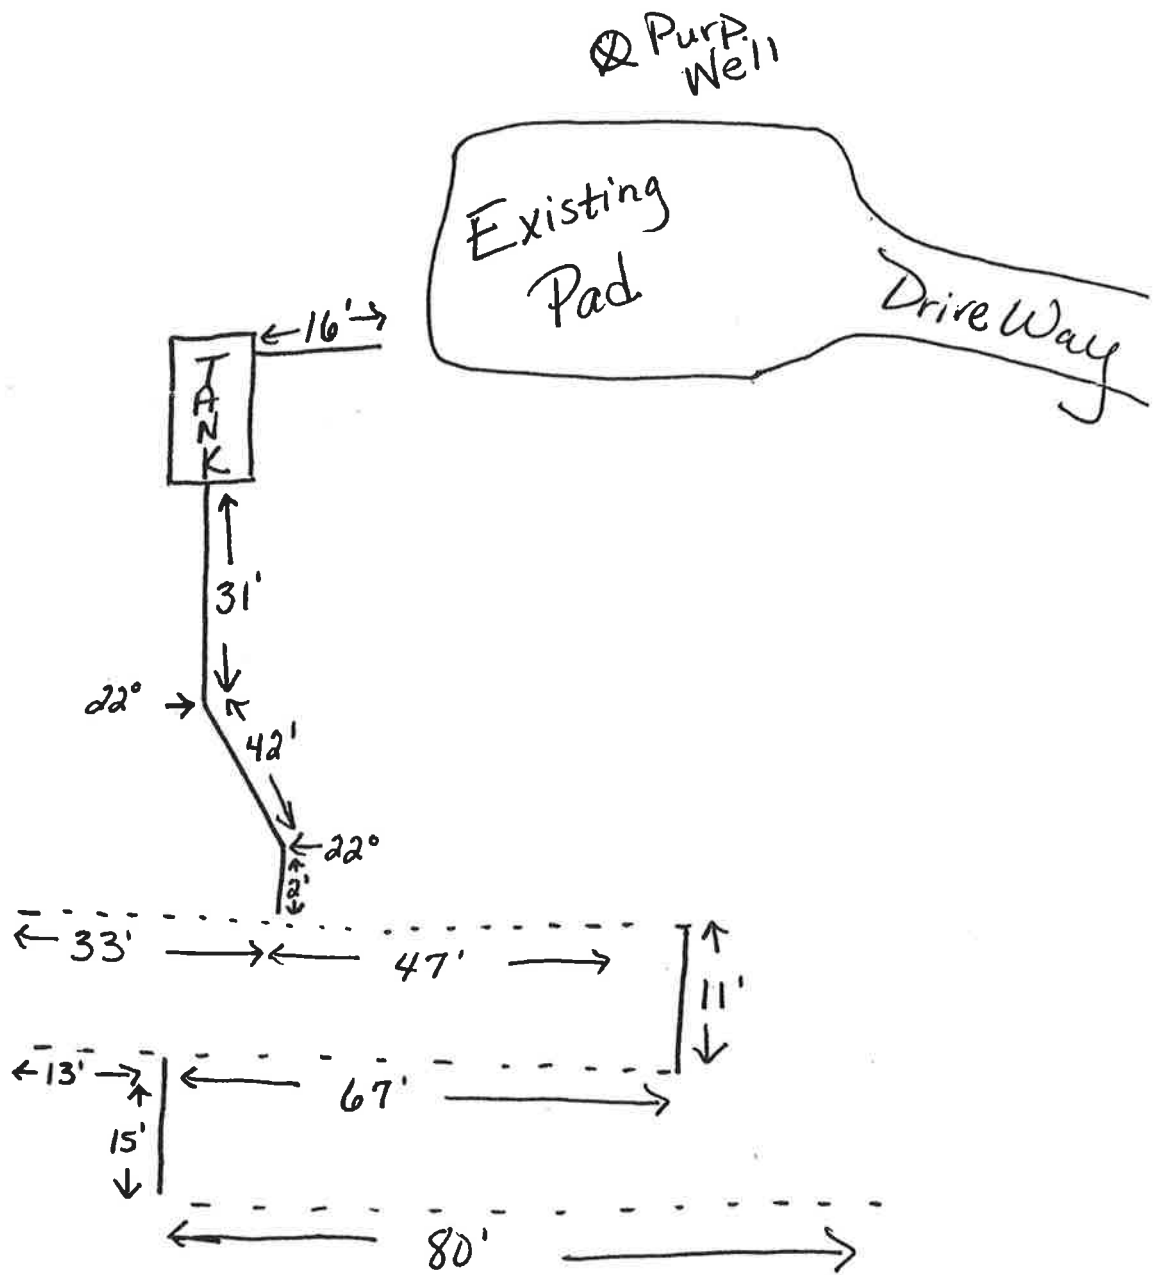
Fredrick W. Traute
ST-36-09-005

Sketch of Installation with Triangulation or Distance to Specific Landmarks:

RESERVE AREA

Wildlife Haven
Lot #2

R091219A
38°49'06.021"N
79°17'48.678"W
