Soil and Slope Levels  
5700 Middle Road  
Petaluma, CA 94952  
Marin County

©May 13th, 2022 JOB NO. 2022-100-BundesenC21-Ledger Ranch

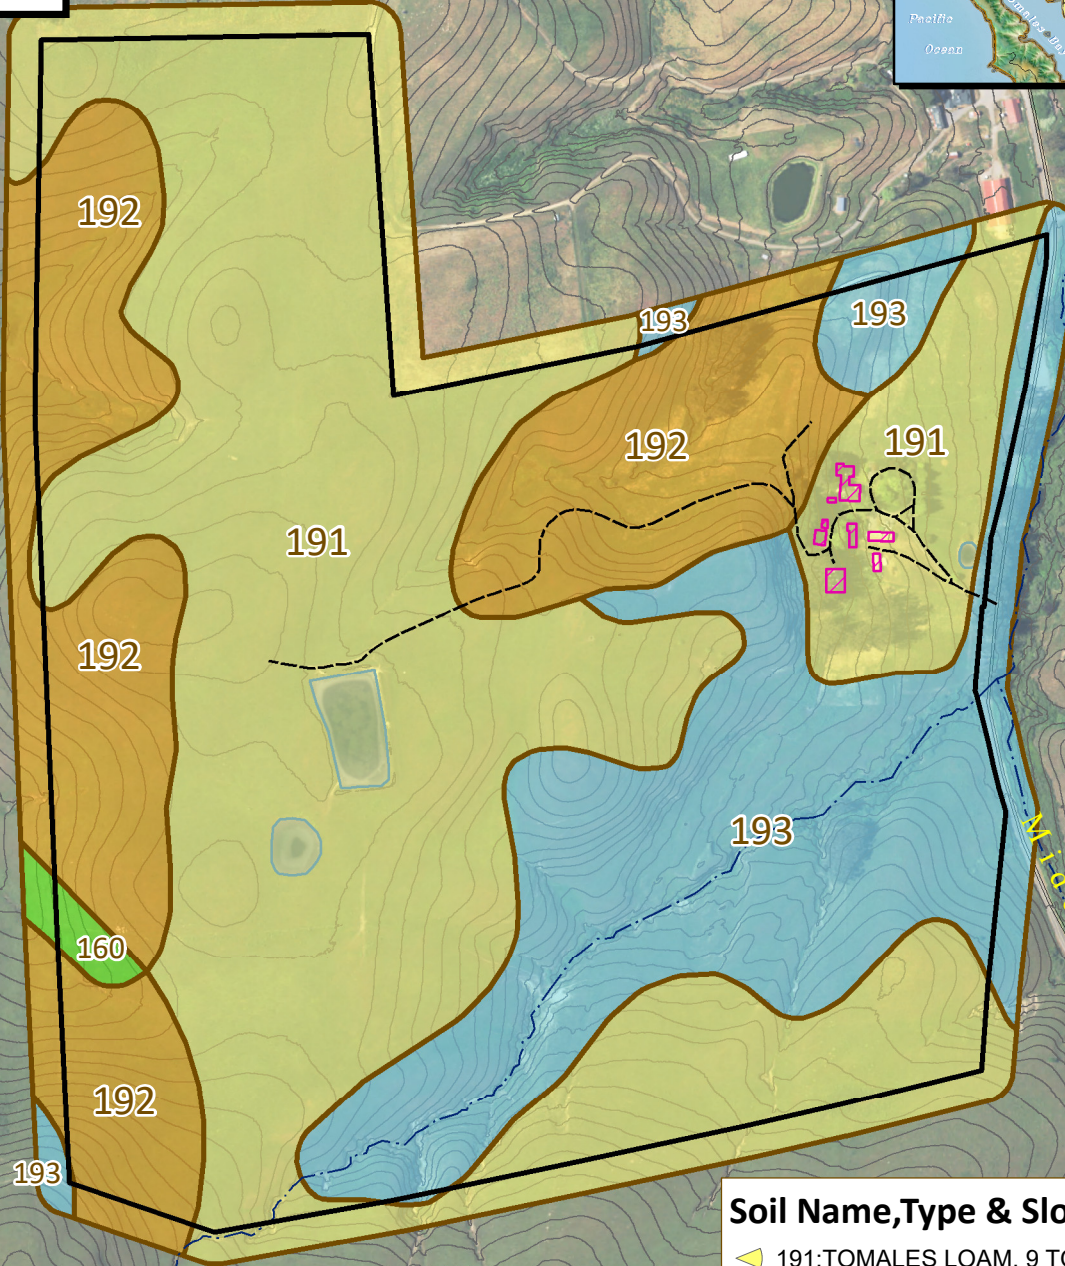
## Soil Name, Type & Slope Level

191; TOMALES LOAM, 9 TO 15% SLOPES
-

192; TOMALES LOAM, 15 TO 30% SLOPES
-

193; TOMALES LOAM, 30 TO 50% SLOPES
-

160; RODEO CLAY LOAM, 2 TO 15% SLOPES

SOIL DATA PER USDA, NATURAL RESOURCES CONSERVATION SERVICE. AERIAL PER NAIP, FLOWN 2020.
