Lot Survey

LOT 33, SADDLECREST ESTATES, PHASE 2, an Addition to Parker County, Texas.

According to the Plat as recorded in Plat Cabinet F, Slide 312, Plat Records, Parker County, Texas.

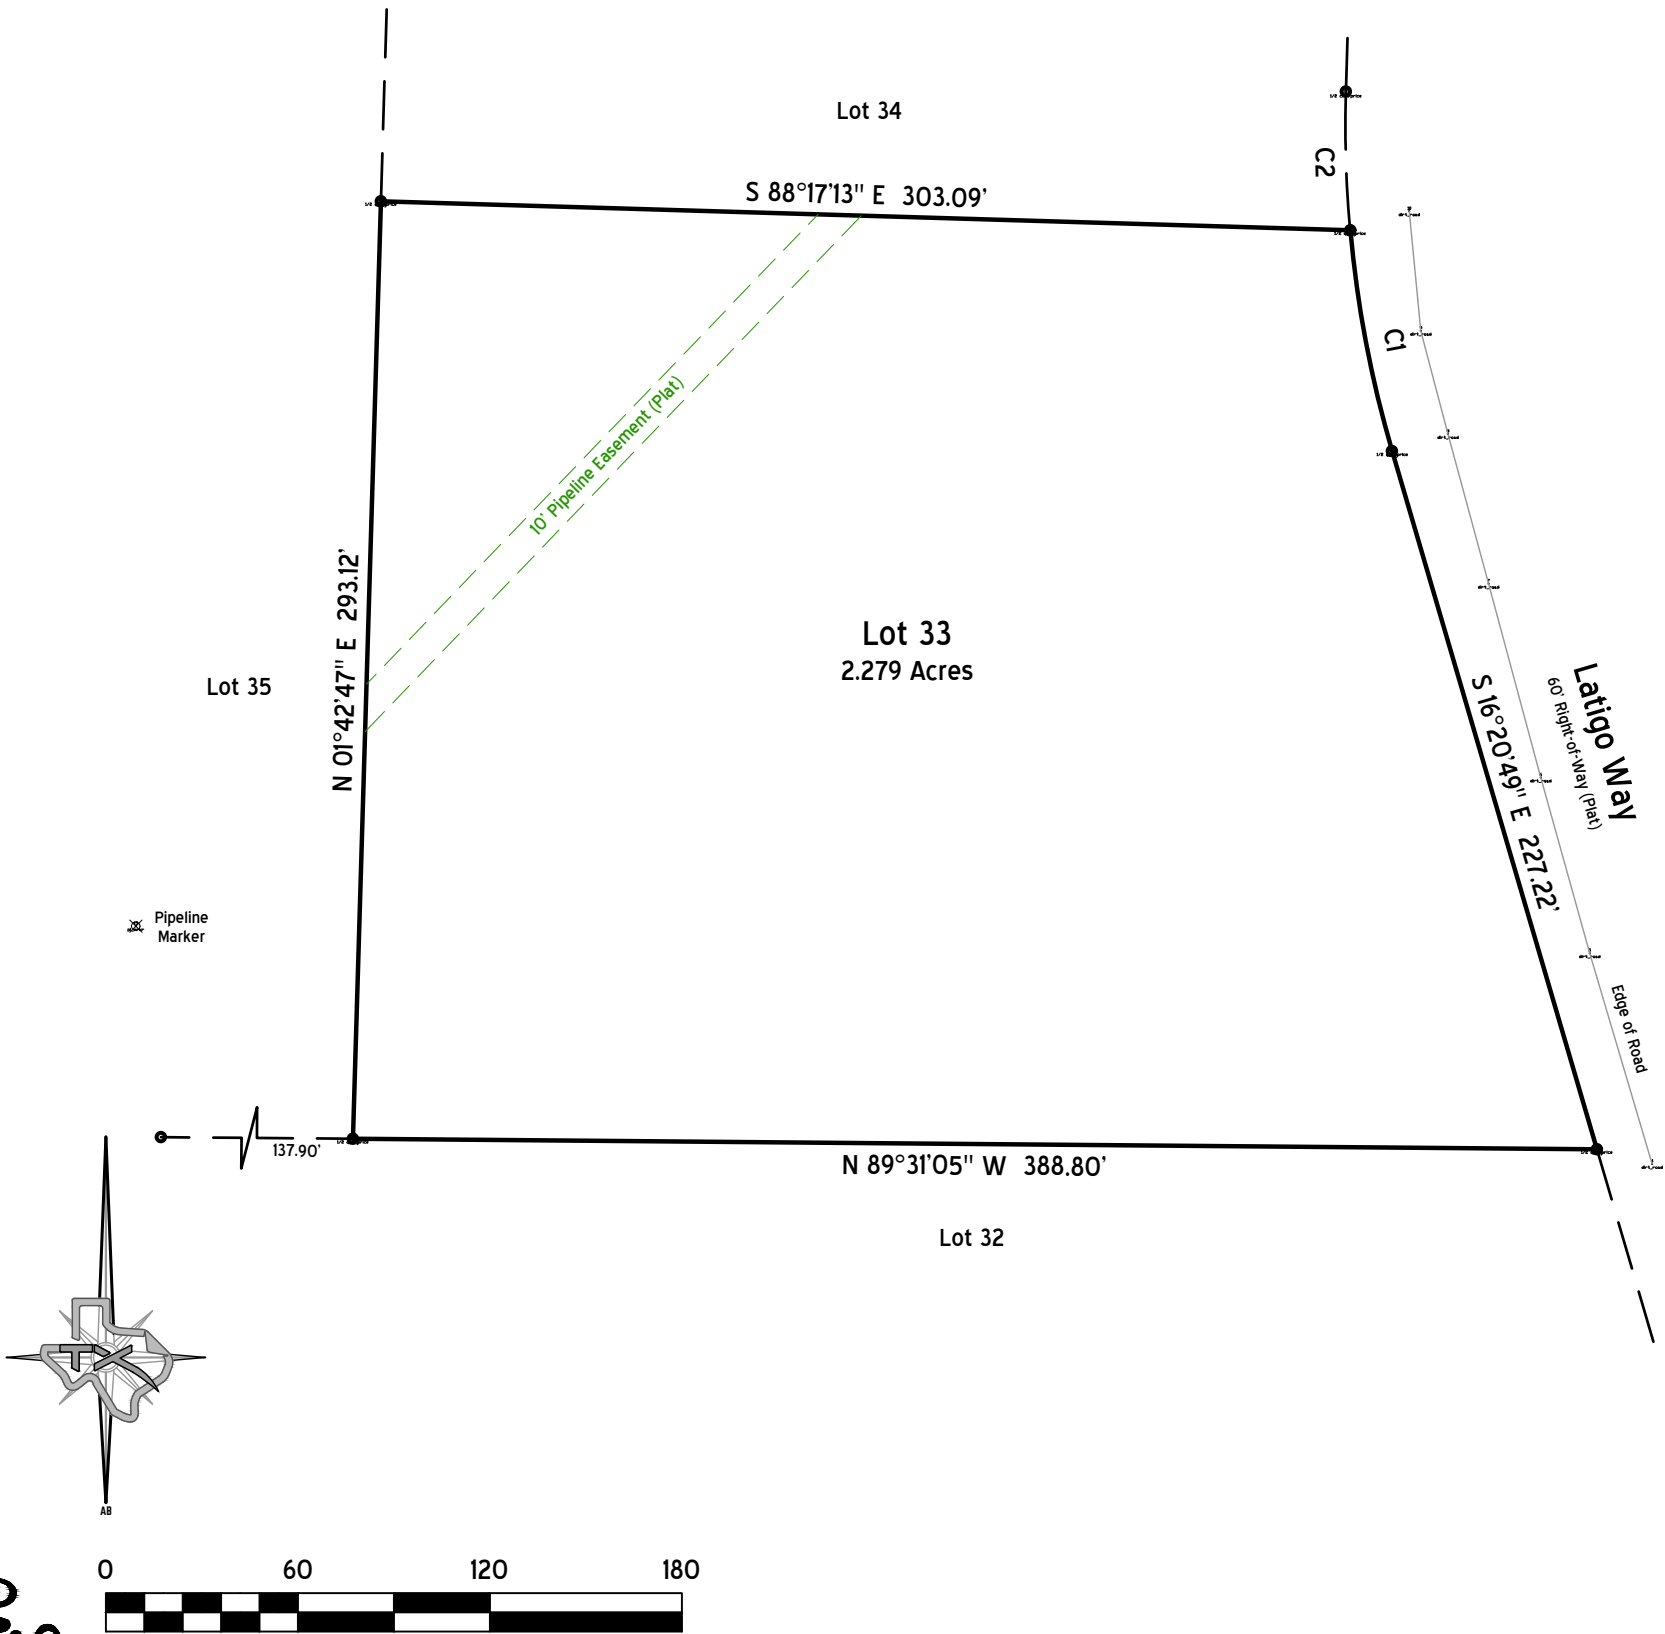
| CURVE | RADIUS | ARC | CHORD BEARING | CHORD |
| C1 | 360.00' | 70.51' | S 10°44'21" E | 70.40' |
| C2 | 360.00' | 43.74' | N 01°45'01" W | 43.72' |

- 6) All corners are found 1/2" capped iron rods, unless otherwise noted.
