STUCCO INSPECTOR

Stucco Inspection Report

495 Hickory Ridge Rd
Martinsville, VA 24112

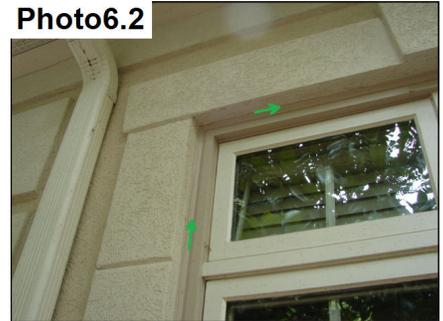
Window caulk at the frame appears to be correct and functioning properly.

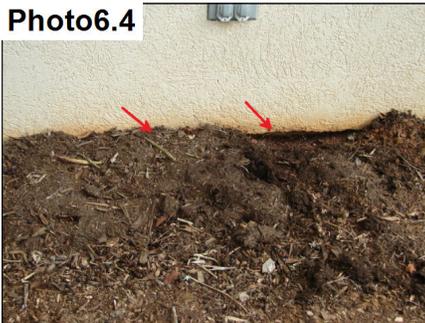
The stucco is below grade, need to bring the stucco above grade.

| Grid Location | Item Description | Moisture Readings | Substrate Condition | Observations | Chapter Reference |
|---|---|---|---|---|---|
| C7 | Below Grade | | | The stucco is below grade, need to bring the stucco above grade. | |

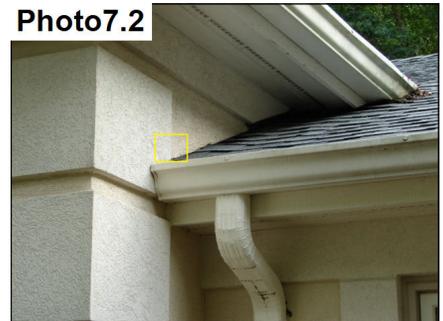
Photo7.2
Kickout flashing is missing and needs to be installed.

| Grid Location | Item Description | Moisture Readings | Substrate Condition | Observations | Chapter Reference |
|---|---|---|---|---|---|
| G&J 4 | Kickout | Normal | Firm | Kickout is missing and needs to be installed. | 3.4 |

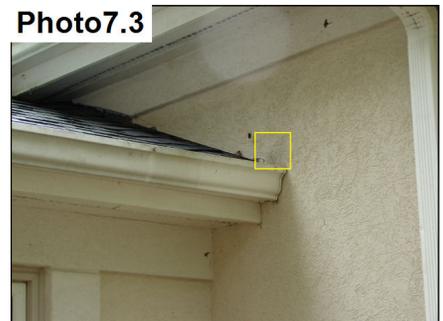
Photo7.3
Kickout flashing is missing and needs to be installed.

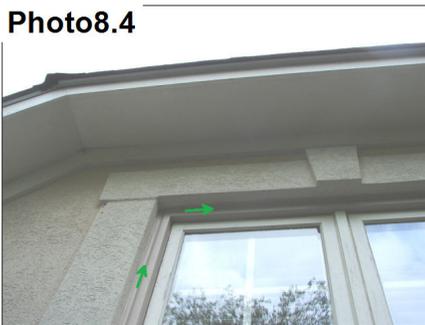
Window caulk at the frame appears to be correct and functioning properly.

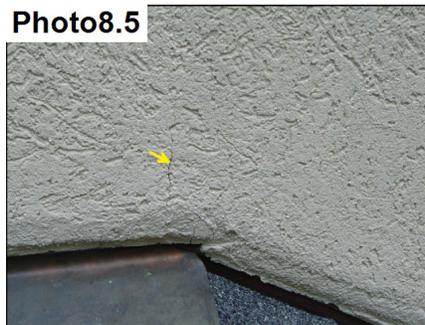
Exposed cracks need to be repaired and or sealed/caulked correctly.

| Grid Location | Item Description | Moisture Readings | Substrate Condition | Observations | Chapter Reference |
|---|---|---|---|---|---|
| F4 | Cracks | Normal | Firm | Exposed cracks need to be repaired and or sealed/caulked correctly. | 3.6 |

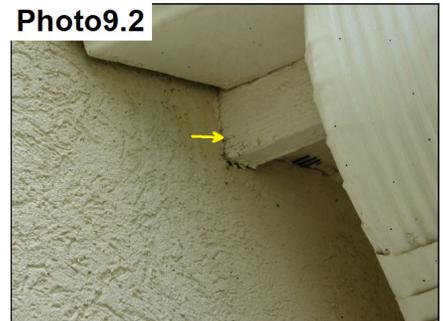
Soffit/Eaves area needs to be caulked at the stucco.

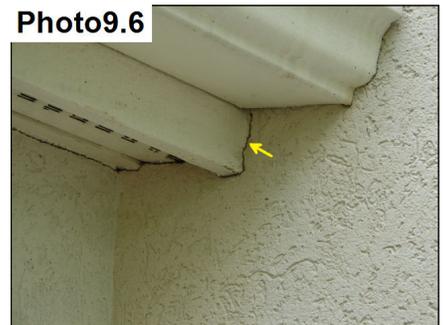
Photo9.6

Soffit/Eaves area needs to be caulked at the stucco.

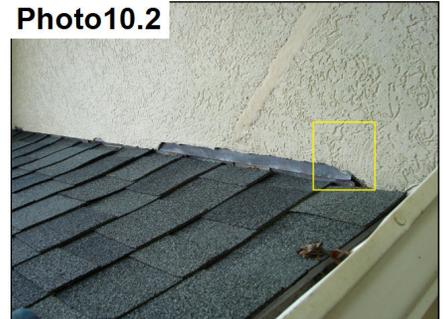
Photo10.2
Kickout flashing is missing and needs to be installed.

| Grid Location | Item Description | Moisture Readings | Substrate Condition | Observations | Chapter Reference |
|---|---|---|---|---|---|
| D4 | Kickout | Normal | Firm | Kickout is missing and needs to be installed. | 3.4 |

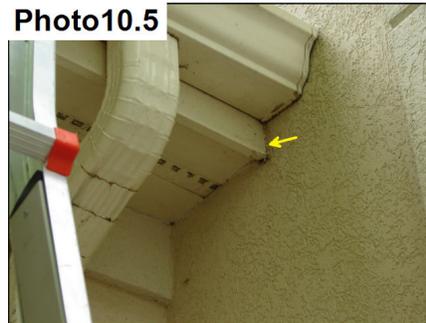
Photo10.5
Soffit/Eaves area needs to be caulked at the stucco.

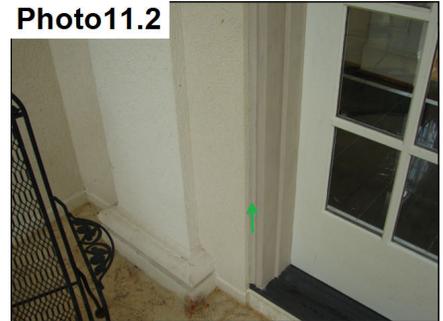
Door frame caulk appears to be correct and functioning properly.

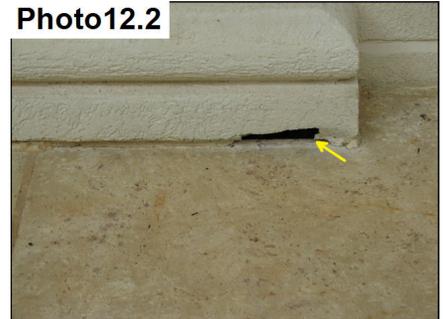
Damaged stucco needs to be repaired/sealed.

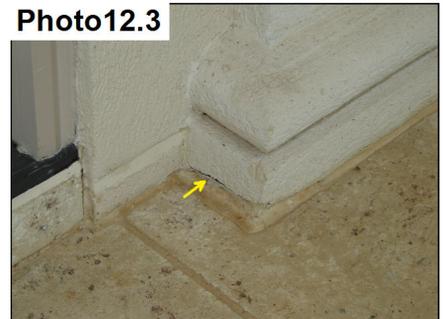
Stucco needs to be sealed at the tile.

| Grid Location | Item Description | Moisture Readings | Substrate Condition | Observations | Chapter Reference |
|---|---|---|---|---|---|
| F&H 7 | Stucco at tile | Normal | Firm | The stucco needs to be sealed at the tile area. | |

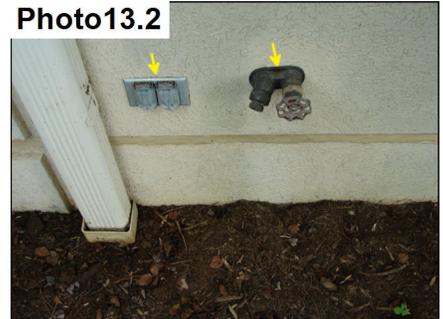
Utility breaches need to be caulked at the stucco.

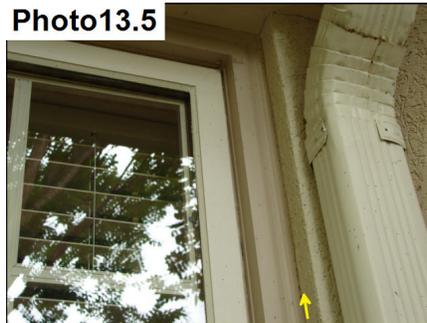
Thin and failing caulk at the window frame, need to re-caulk.

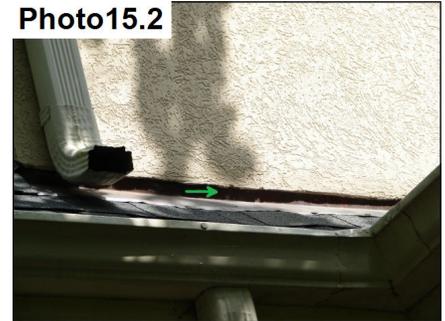
Proper stucco cutback at the roof shingles.

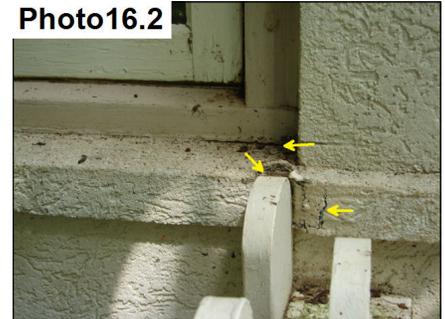
I suggest that window sill be caulked/re-caulked correctly.

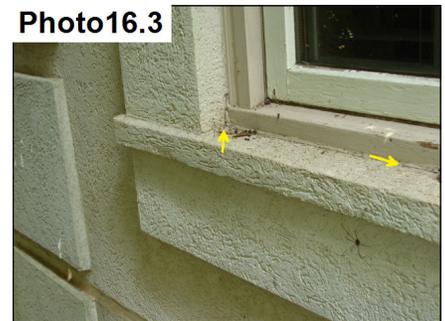
I suggest that window sill be caulked/re-caulked correctly.

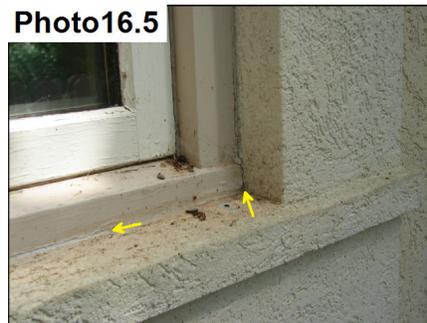
I suggest that window sill be caulked/re-caulked correctly.

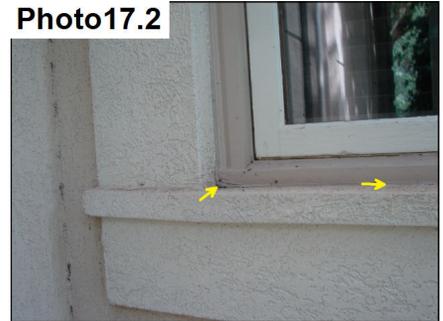
I suggest that window sill be caulked/re-caulked correctly.

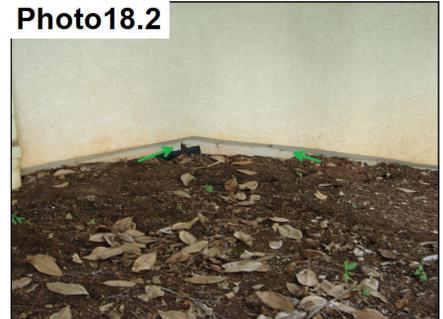
This area has the proper cutback at the stucco.

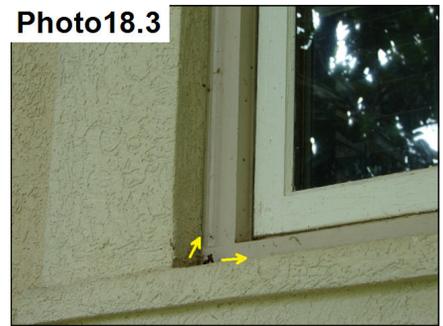
I suggest that window sill be caulked/re-caulked correctly.

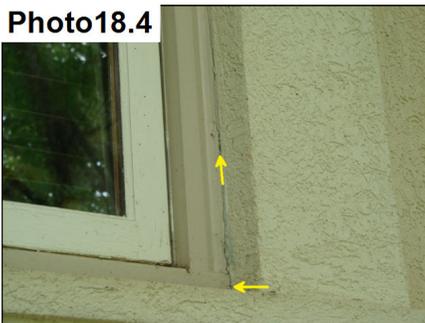
Thin and failing caulk at the window frame, need to re-caulk.

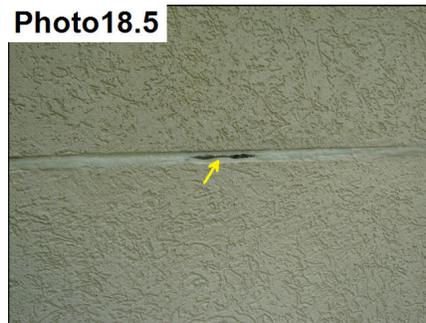
Failed caulked at the joint, need to caulk correctly.

| Grid Location | Item Description | Moisture Readings | Substrate Condition | Observations | Chapter Reference |
|---|---|---|---|---|---|
| H&J 6 | Joint failure | | | Caulk failure at the joint, need to re-caulk correctly. | |

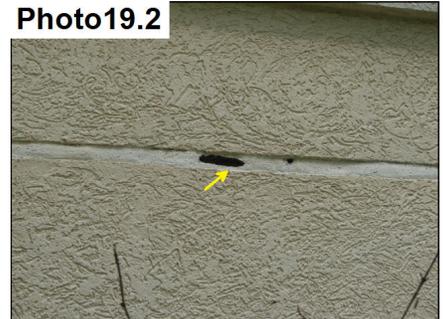
Caulk failure at the joint, need to re-caulk correctly.

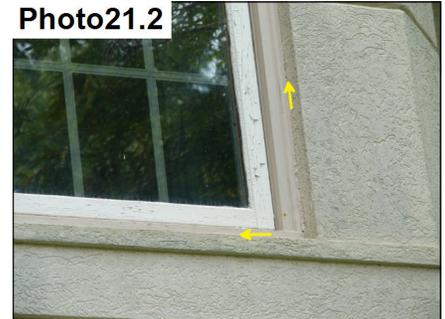
Photo21.2
Thin and failing caulk at the window frame, need to re-caulk.

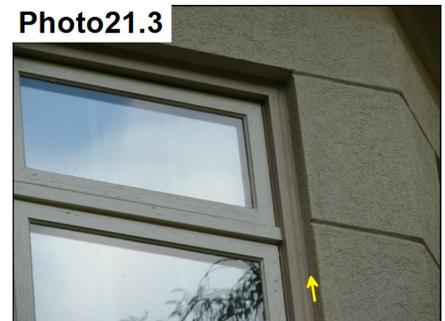
Photo21.3
Thin and failing caulk at the window frame, need to re-caulk.

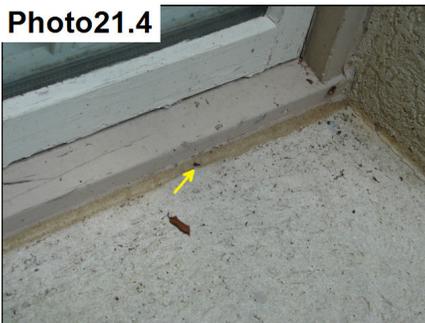
Photo21.4
Caulk failure at the window frame, need to re-caulk the window.

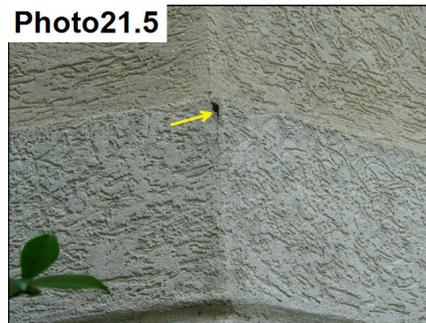
Photo21.5
Exposed cracks need to be repaired and or sealed/caulked correctly.

| Grid Location | Item Description | Moisture Readings | Substrate Condition | Observations | Chapter Reference |
|---|---|---|---|---|---|
| D6 | Cracks | Normal | Firm | Exposed cracks need to be repaired and or sealed/caulked correctly. | 3.6 |

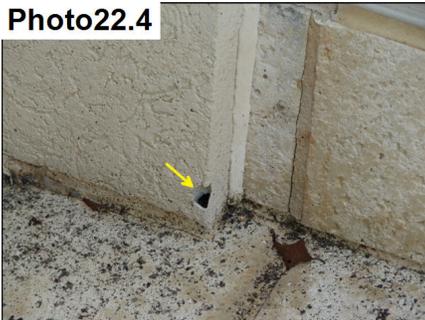
Damaged stucco, need to seal correctly.

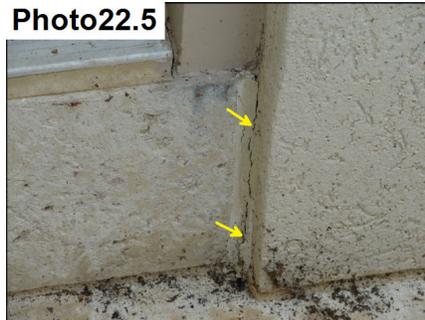
Caulk failure at the accent door threshold area, need to re-caulk.

| Grid Location | Item Description | Moisture Readings | Substrate Condition | Observations | Chapter Reference |
|---|---|---|---|---|---|
| C&D 6 | Door threshold | | | Caulk failure and damage at the stucco, needs to be sealed/repared. | |

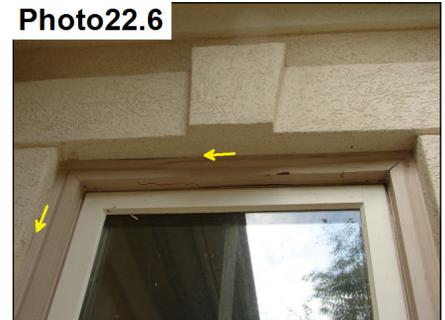
Thin and failing caulk at the window frame, need to re-caulk.

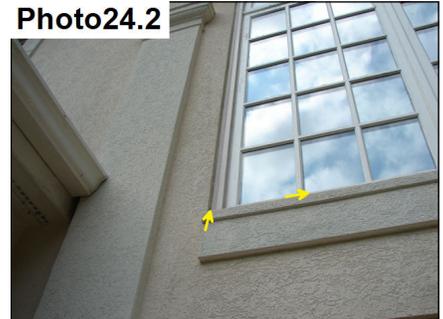
Photo24.2
Thin and failing caulk at the window frame, need to re-caulk.

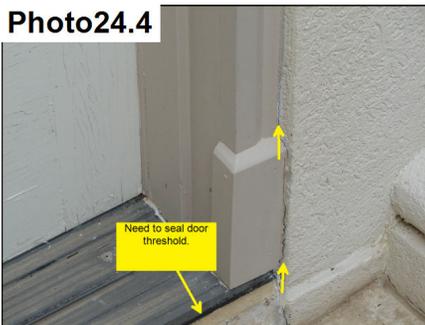
Photo24.4
Thin and failing caulk at the door frame, need to re-caulk.

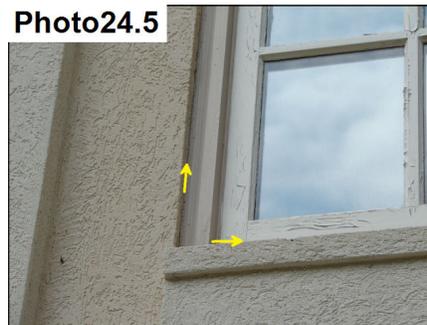
Photo24.5
Thin and failing caulk at the window frame, need to re-caulk.

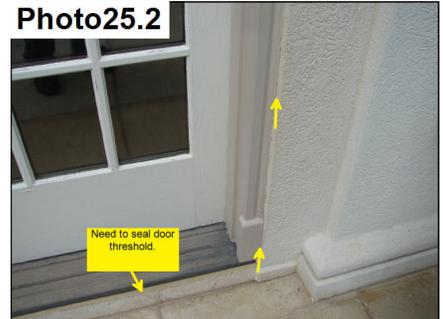
Thin and failing caulk at the door frame, need to re-caulk.

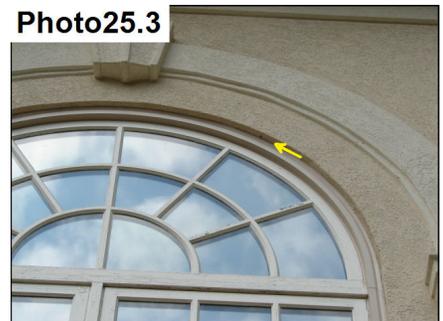
Thin and failing caulk at the window frame, need to re-caulk.

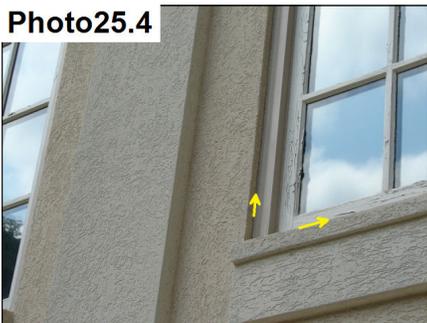
Thin and failing caulk at the window frame, need to re-caulk.

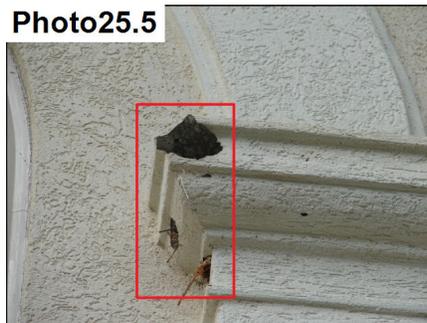
Damaged stucco needs to be repaired.

| Grid Location | Item Description | Moisture Readings | Substrate Condition | Observations | Chapter Reference |
|---|---|---|---|---|---|
| I3 | Damage | | | Damaged stucco needs to be repaired. | |

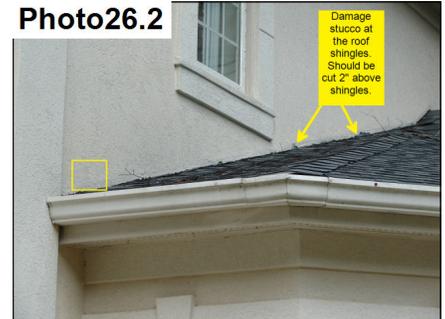
Photo26.2

Kickout flashing is missing and needs to be installed.

| Grid Location | Item Description | Moisture Readings | Substrate Condition | Observations | Chapter Reference |
|---|---|---|---|---|---|
| A3 | Kickout | Normal | Firm | Kickout is missing and needs to be installed. | 3.4 |

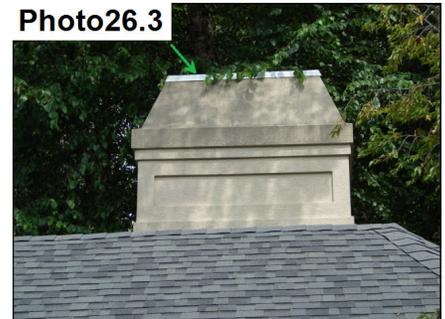
Photo26.3

Chimney is capped correctly.

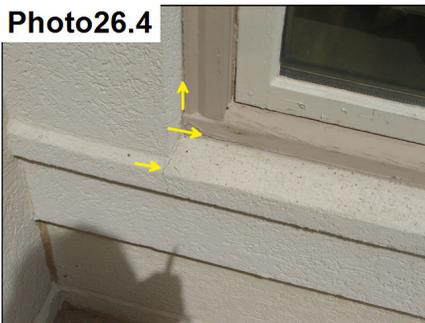
Photo26.4

Thin and failing caulk at the window frame, need to re-caulk.

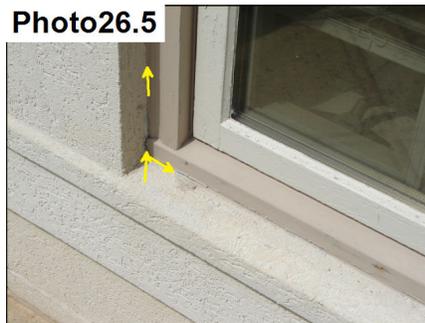
Photo26.5

Thin and failing caulk at the window frame, need to re-caulk.

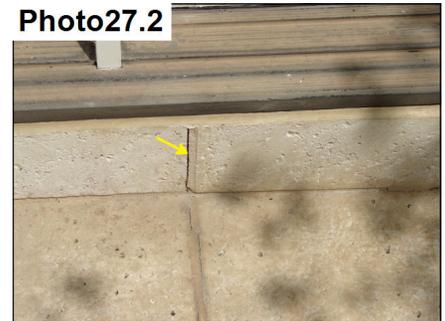
Grout failure, deck area.

| Grid Location | Item Description | Moisture Readings | Substrate Condition | Observations | Chapter Reference |
|---|---|---|---|--|---|
| | Grout failure | | | Grout failure is causing stucco issues at the lower deck area. | |

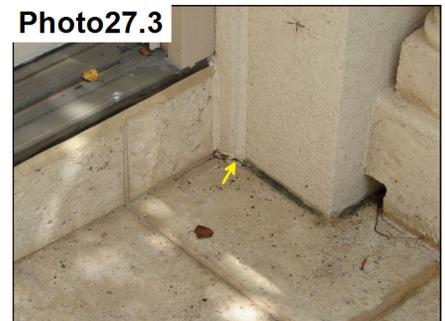
Leak area at deck flowing to lower area.

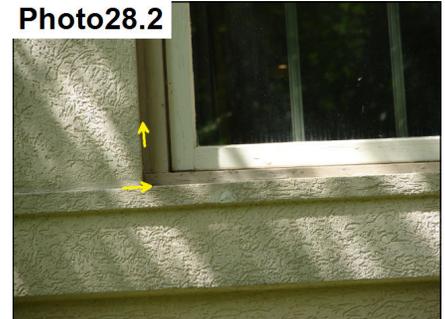
Thin and failing caulk at the window frame, need to re-caulk.

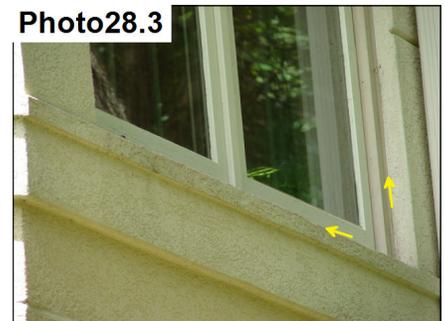
Thin and failing caulk at the window frame, need to re-caulk.

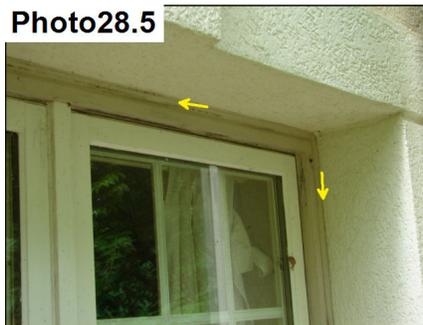
Thin and failing caulk at the window frame, need to re-caulk.

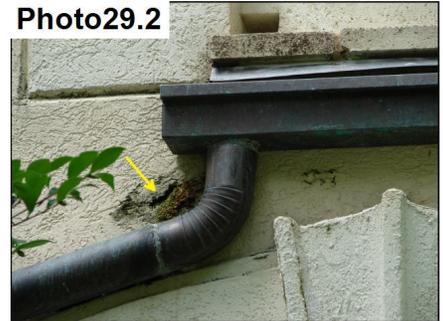
Water entering the stucco.

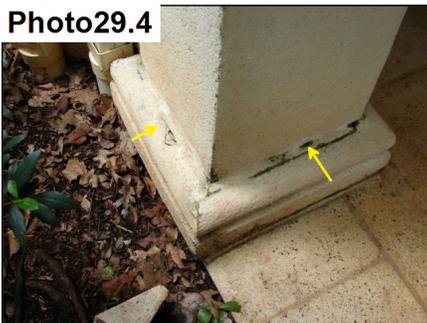
Water entering the stucco between the stucco and concrete.

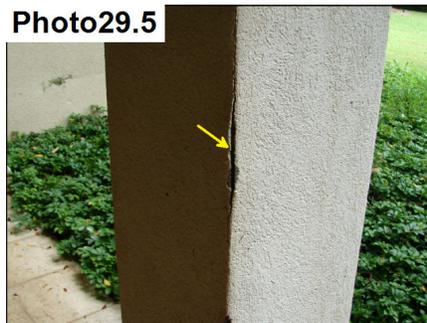
Water entering the stucco between the stucco and concrete.

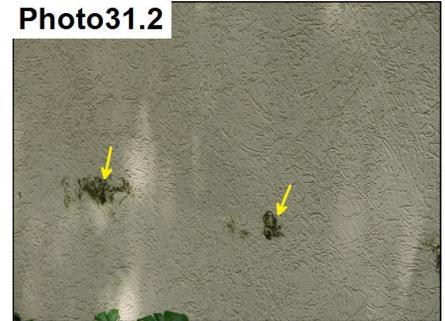
Signs of water entry between the stucco and the concrete construction.

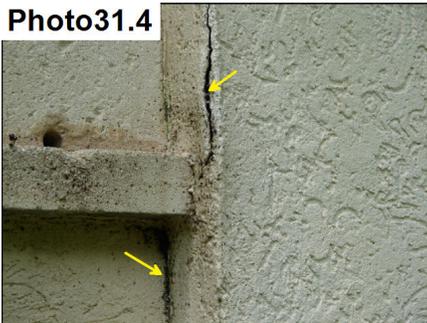
Signs of water entry between the stucco and the concrete construction.

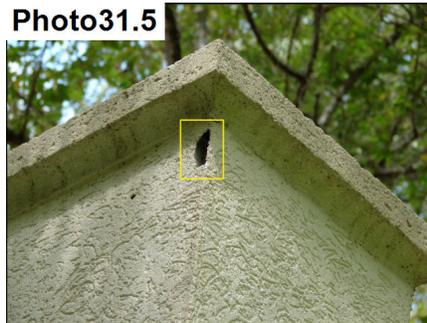
Hole in the stucco needs to be sealed.

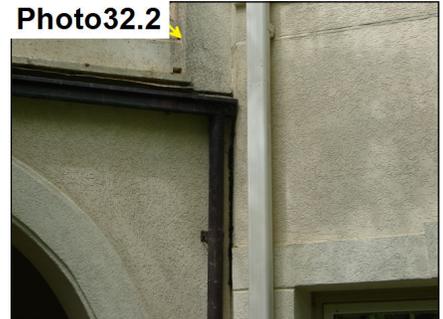
It appears that this is one water entry area.

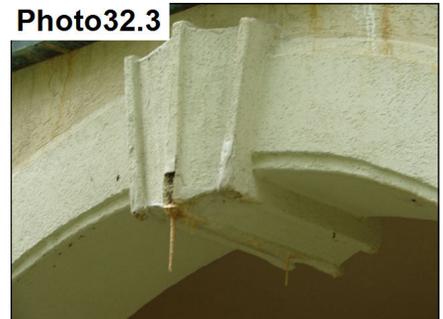
Signs of water entry between the stucco and the concrete construction.

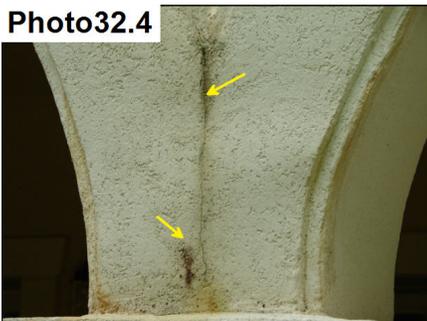
Signs of water entry between the stucco and the concrete construction.

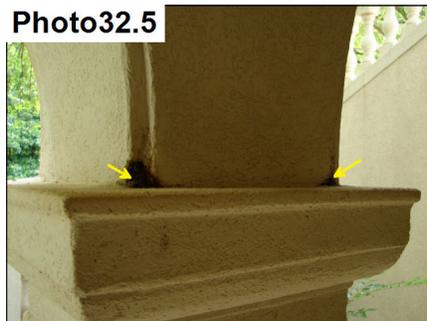
Signs of water entry between the stucco and the concrete construction.

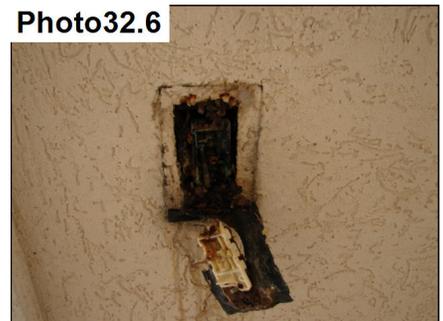
Signs of water entry between the stucco and the concrete construction.

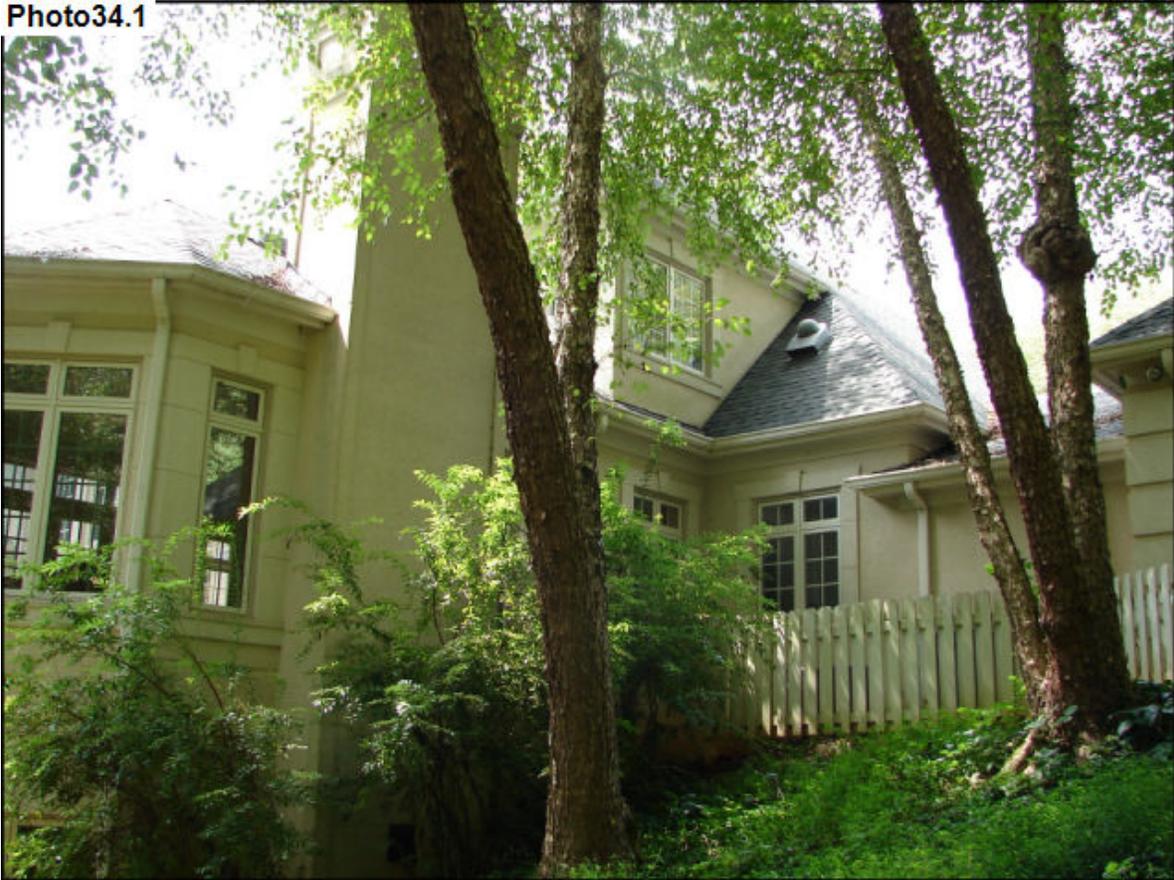
Photo34.1

Right back area.

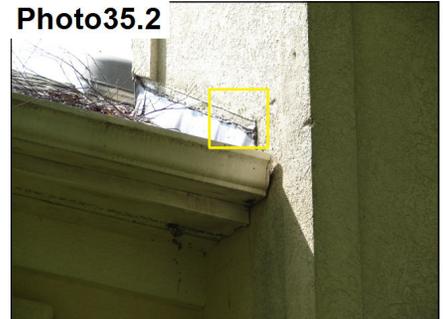
Photo35.2
Kickout flashing is missing and needs to be installed.

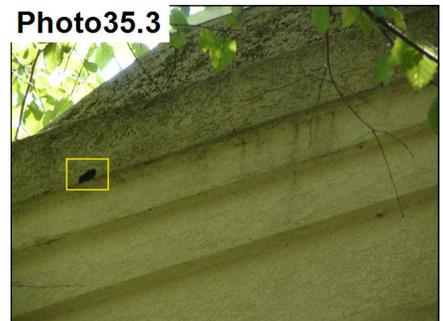
Photo35.3
Hole in the chimney, need to seal correctly.

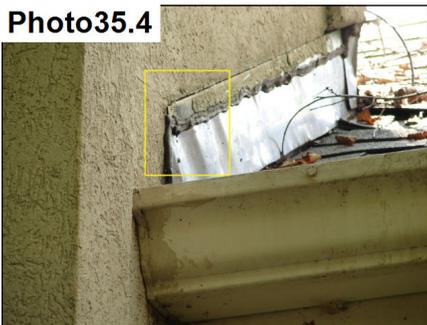
Photo35.4
Kickout flashing is missing and needs to be installed.

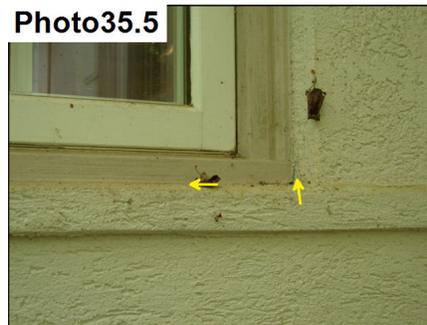
Photo35.5
Thin and failing caulk at the window frame, need to re-caulk.

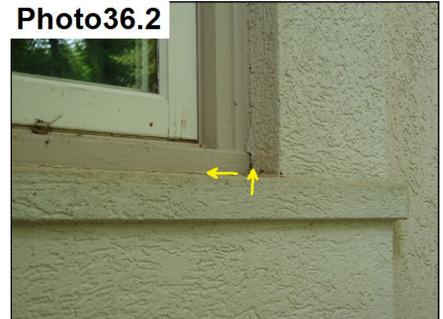
Thin and failing caulk at the window frame, need to re-caulk.

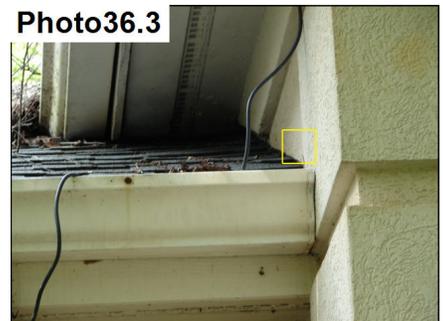
Kickout flashing is missing and needs to be installed.

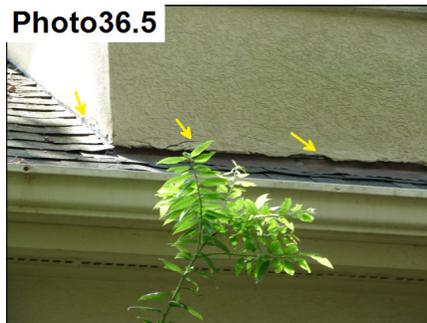
Damaged stucco needs repair.

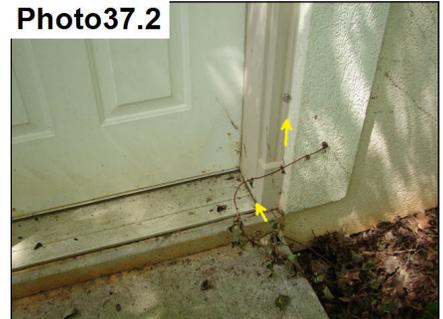
Door frame and thresholds need to be sealed correctly.

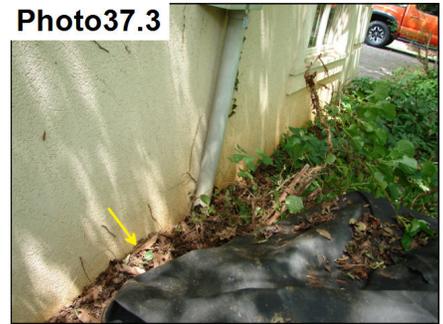
Stucco is below grade, need to bring above the grade.

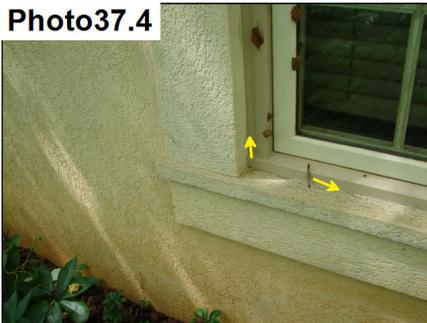
Thin and failing caulk at the window frame, need to re-caulk.

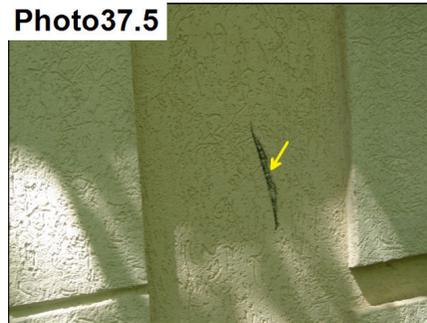
Damaged stucco needs to be sealed.

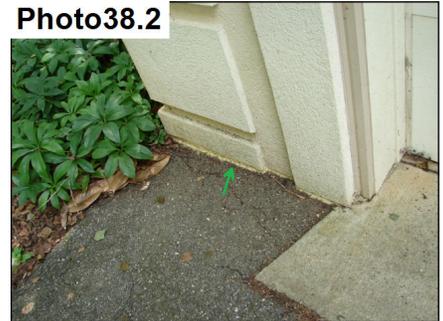
Stucco is sealed correctly.

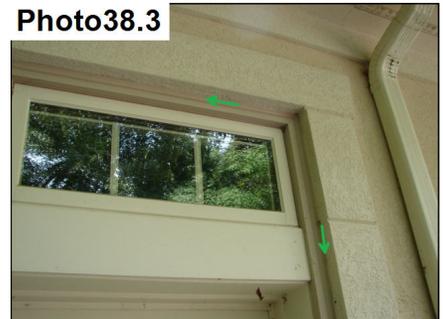
Garage door frame caulk appears to be functioning properly.

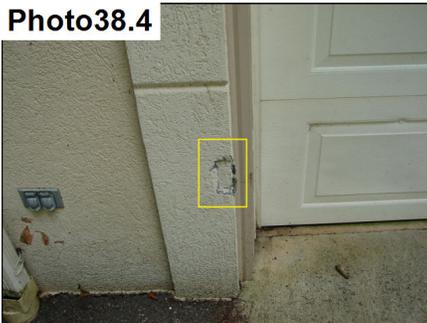
Damaged stucco needs to be repaired.

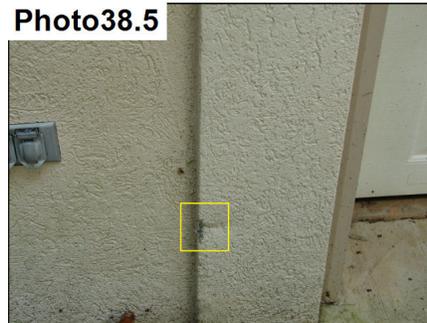
Damaged stucco needs to be repaired.

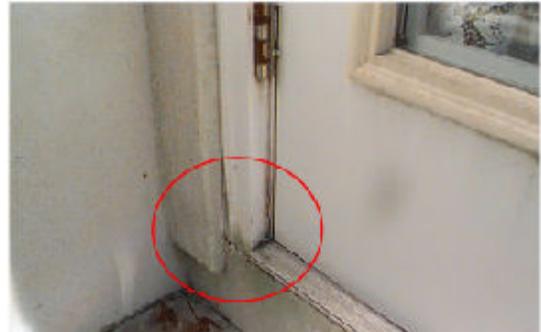
Fig. 1: Damage caused by No sealants

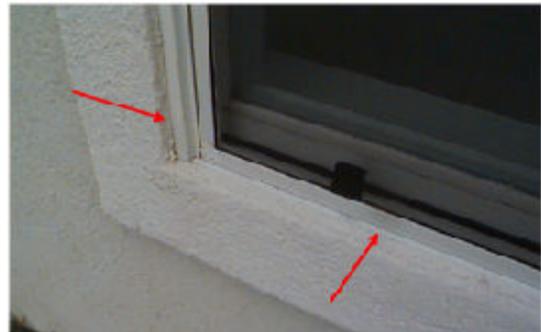
Fig. 2: Example of unsealed window perimeter

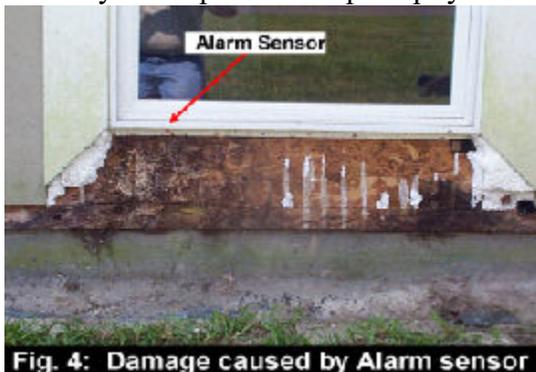
Fig. 4: Damage caused by Alarm sensor

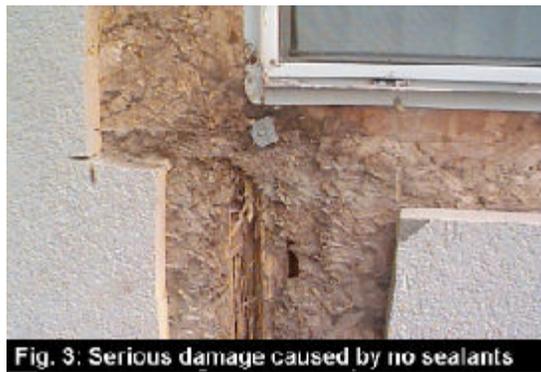
Fig. 3: Serious damage caused by no sealants

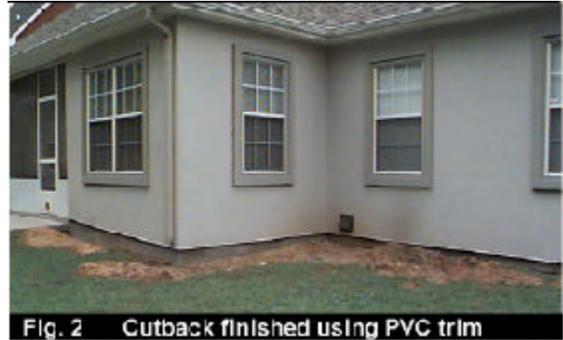
Fig. 2 Cutback finished using PVC trim

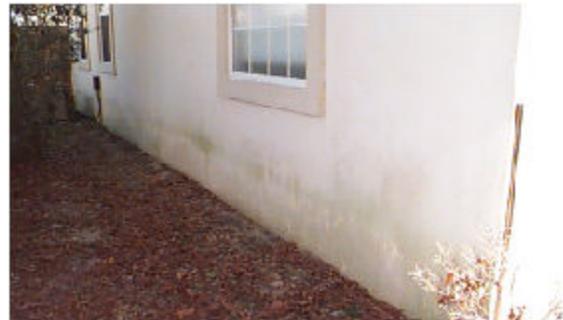
1) To prevent wicking, a process in which standing water is absorbed by the EPS foam board, which leads to mold and mildew behind EIFS. Figure 1 shows an example of a home where the stucco system was not backwrapped and extended below grade. Water wicked up behind the stucco, causing mold, mildew and decay of the underlying sheathing. Wicking can also occur when stucco is terminated at grade level as seen in Figure 4.

Fig. 1 Moisture caused by the wicking process

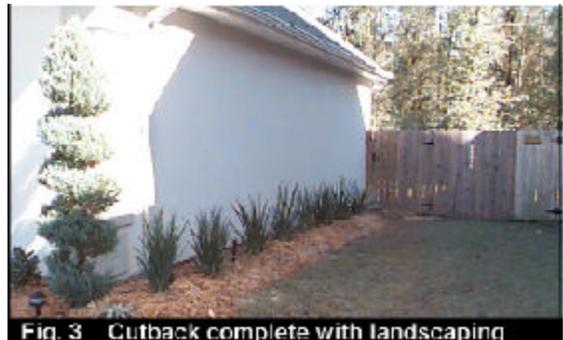
Fig. 3 Cutback complete with landscaping

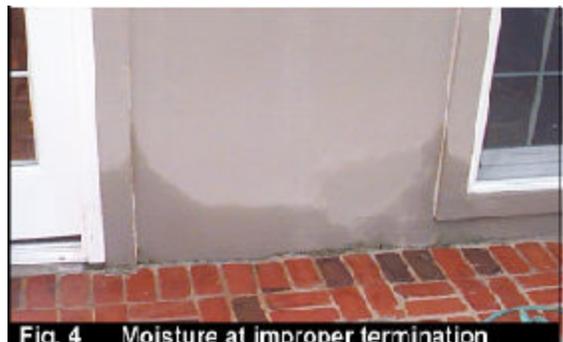
Fig. 4 Moisture at improper termination

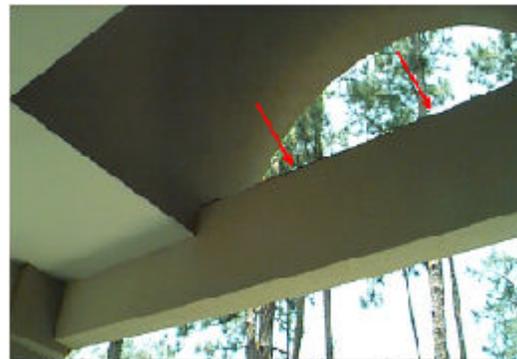
Fig. 2: Flat surfaces on top of beams

The easiest corrective measure would be to coat all flat surfaces with an elastomeric waterproofing coating tinted to match the existing stucco color as closely as possible. Large flat areas, such as a parapet wall, can be capped with metal and sealed.

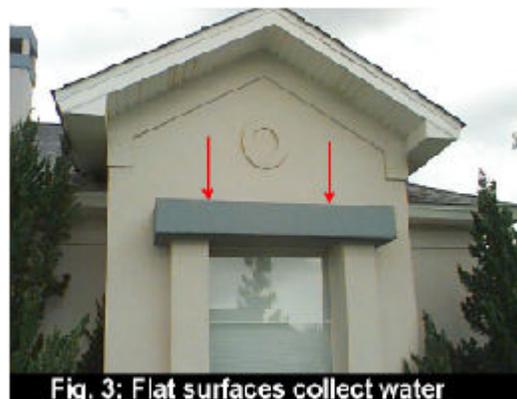
Fig. 3: Flat surfaces collect water

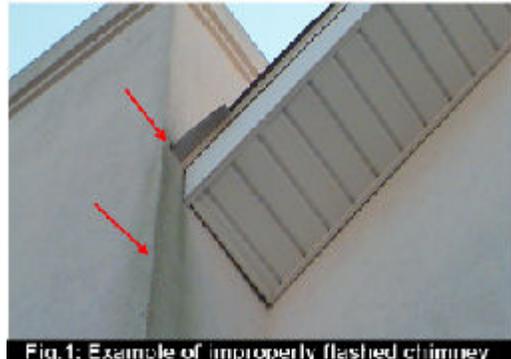
Fig.1: Example of improperly flashed chimney

Figure 1 shows a chimney that was not properly flashed (sidewall and kickout flashing see section 3.4) which resulted in wood rot and termite infestation. Figure 2 shows a chimney coping that was not sealed to the stucco which has now separated and will allow water into the chimney chase.

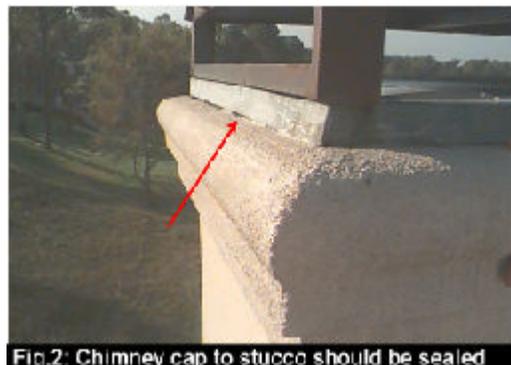
Fig.2: Chimney cap to stucco should be sealed

A properly designed chimney cap (coping) will shed water away from the stucco to metal joint (Figure 2) and help prevent leaks in this area. The flue should be properly sealed to the "storm flashing" and the chimney cap (coping) sealed to the stucco.
