Hansen Home  
Inspections

# Home Inspection Report

407 High Crossing Road, Smithville, TX 78957

Thursday, May 6, 2021

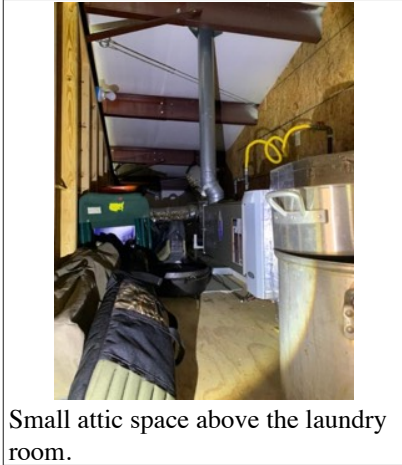
*Comments:* The roof and attic structure were performing as intended on the day of the inspection.

Small attic space above the laundry room.

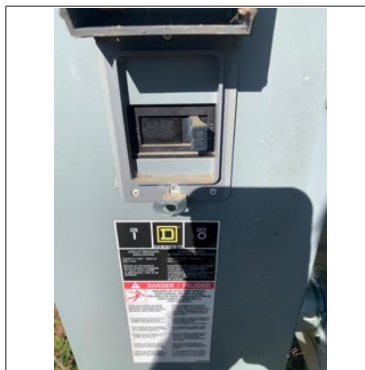
200 amp service.

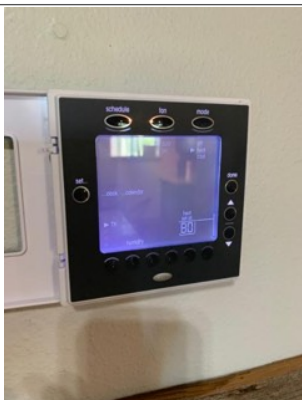
System was operational.

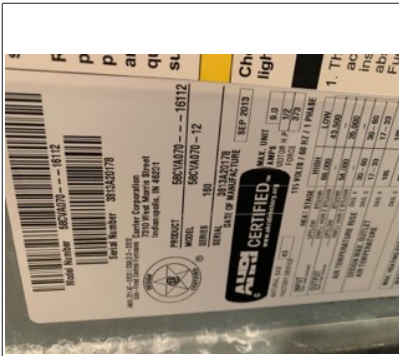
Label inside the furnace- made in 2013.

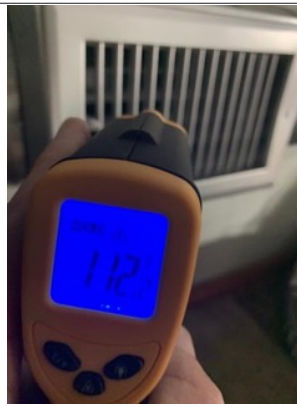
The temperature at the return vents was measured at 72 degrees, and the temperature at the air vents was measured at 107-112 degrees. This is within normal parameters.

Air vent temp = 112 degrees.

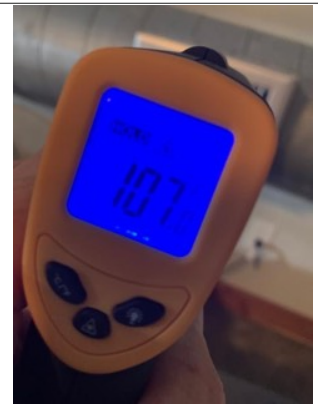
Air vent temp = 107 degrees.

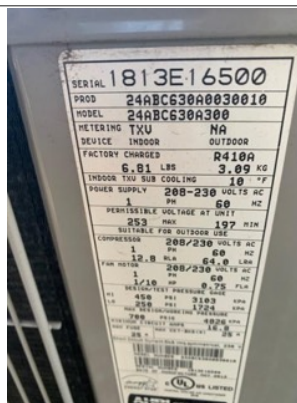
Label on the outside unit. Made in 2013.

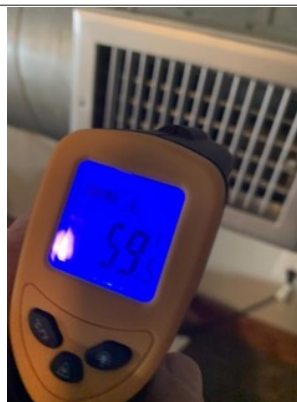
The temperature at the return vents was measured at 74 degrees, and the temperature at the air vents was measured at 57-59 degrees. This is within normal parameters.

Air vent temp = 59 degrees.

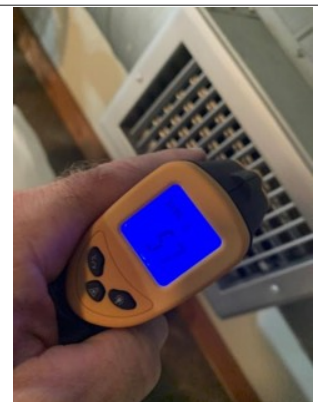
Air vent temp = 57 degrees.

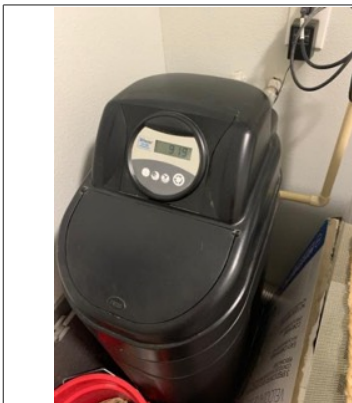
Water softener systems are not inspected.

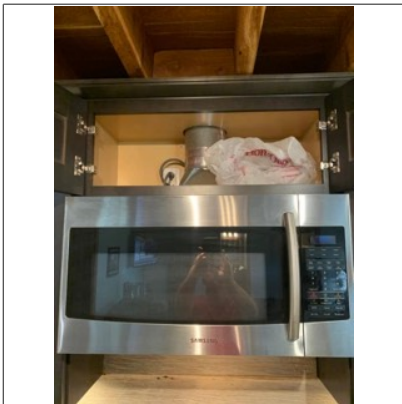
*Comments:* The range hood exhaust system was performing as intended on the day of the inspection.

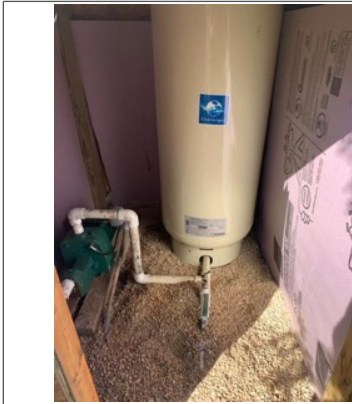
Pressurized tank in well house.

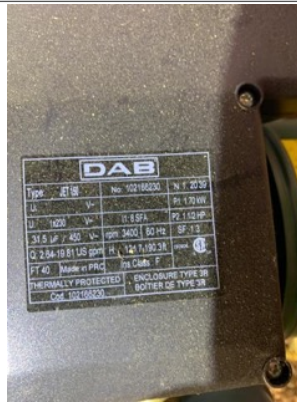
Pump label.
